Road Shoulder Hazards along
Branch Crossing and Terramont
January 2015

Hazards on road shoulders, that could pose a risk to cyclists, were identified in January 2015 by volunteers from Bike The Woodlands Coalition.

Branch Crossing and Terramont Hazard Locations

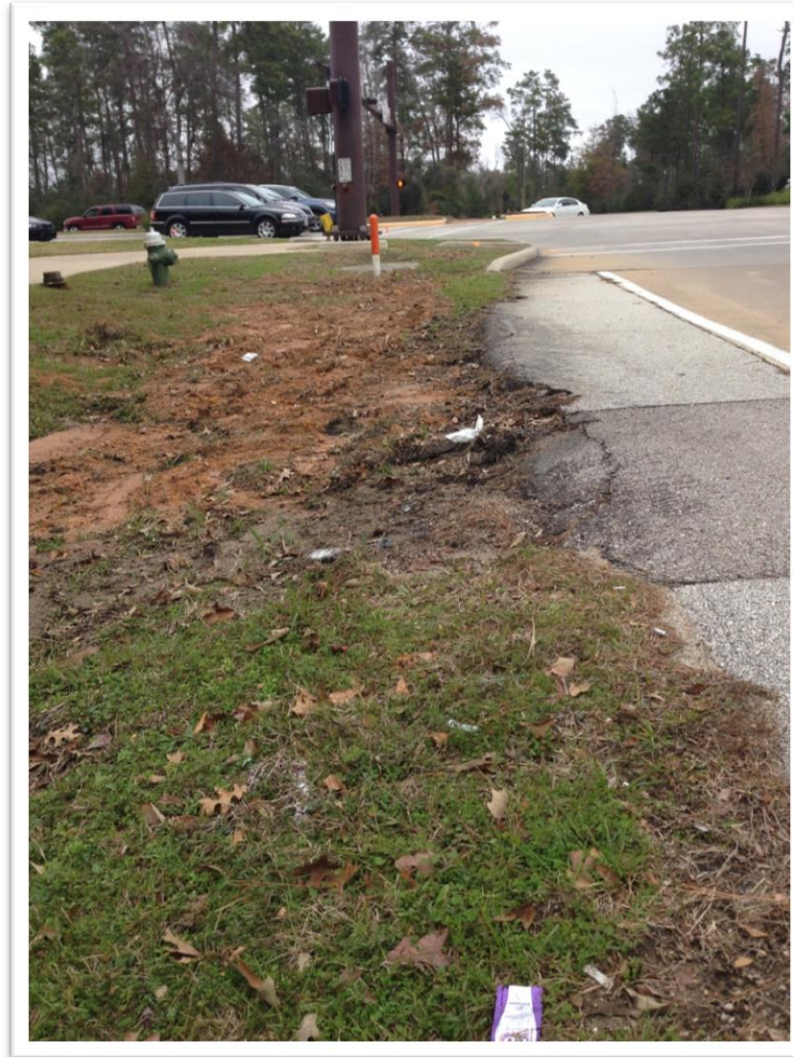
Location BC-1
Branch Crossing
Eastbound

Hazard Type: Other
Severity: 3

Damage was caused by digging adjacent to
the roadway

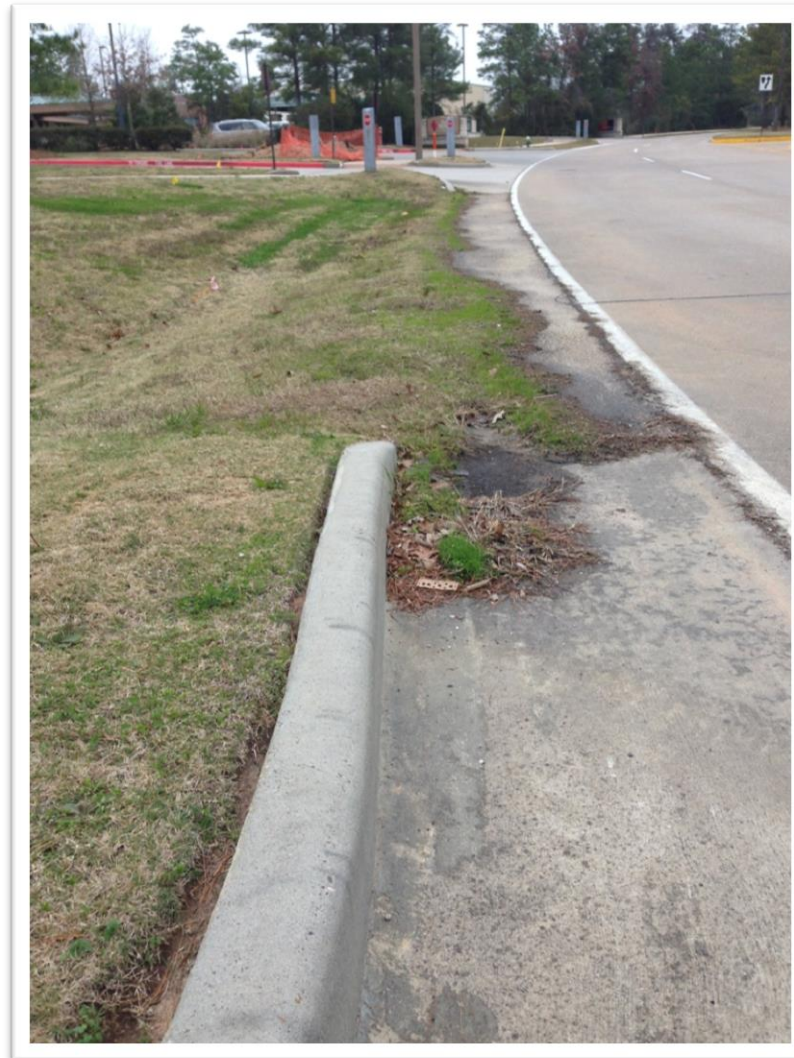
Location BC-2
Branch Crossing
Eastbound

Hazard Type: Other
Severity: 3

Vegetation growing across the shoulder

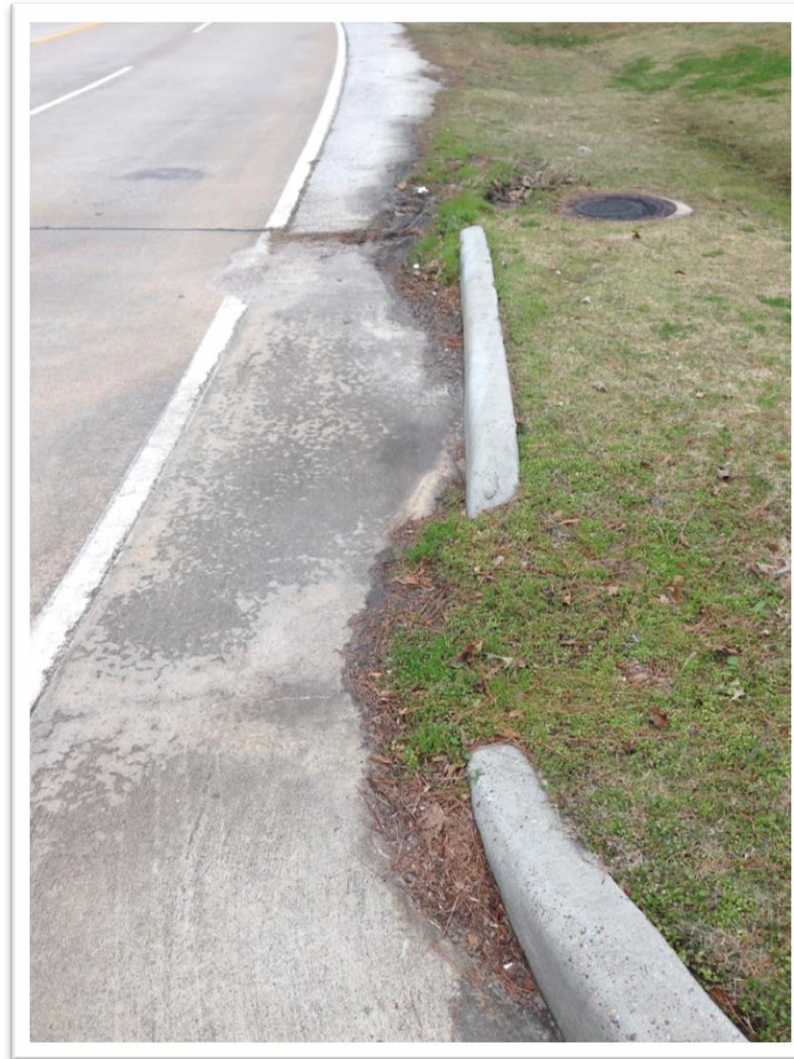
Location BC-3
Branch Crossing
Eastbound

Hazard Type: Other
Severity: 2

Silt accumulating on the shoulder - allowing
vegetation to grow.

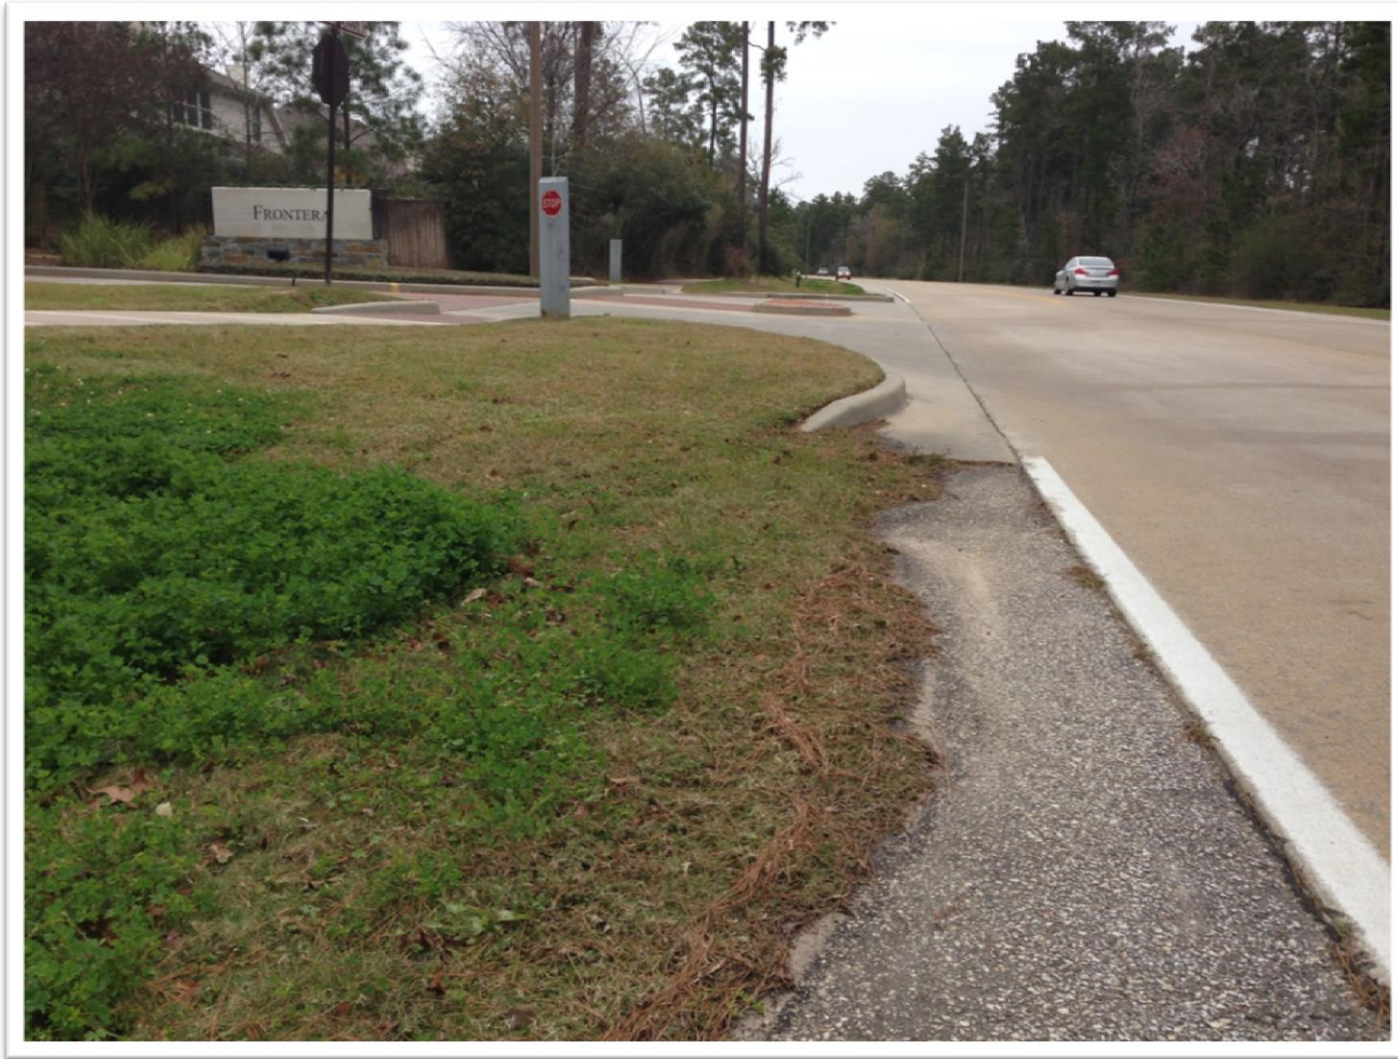
Location BC-4
Branch Crossing
Eastbound

Hazard Type: Other
Severity: 2

Silt accumulating on the shoulder - allowing
vegetation to grow.

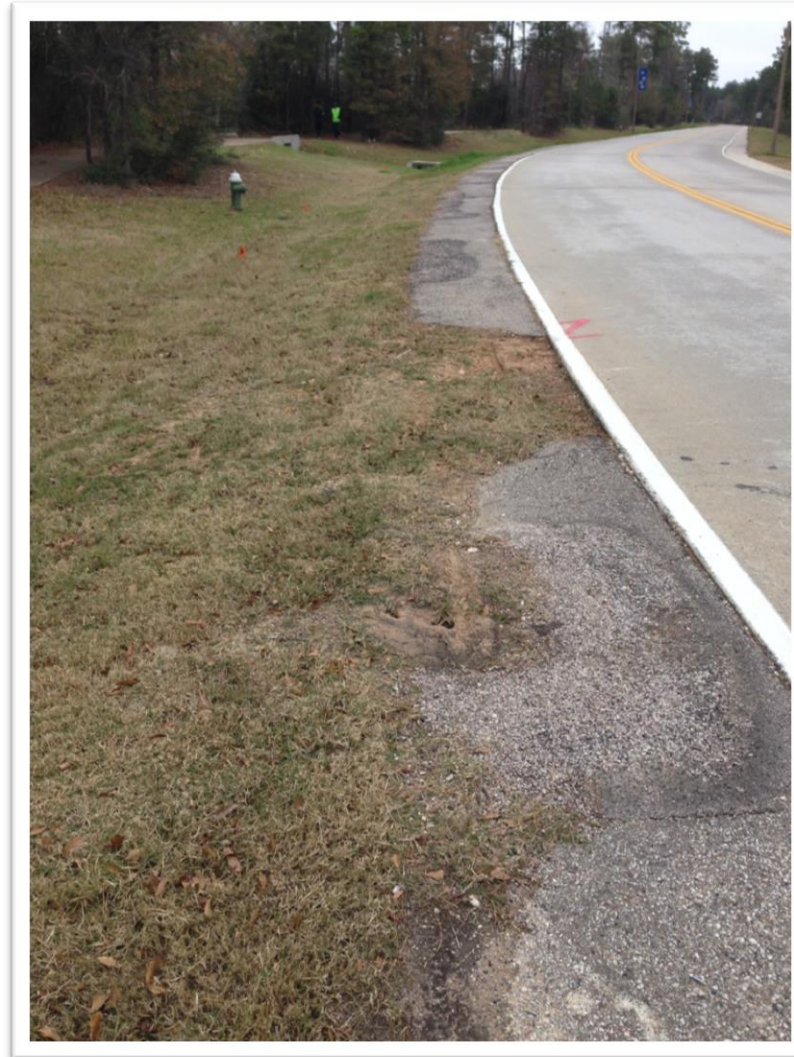
Location BC-5
Branch Crossing
Eastbound

Hazard Type: Rough Area No paving on the shoulder - bare earth
Severity: 4

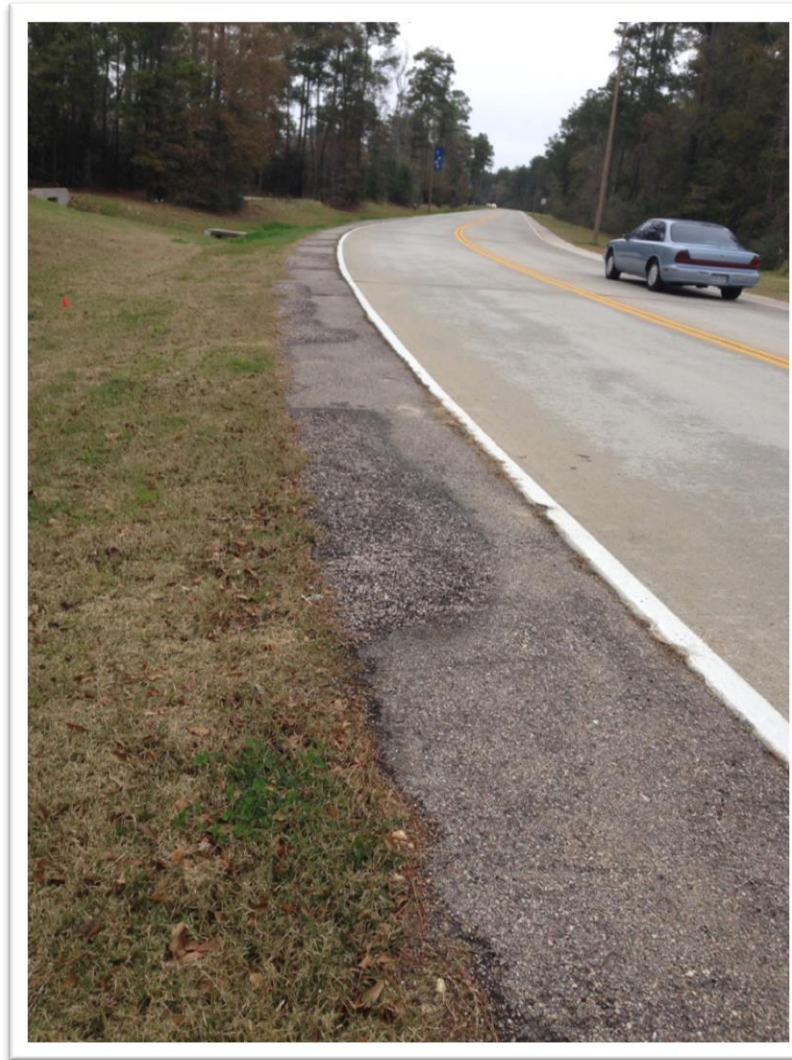
Location BC-6
Branch Crossing
Eastbound

Hazard Type: Rough Area Series of patches results in a rough shoulder
Severity: 3

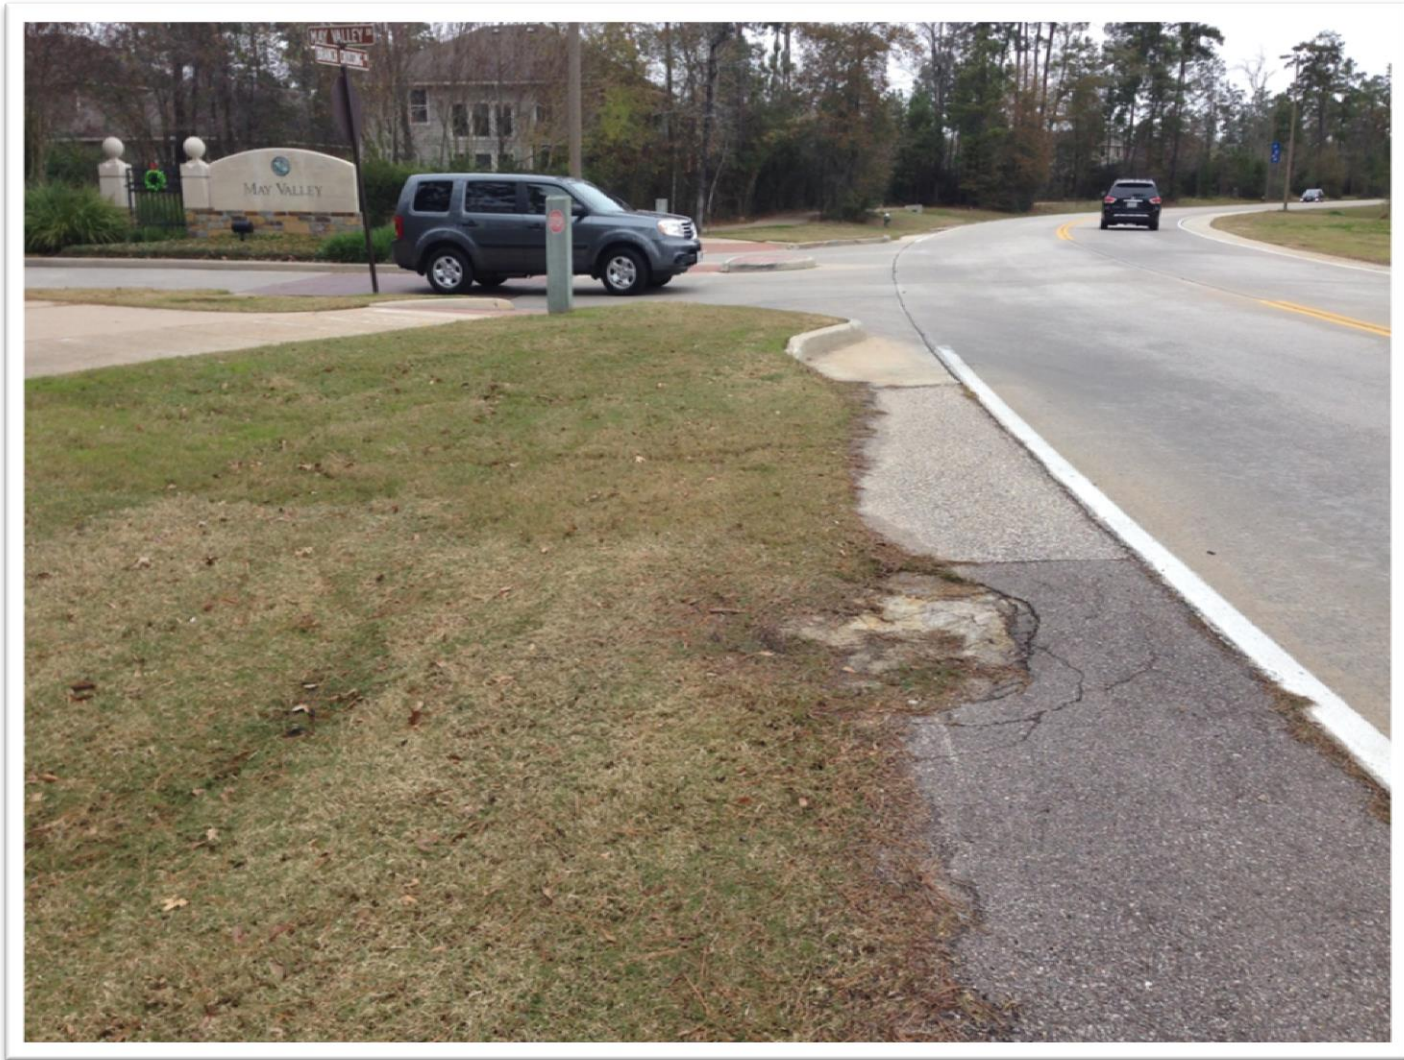
Location BC-7
Branch Crossing
Eastbound

Hazard Type: Rough Area
Severity: 3

Depression in the shoulder - needs to be
filled and patched

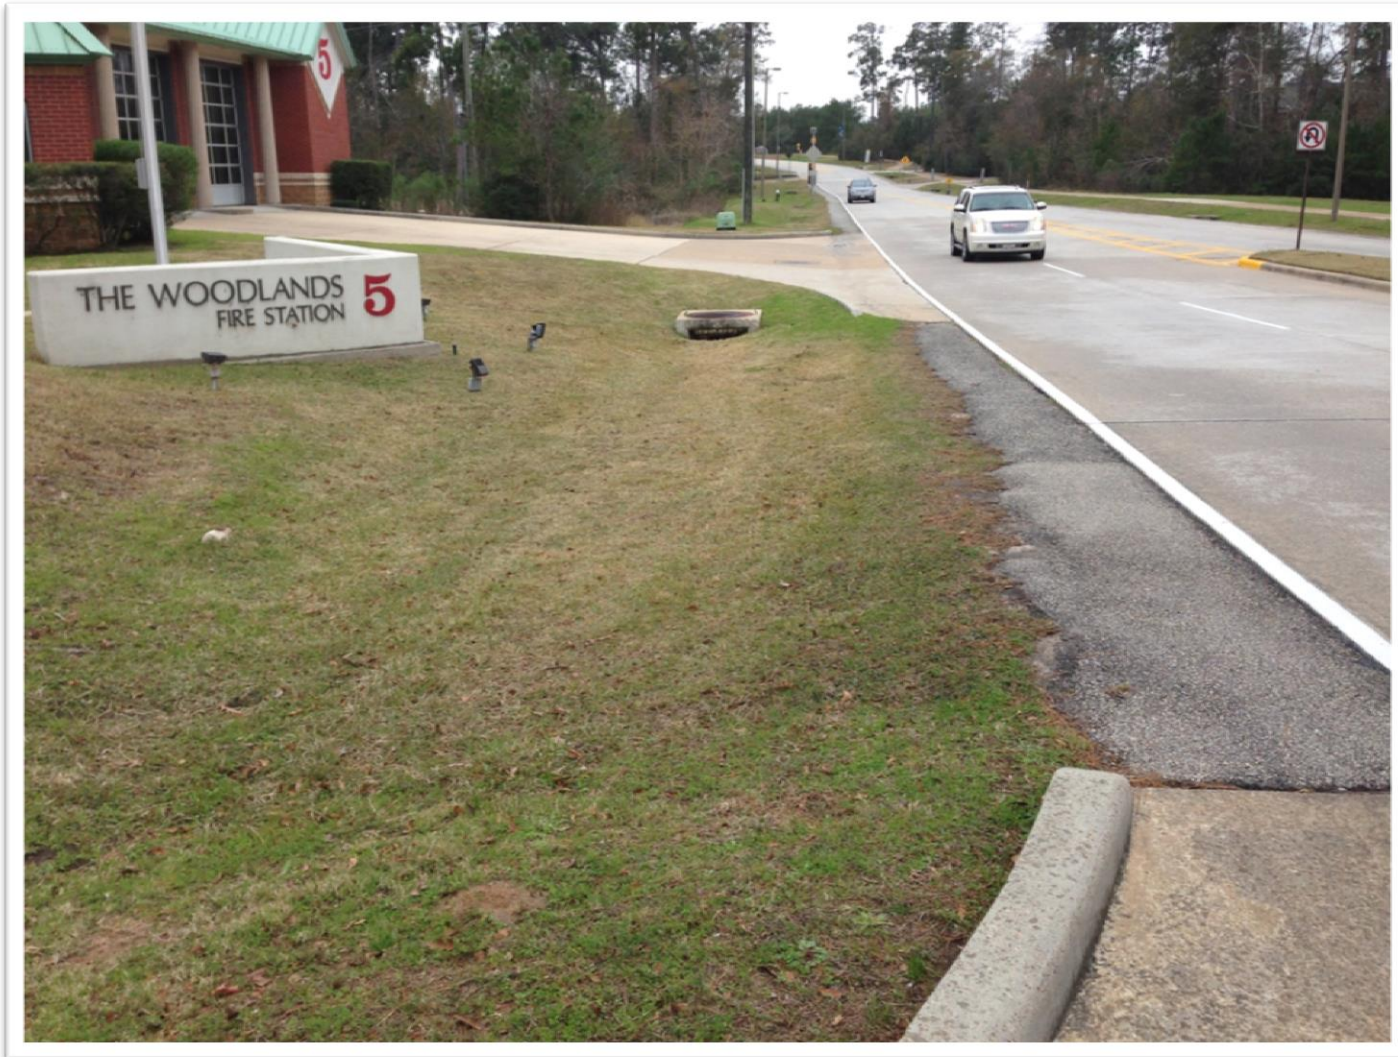
Location BC-8
Branch Crossing
Eastbound

Hazard Type: Other
Severity: 2

Silt accumulating on the shoulder - allowing
vegetation to grow.

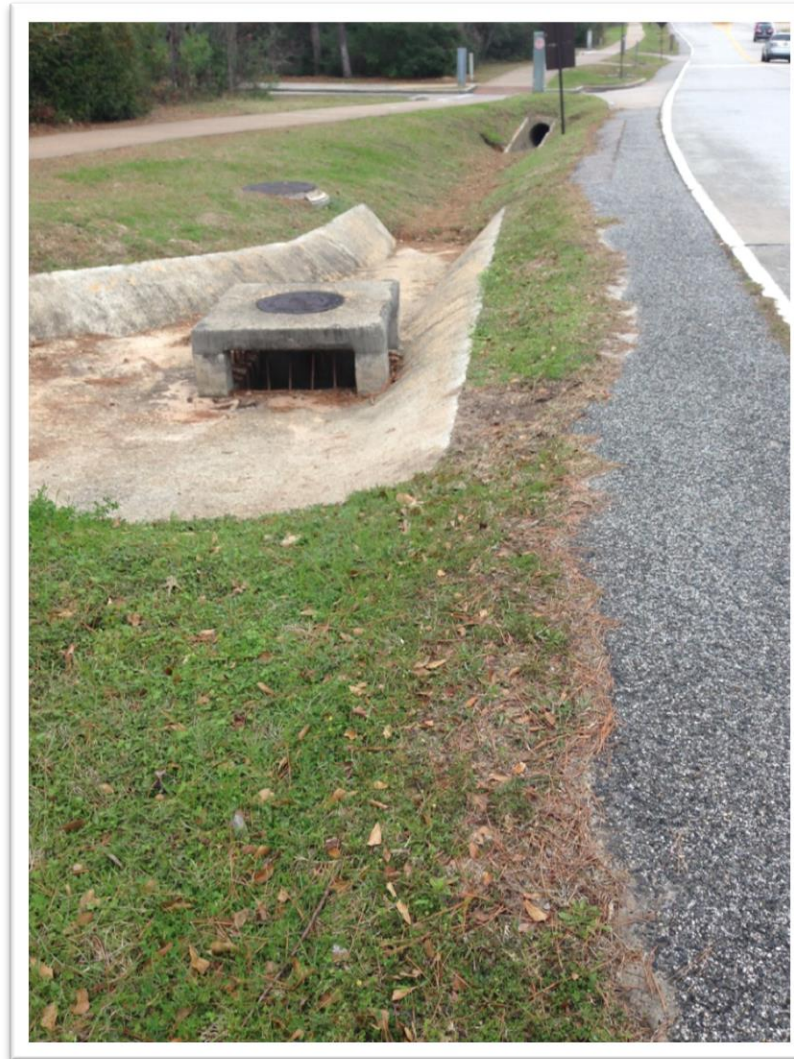
Location BC-9
Branch Crossing
Westbound

Hazard Type: Other
Severity: 2

Silt accumulating on the shoulder - allowing
vegetation to grow.

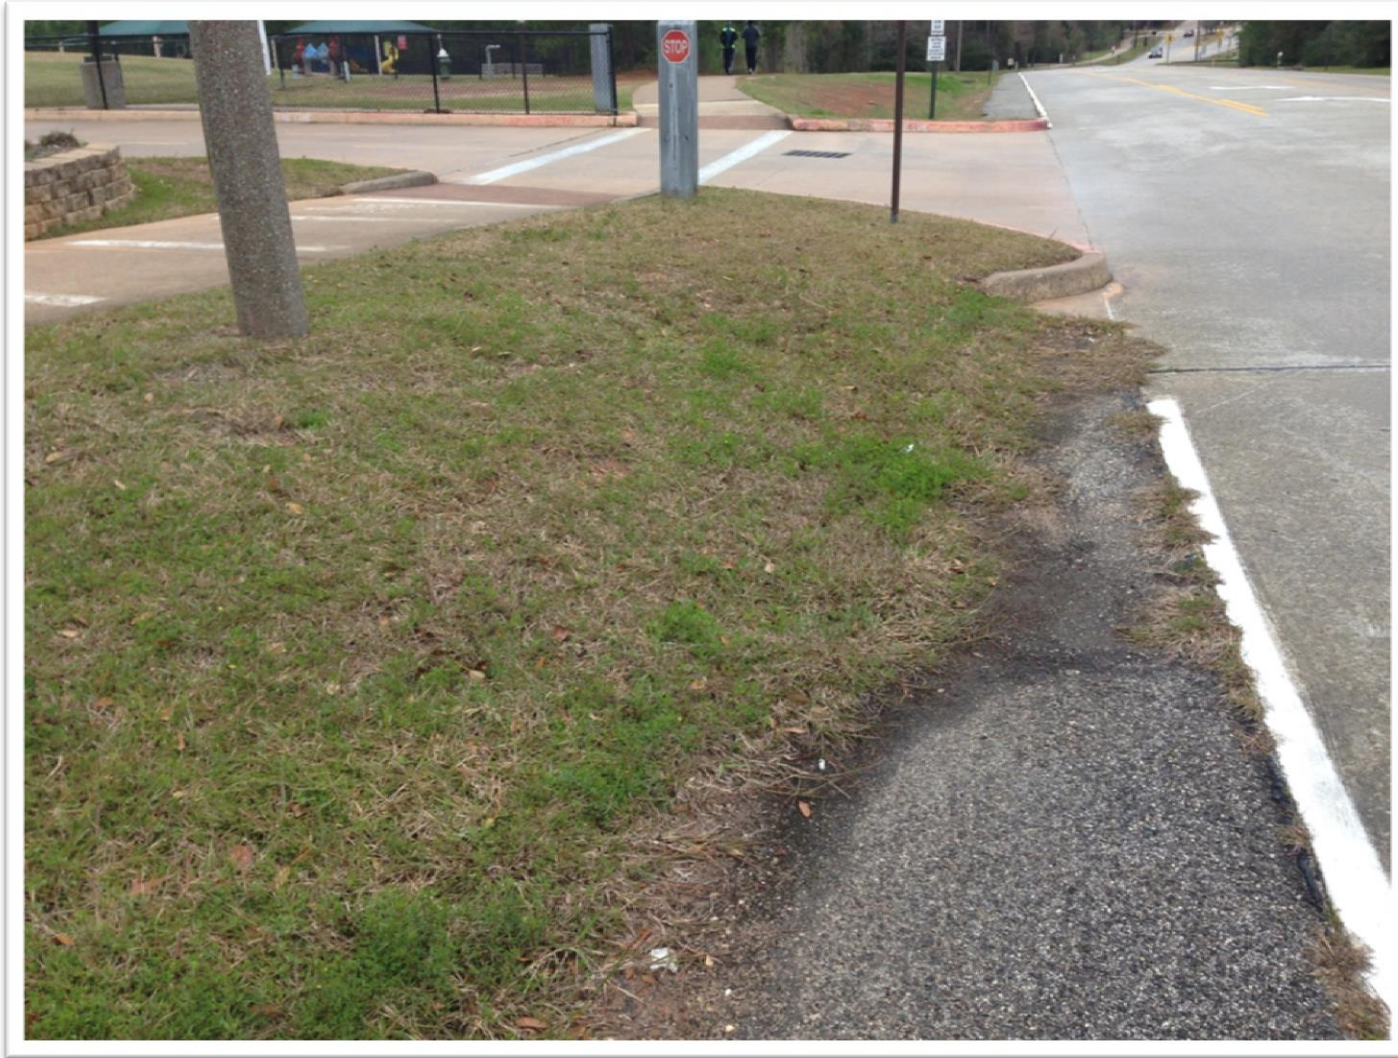
Location BC-10
Branch Crossing
Westbound

Hazard Type: Other
Severity: 2

Silt accumulating on the shoulder - allowing
vegetation to grow.

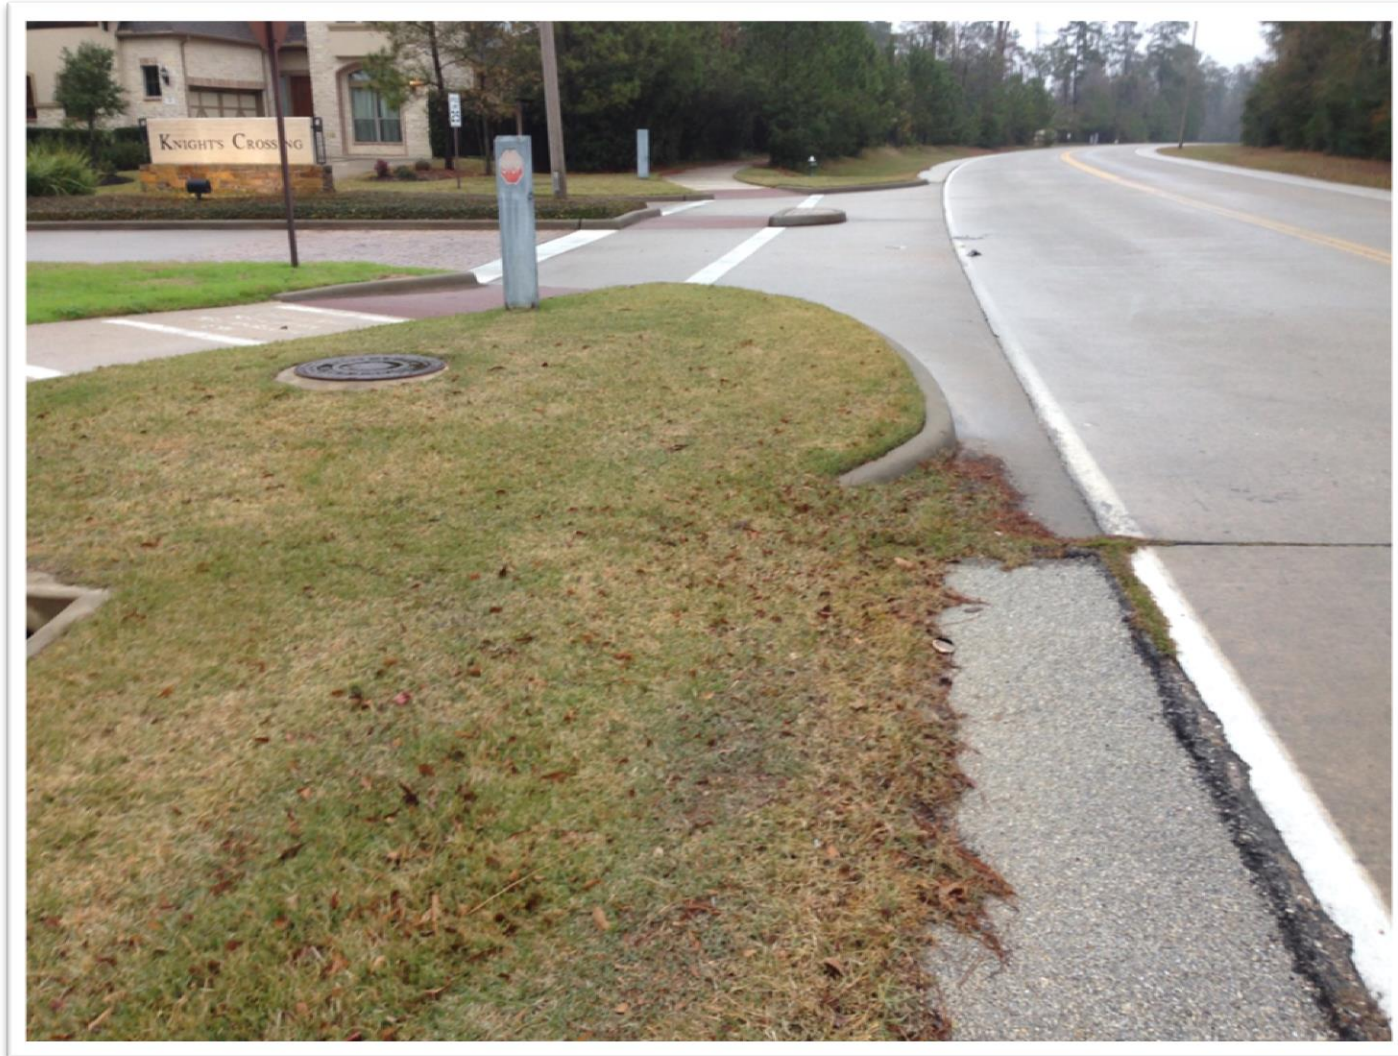
Location BC-11
Branch Crossing
Southbound

Hazard Type: Other
Severity: 6

Silt accumulating on the shoulder - allowing
vegetation to grow.

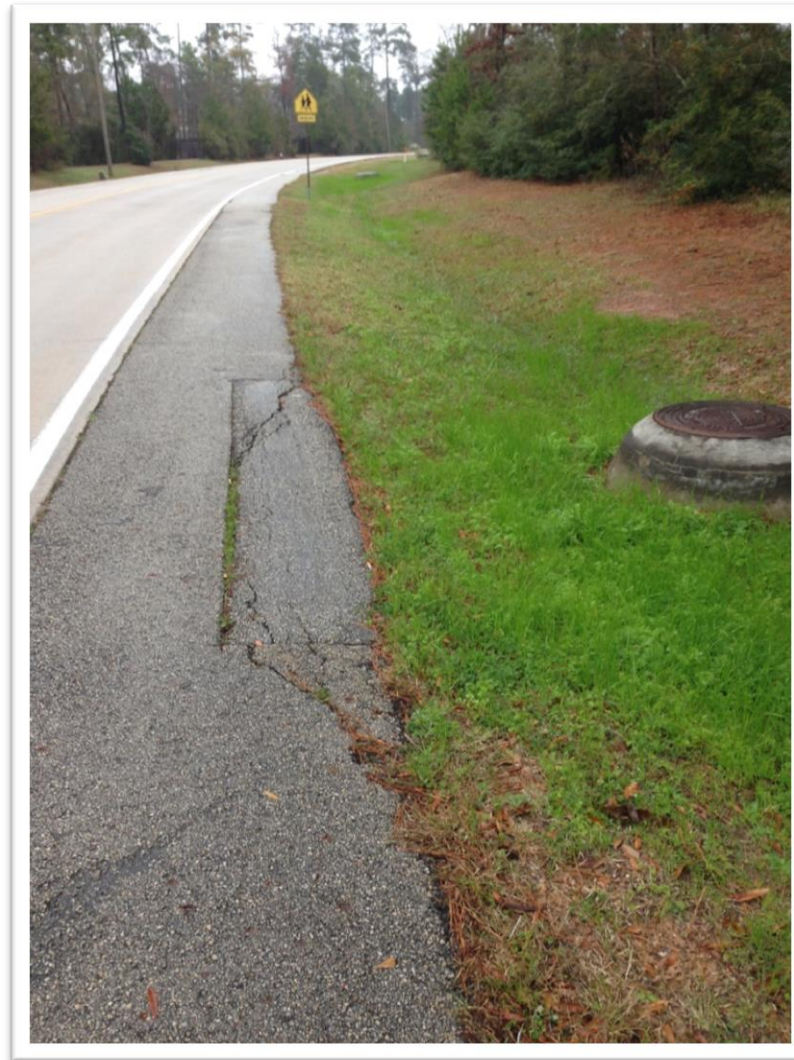
Location TR-1
Terramont
Northbound

Hazard Type: Other
Severity: 3

Earlier patch is starting to fail due to sinking earth.

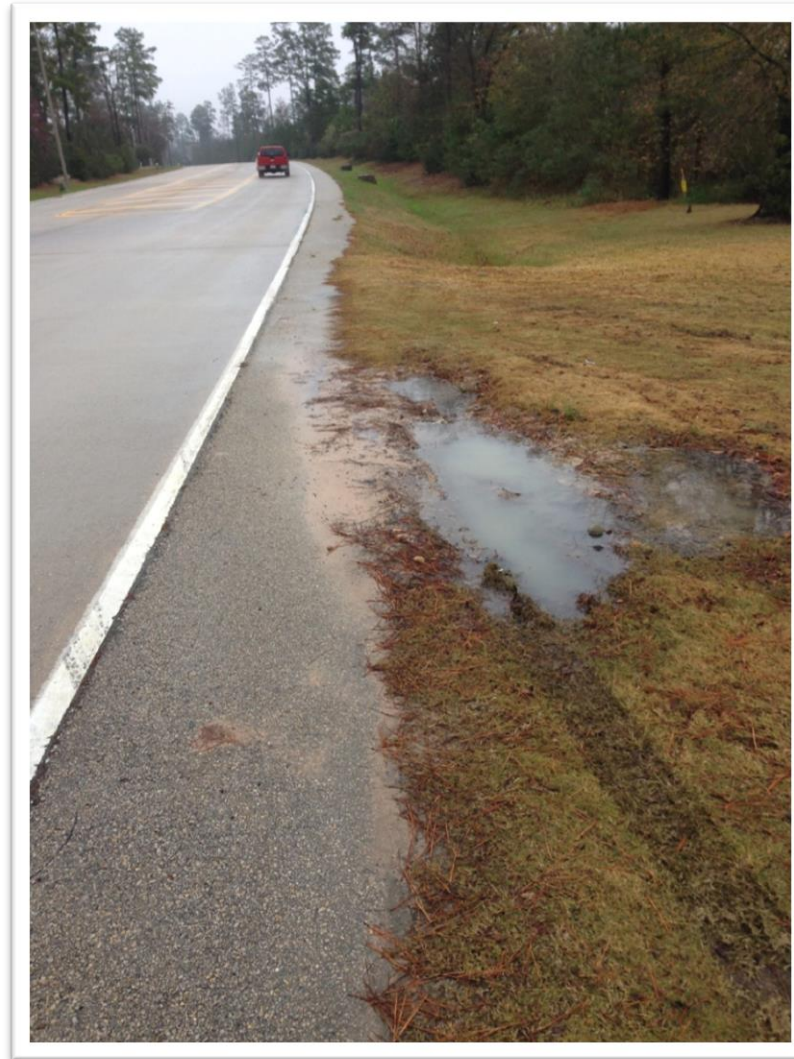
Location TR-2
Terramont
Northbound

Hazard Type: Pothole
Severity: 3

Pot hole adjacent to shoulder will cause failure of the road surface. (the hole looks more significant when it is dry)

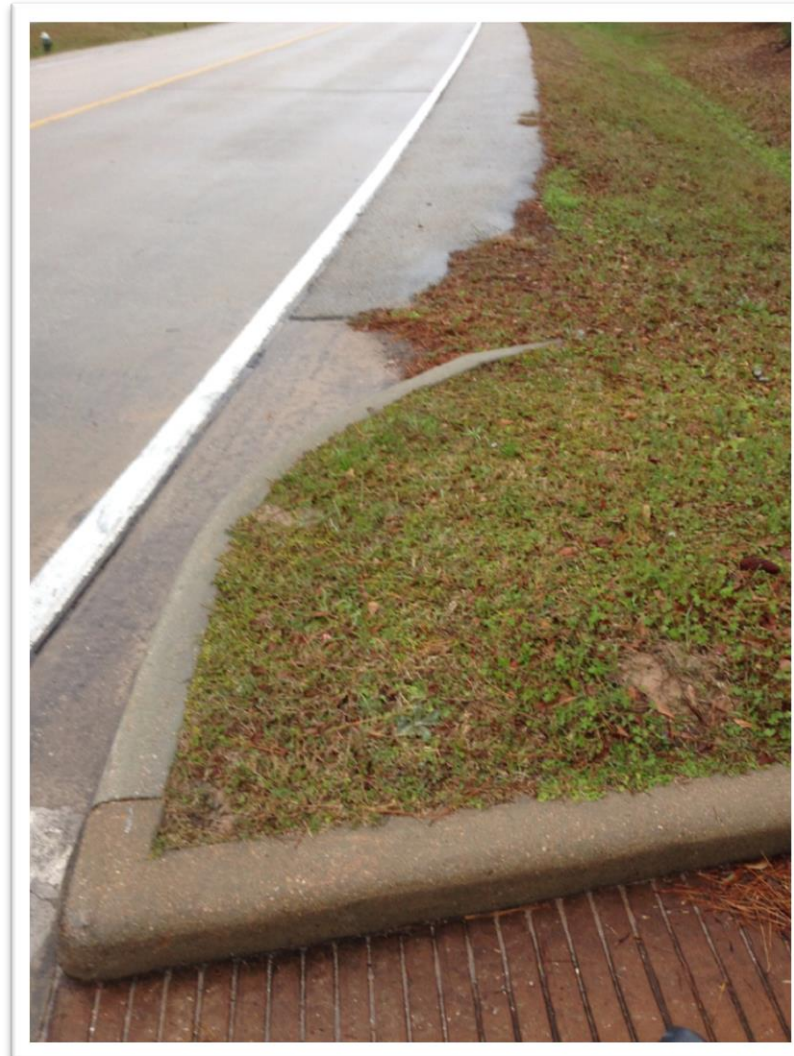
Location TR-3
Terramont
Northbound

Hazard Type: Other
Severity: 2

Silt accumulating on the shoulder - allowing
vegetation to grow.
