Road Shoulder Hazards along
Cochrans Crossing – January 2015

Hazards on road shoulders, that could pose a risk to cyclists, were identified in January 2015 by volunteers from Bike The Woodlands Coalition.

Cochrans Crossing Hazard Locations

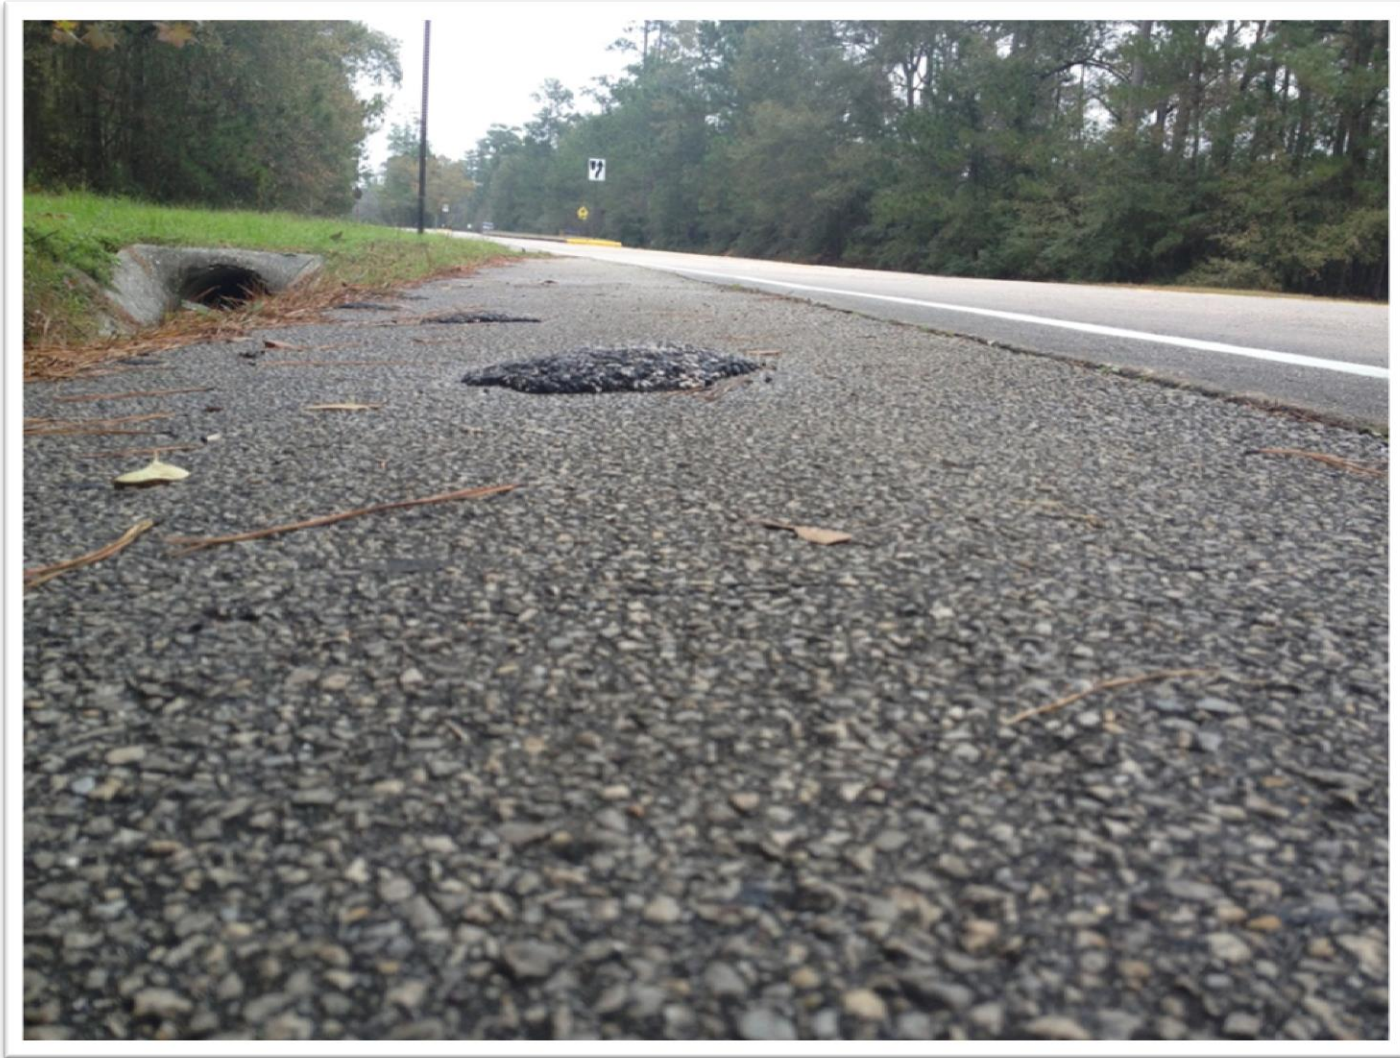
Location CC-1
Cochrans Crossing

Southbound
Severity: 2

Dumped paving materials

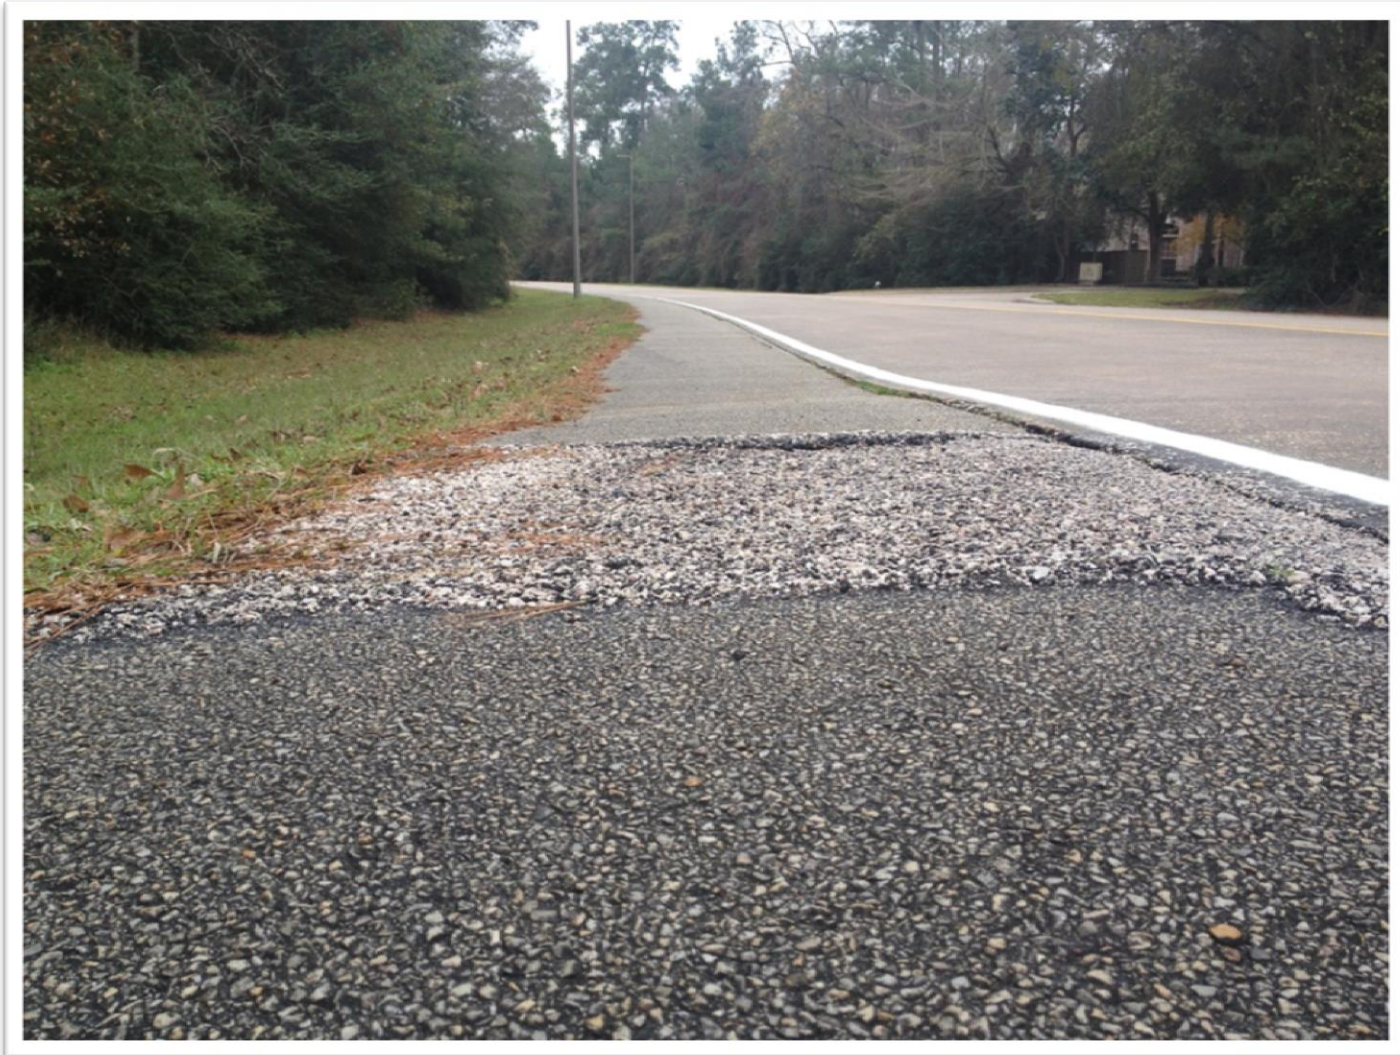
Location CC-2
Cochrans Crossing
Southbound

Hazard Type: Rough Area Bad shoulder patch
Severity: 2

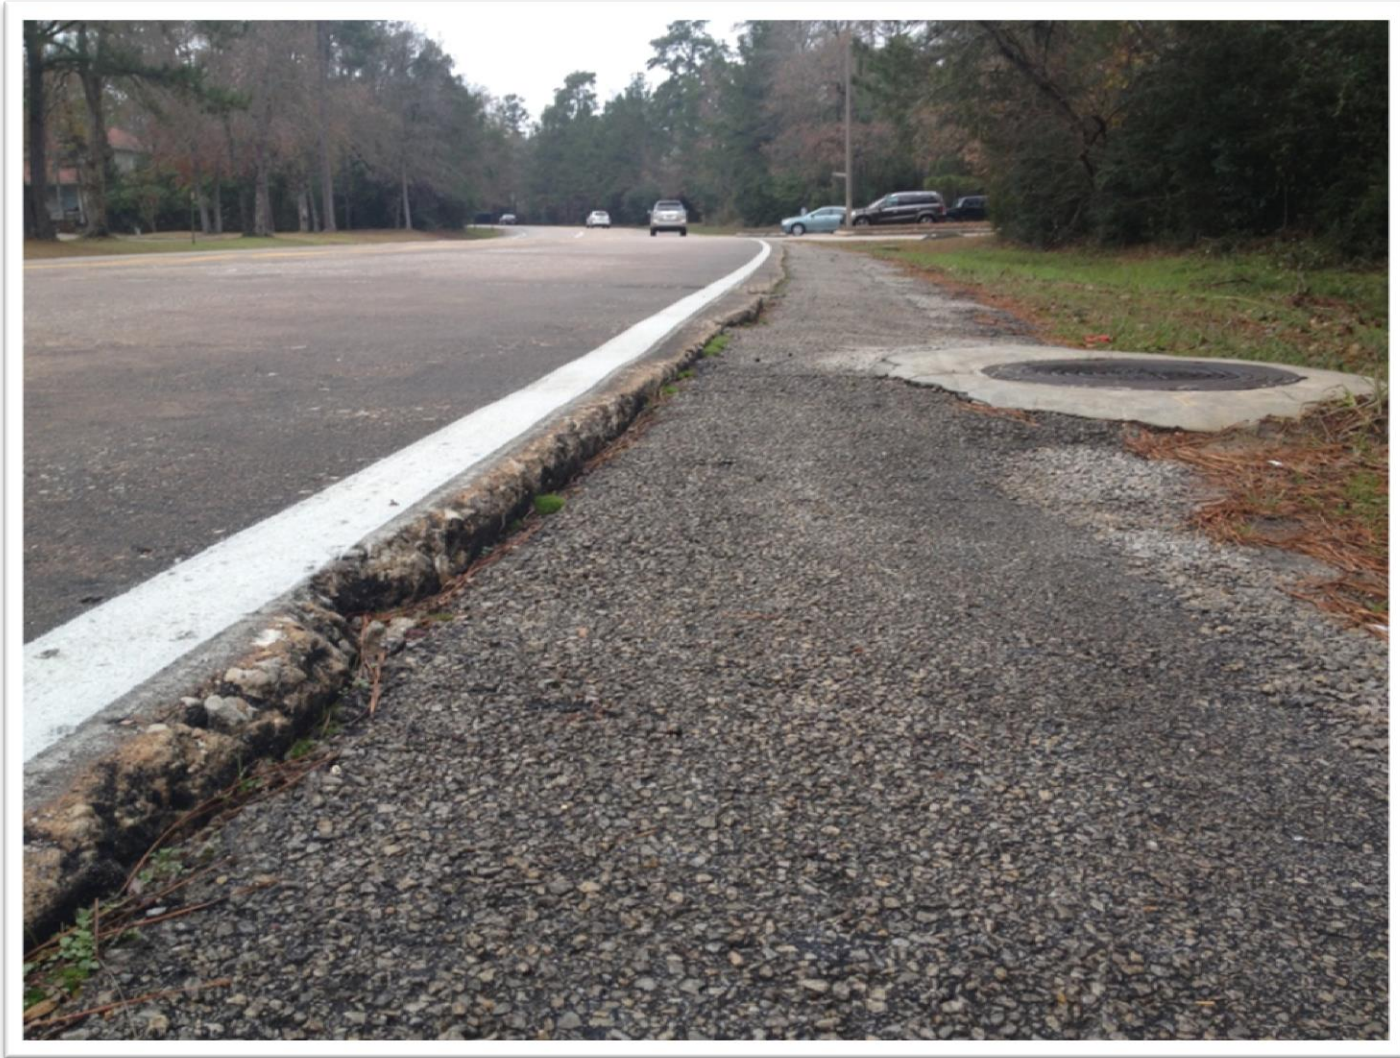
Location CC-3
Cochrans Crossing
Southbound

Hazard Type: Lip
Severity: 4

Lip 1" to 2" next to manhole cover with rough area; note that many of the manhole covers and their concrete structures are not level with shoulder.

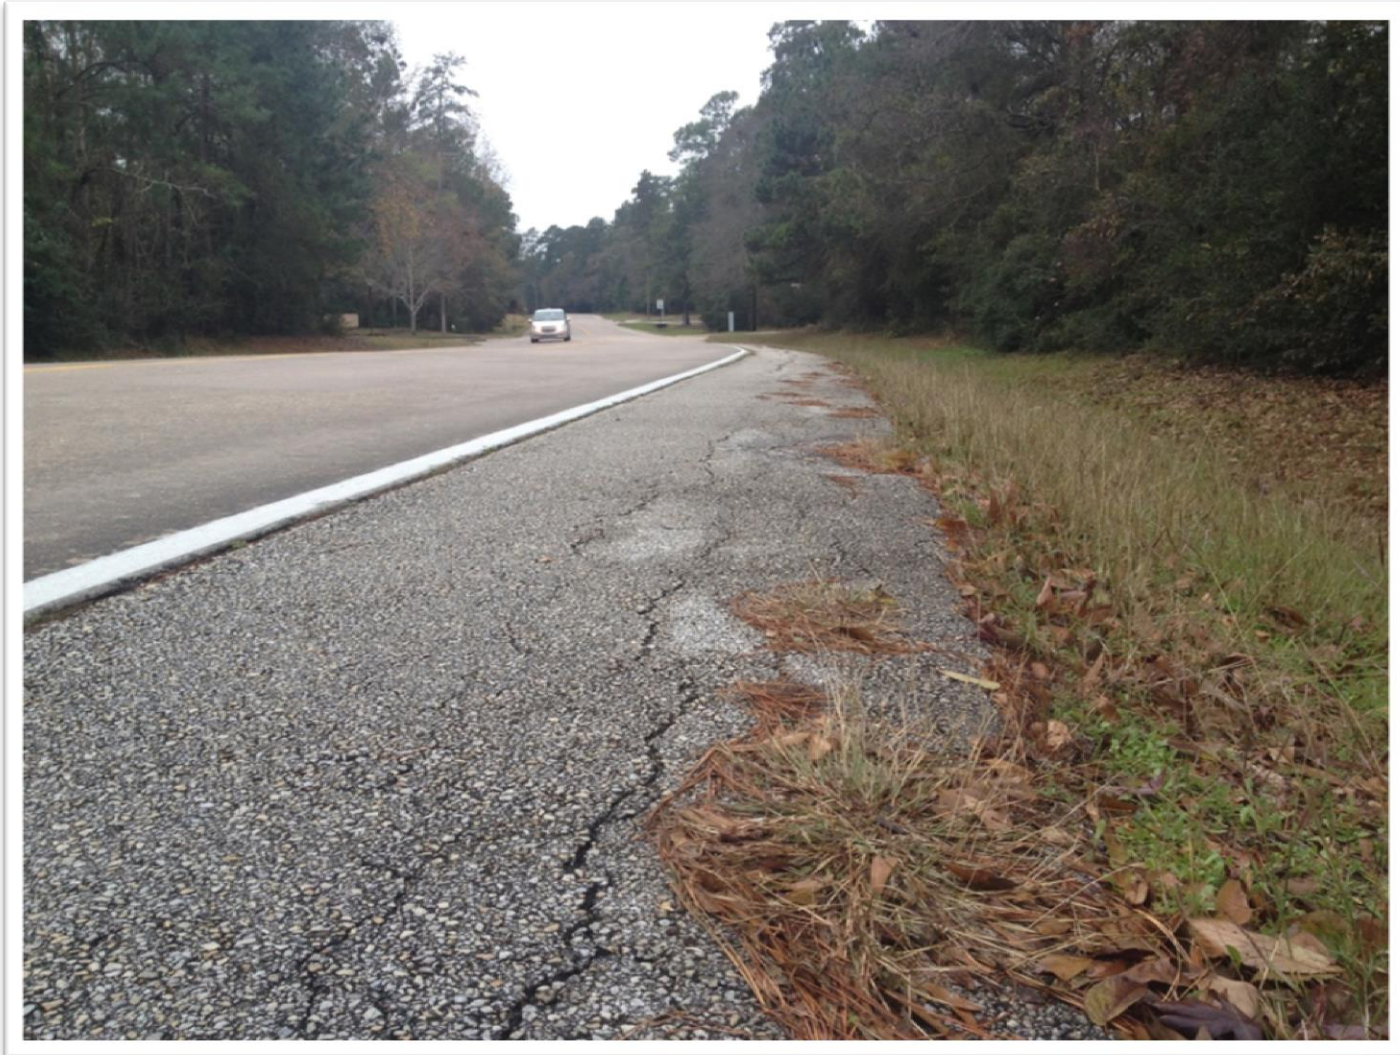
Location CC-4
Cochrans Crossing
Southbound

Hazard Type: Gap
Severity: 3

Shoulder cracked and collapsing into ditch

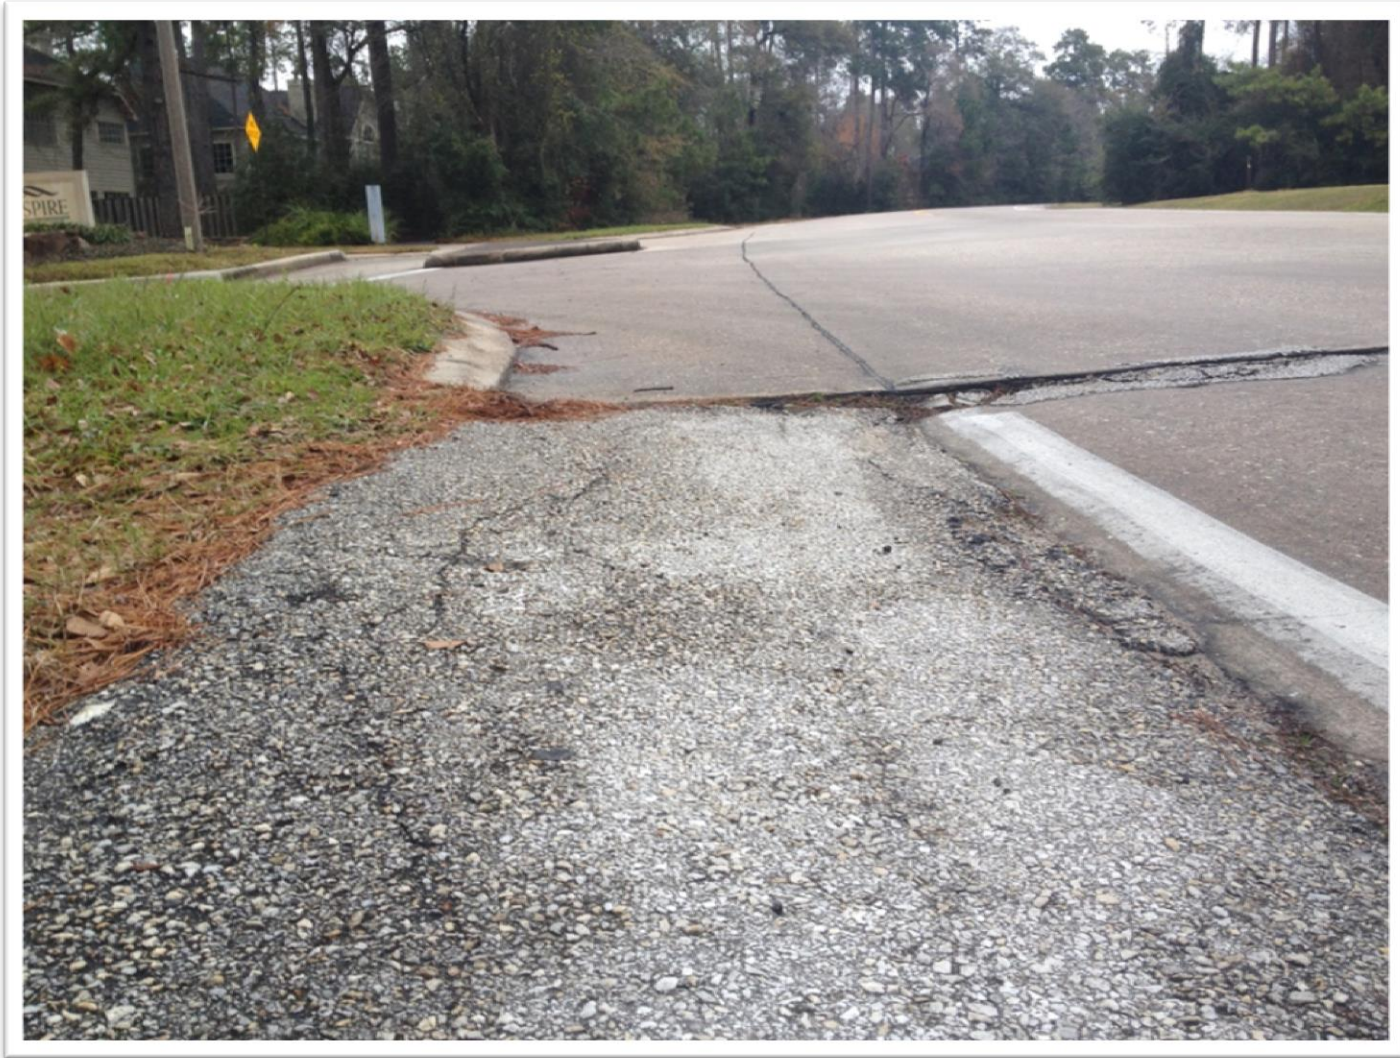
Location CC-5
Cochrans Crossing
Southbound

Hazard Type: Lip

Lip drop off at crossing of Spiral Leaf

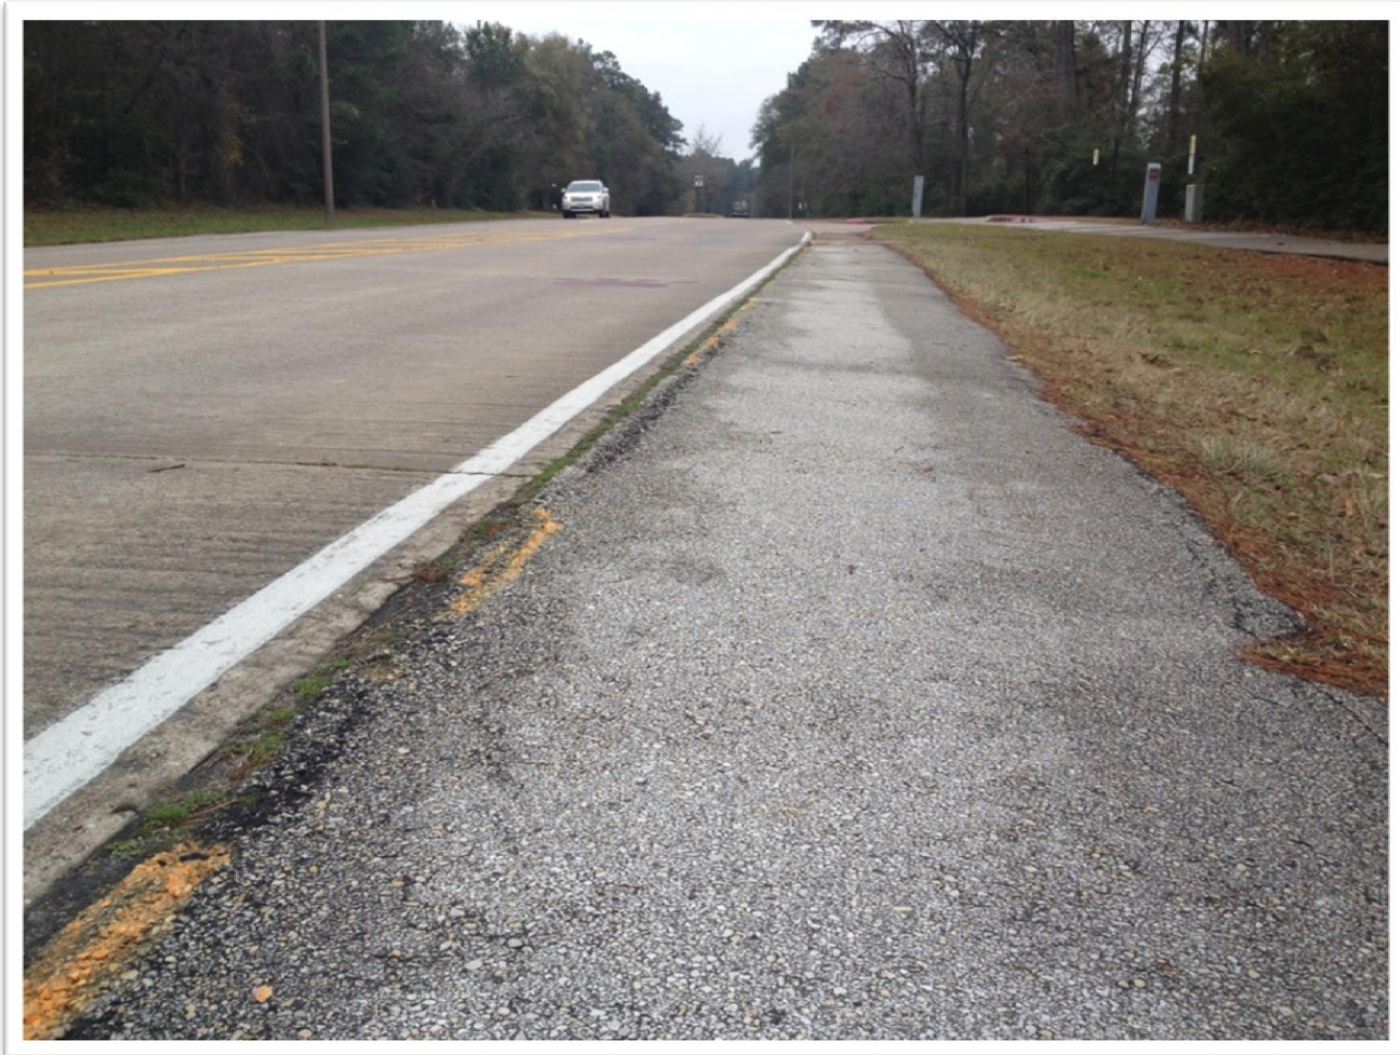
Location CC-6
Cochrans Crossing
Southbound

Hazard Type: Rough Area
Severity: 4

Very bad shoulder in front of church and elementary school which has been possibly marked for repair

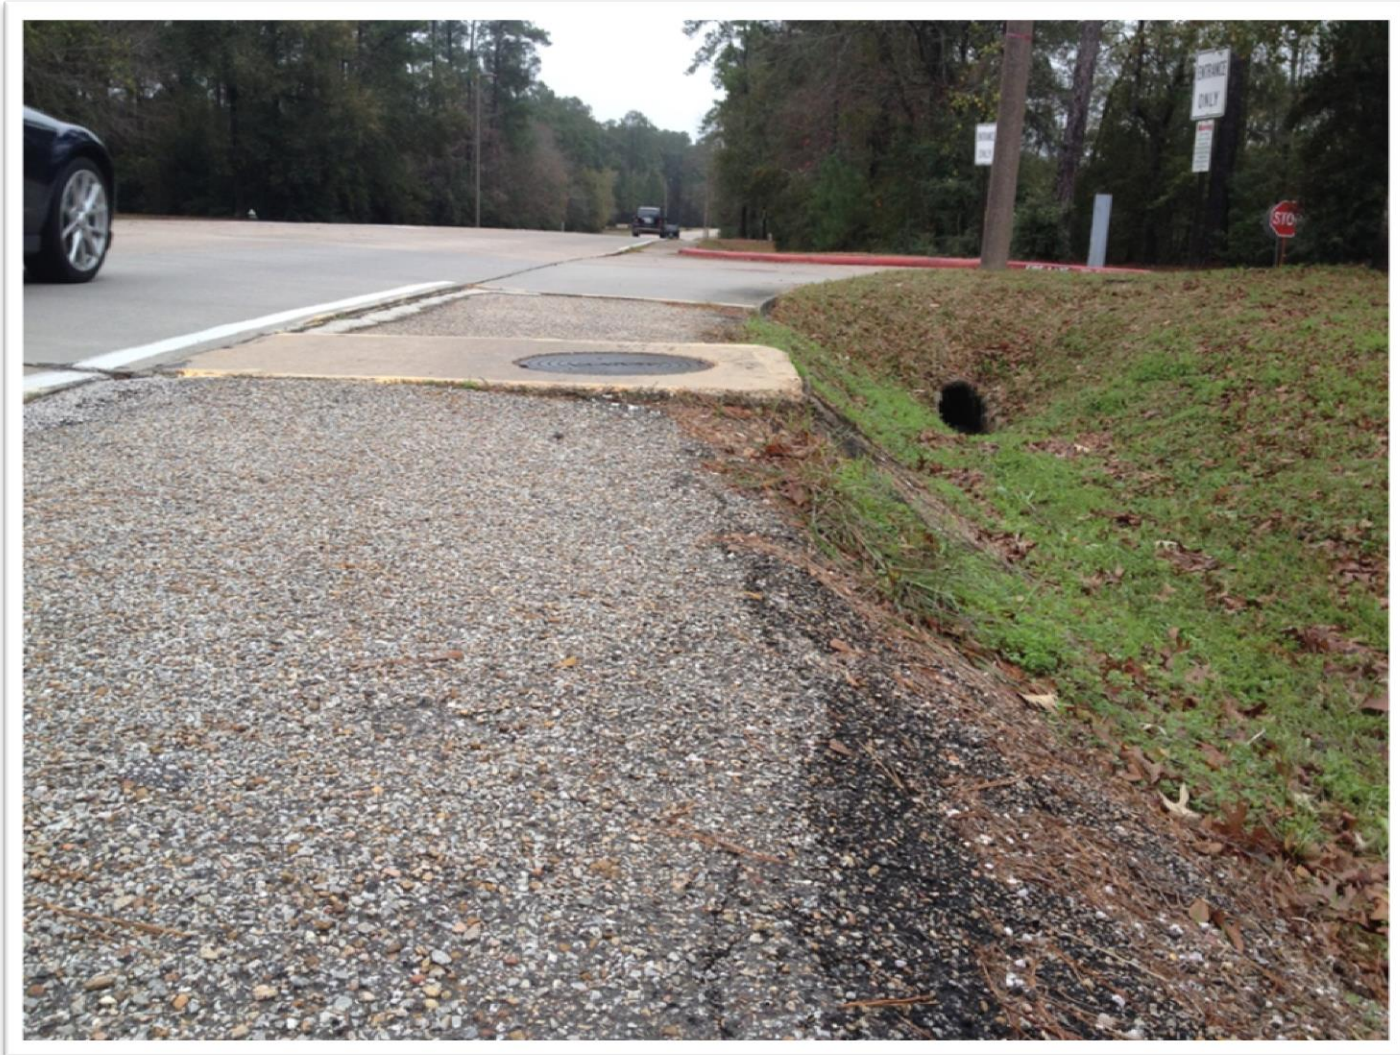
Location CC-7
Cochrans Crossing
Southbound

Hazard Type: Lip
Severity: 4

Lip at manhole structure at Galatas
Elementary entrance

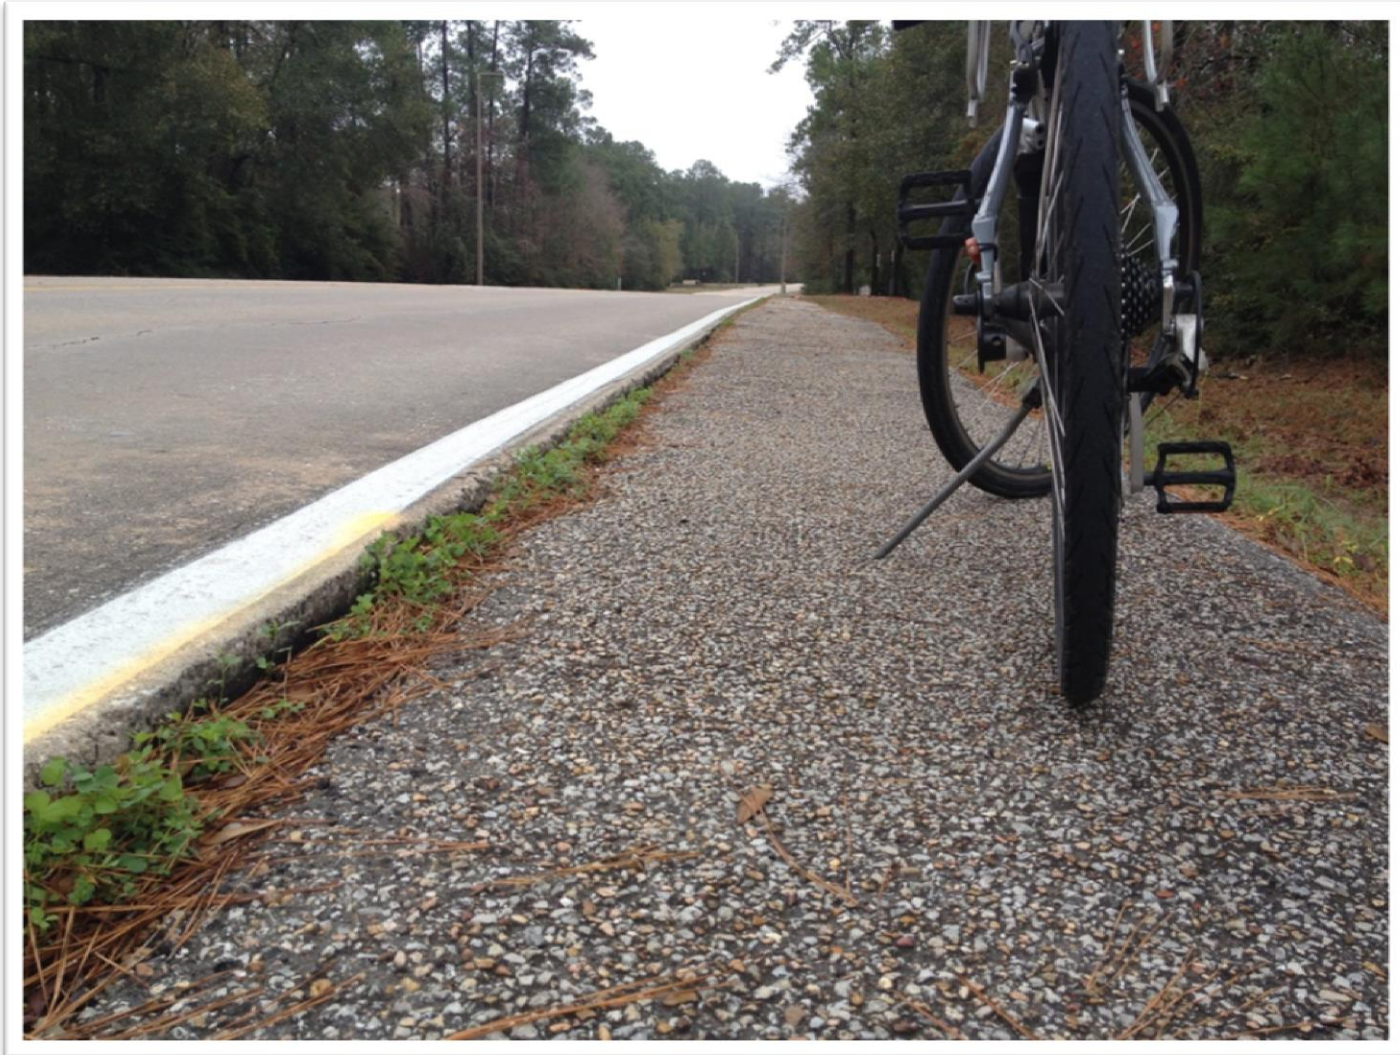
Location CC-8
Cochrans Crossing
Southbound

Hazard Type: Lip
Severity: 4

2" lip hidden with vegetation; possibly
marked for repair

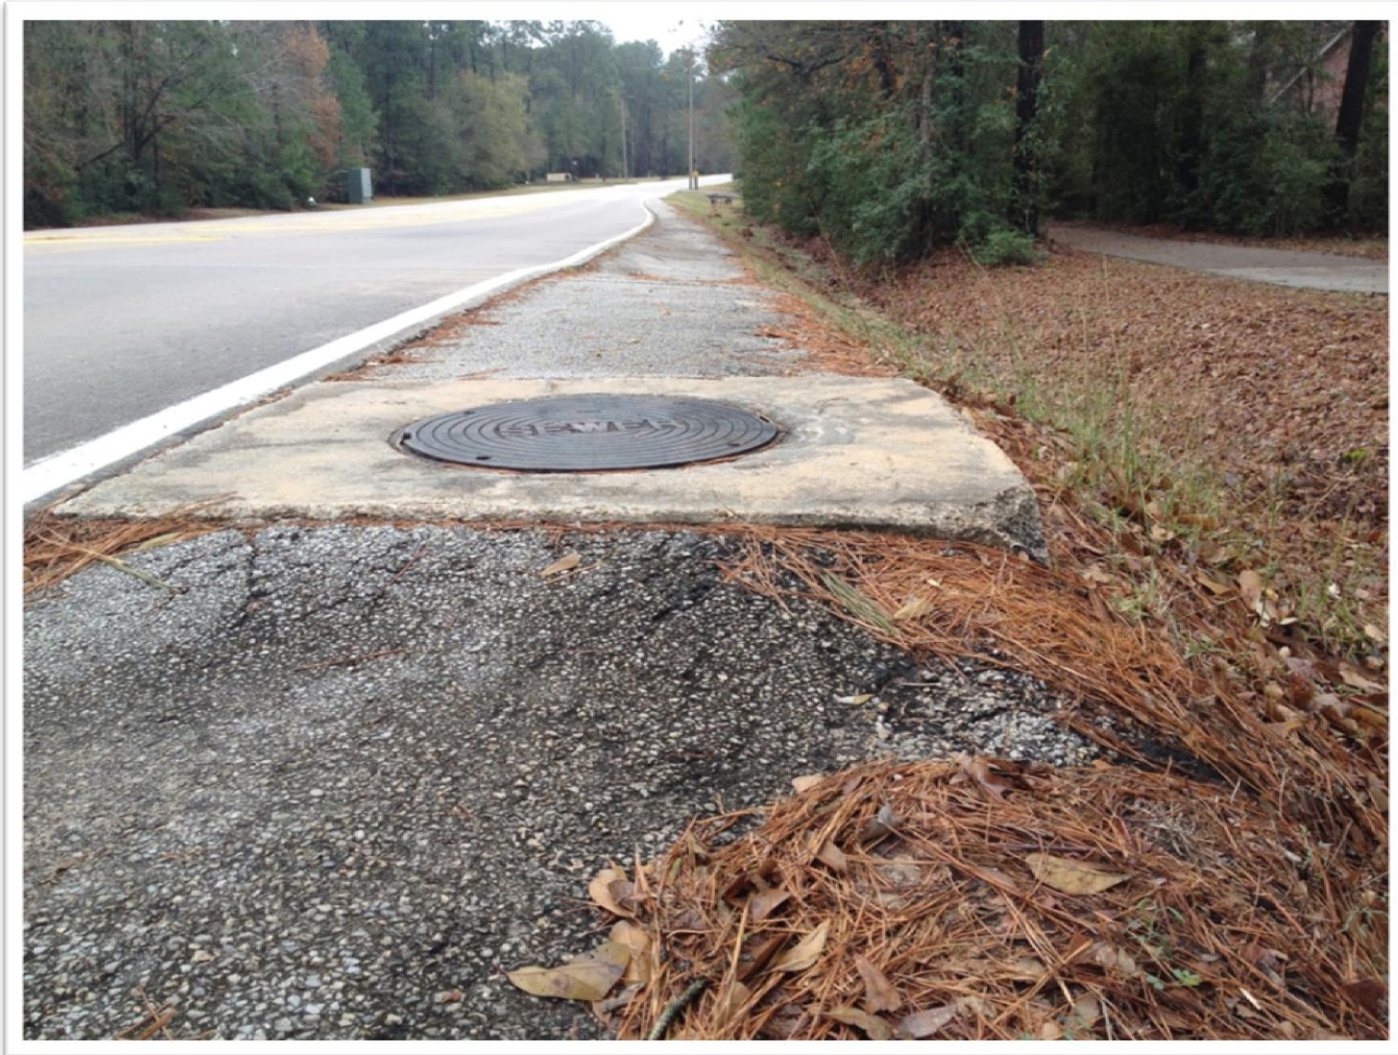
Location CC-9
Cochrans Crossing
Southbound

Hazard Type: Lip
Severity: 4

120 feet of bad shoulder repair with manhole hazard, uneven shoulder surface, and drop off into ditch

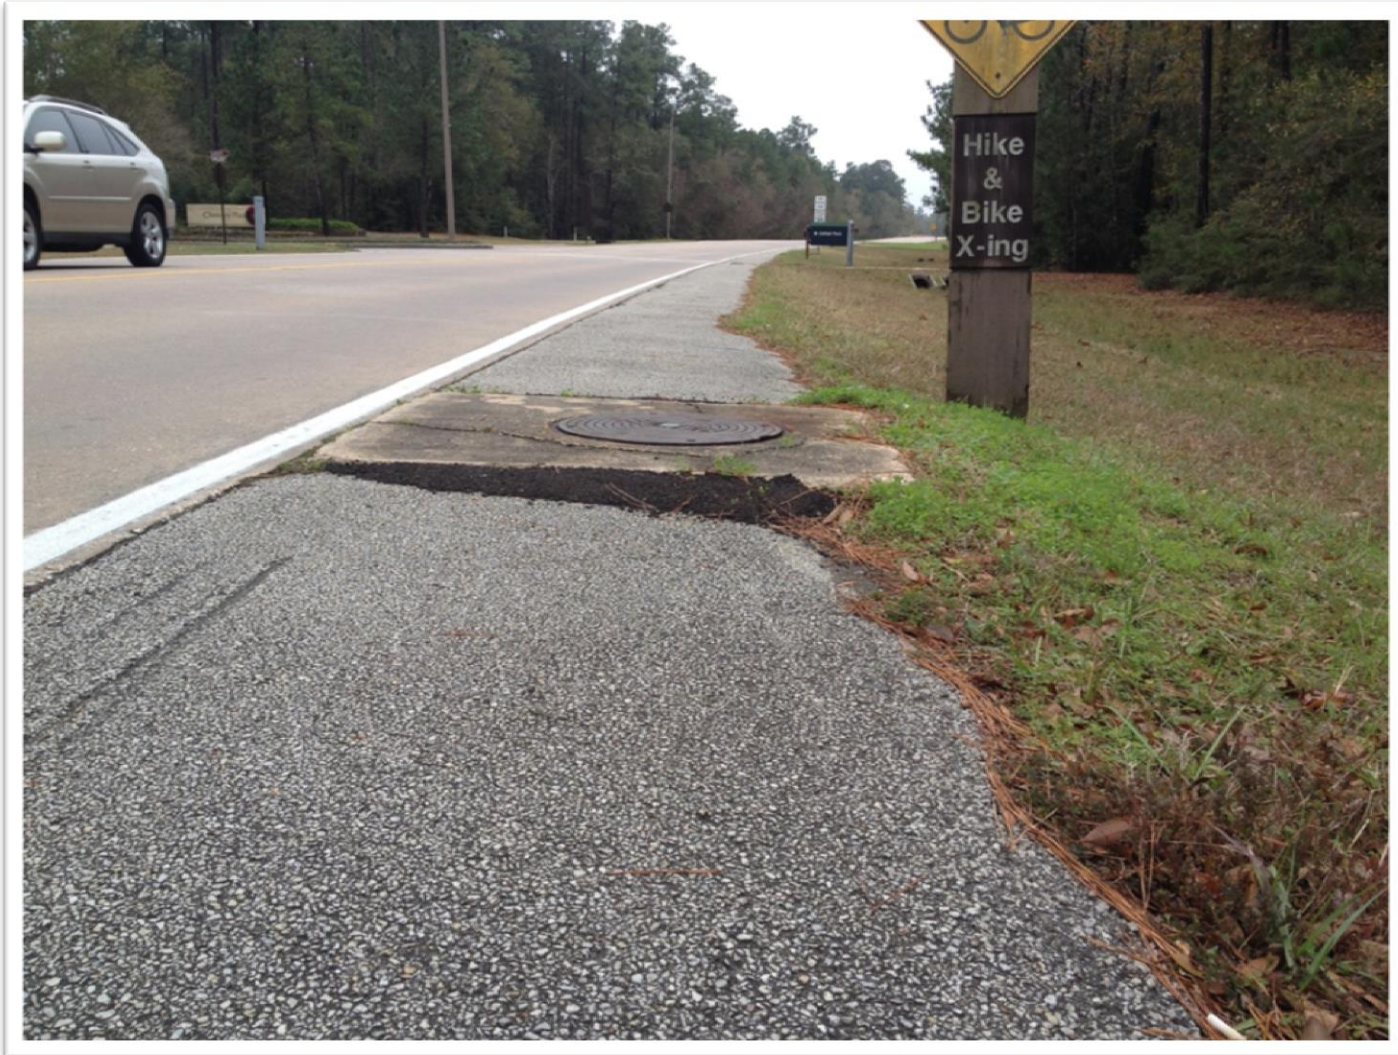
Location CC-10
Cochrans Crossing
Southbound

Hazard Type: Lip
Severity: 4

Manhole structure with 2" to 3" lip and edge hazard; has been patched but only marginally reduces hazard.

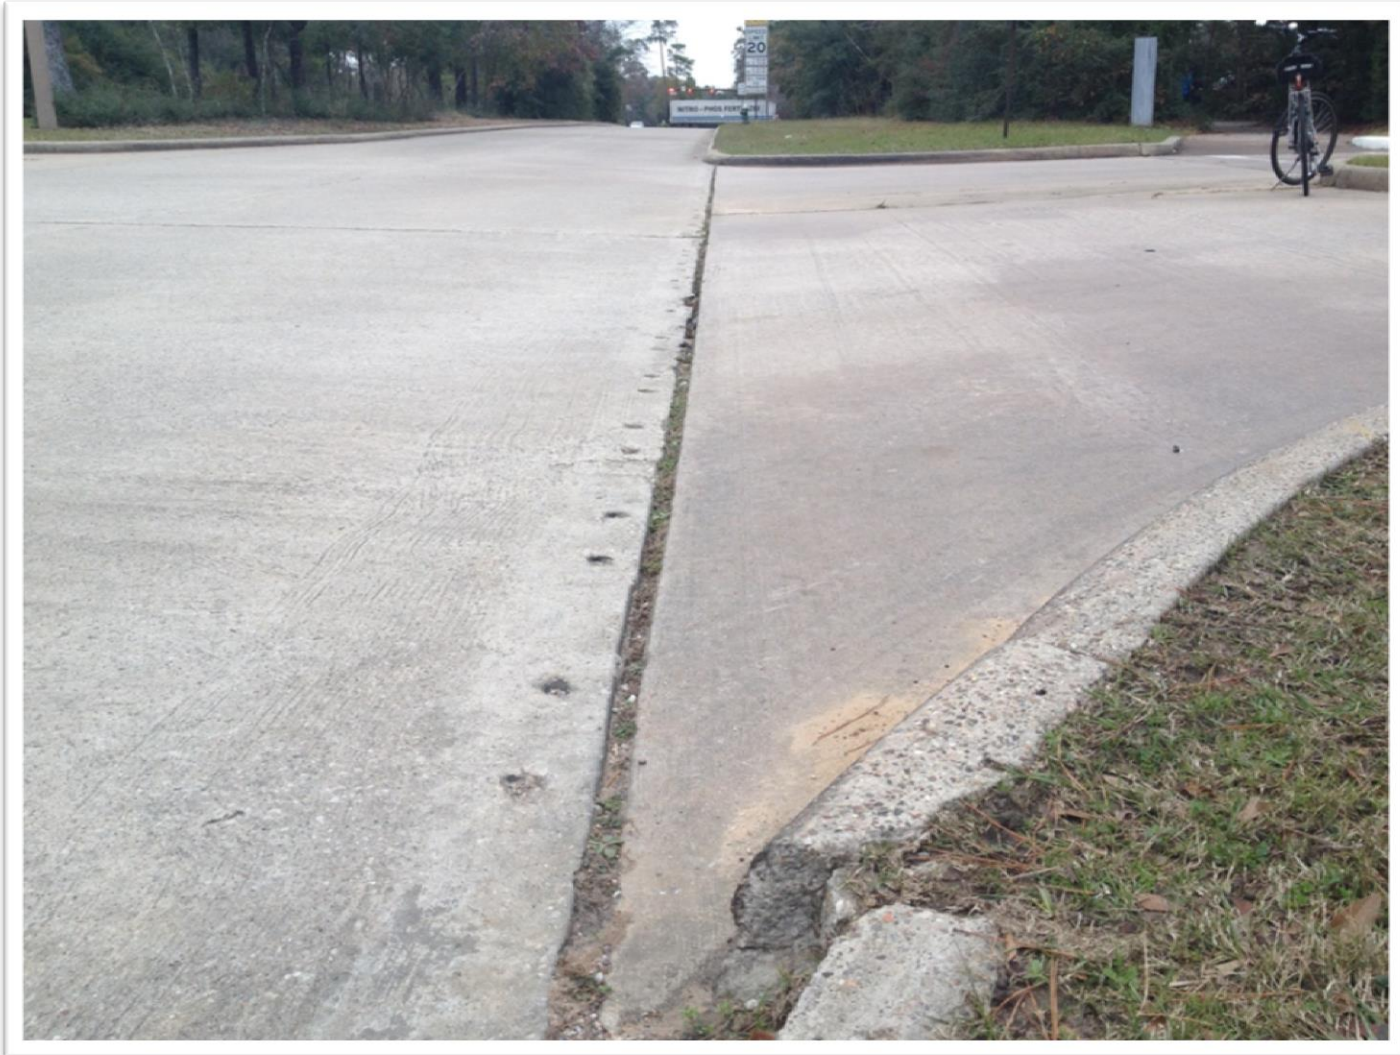
Location CC-11
Cochrans Crossing
Northbound

Hazard Type: Gap
Severity: 3

2" gap at entrance to Lower School at John
Cooper School

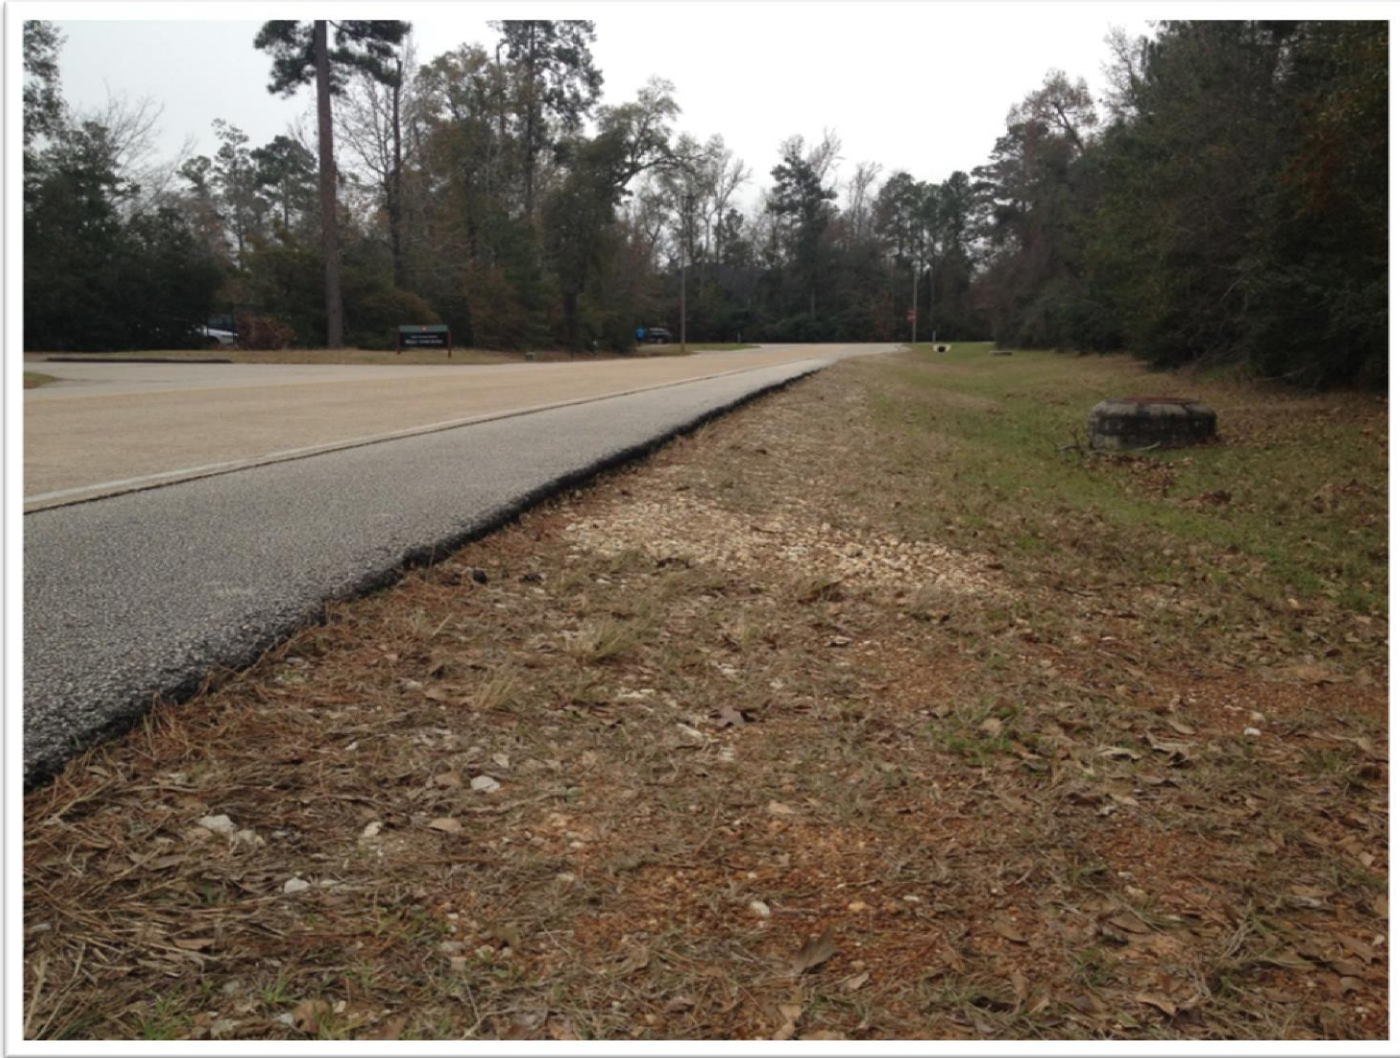
Location CC-12
Cochrans Crossing
Southbound

Hazard Type: Rough Area
Severity: 3

Drop off of outer shoulder edge from erosion
and ground subsidence; drop of 3" to 4"

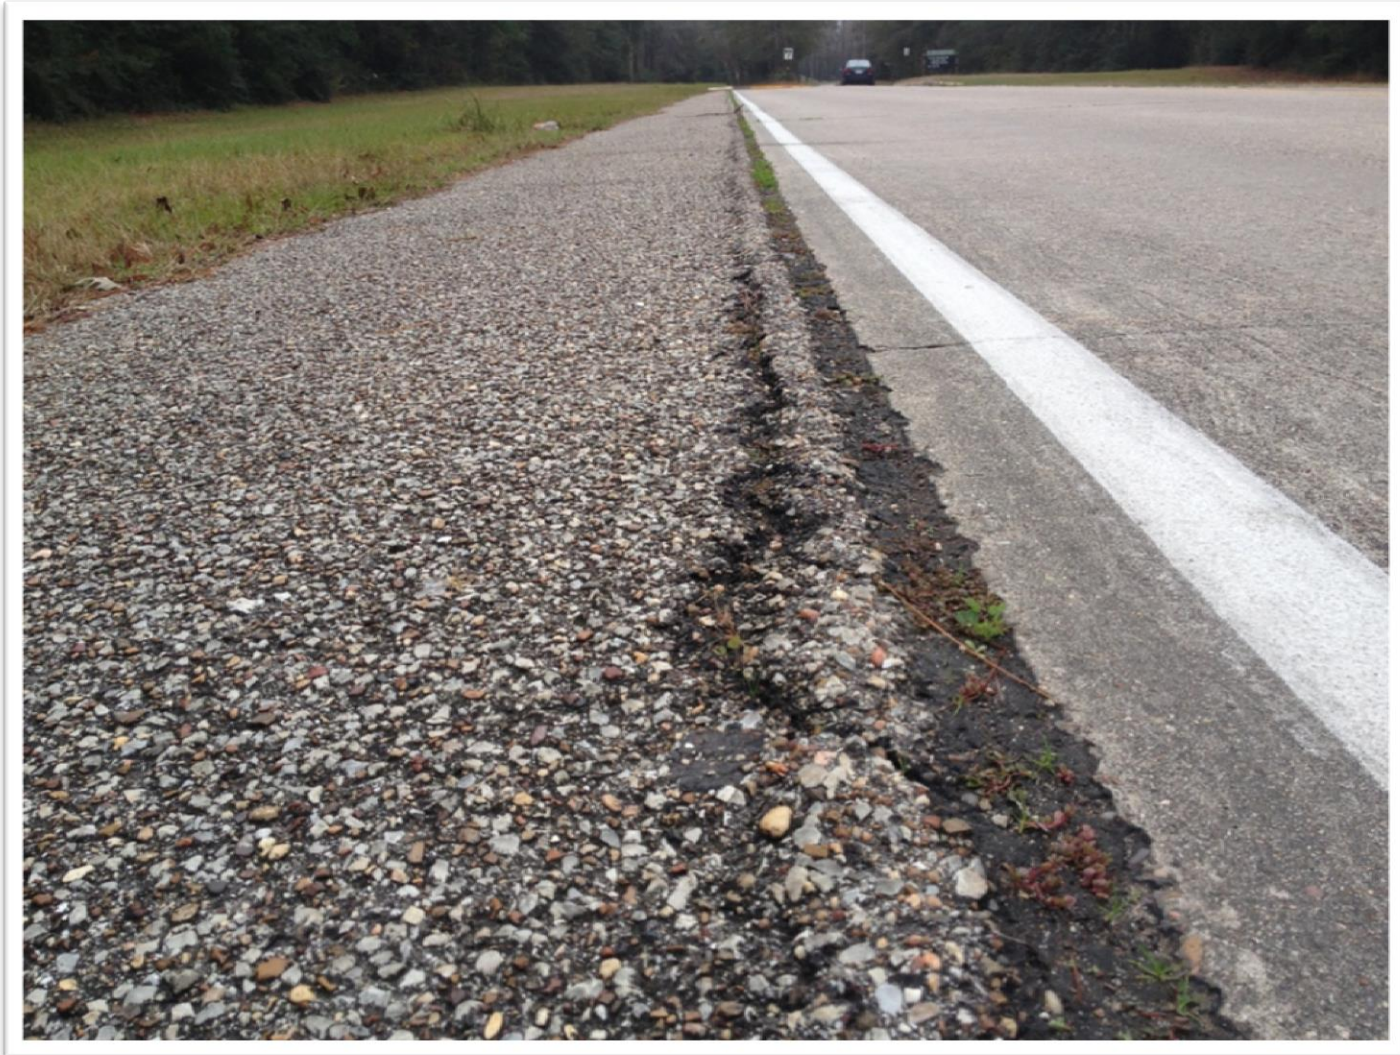
Location CC-13
Cochrans Crossing
Northbound

Hazard Type: Gap
Severity: 3

Ridge along gap for 100 ft and more

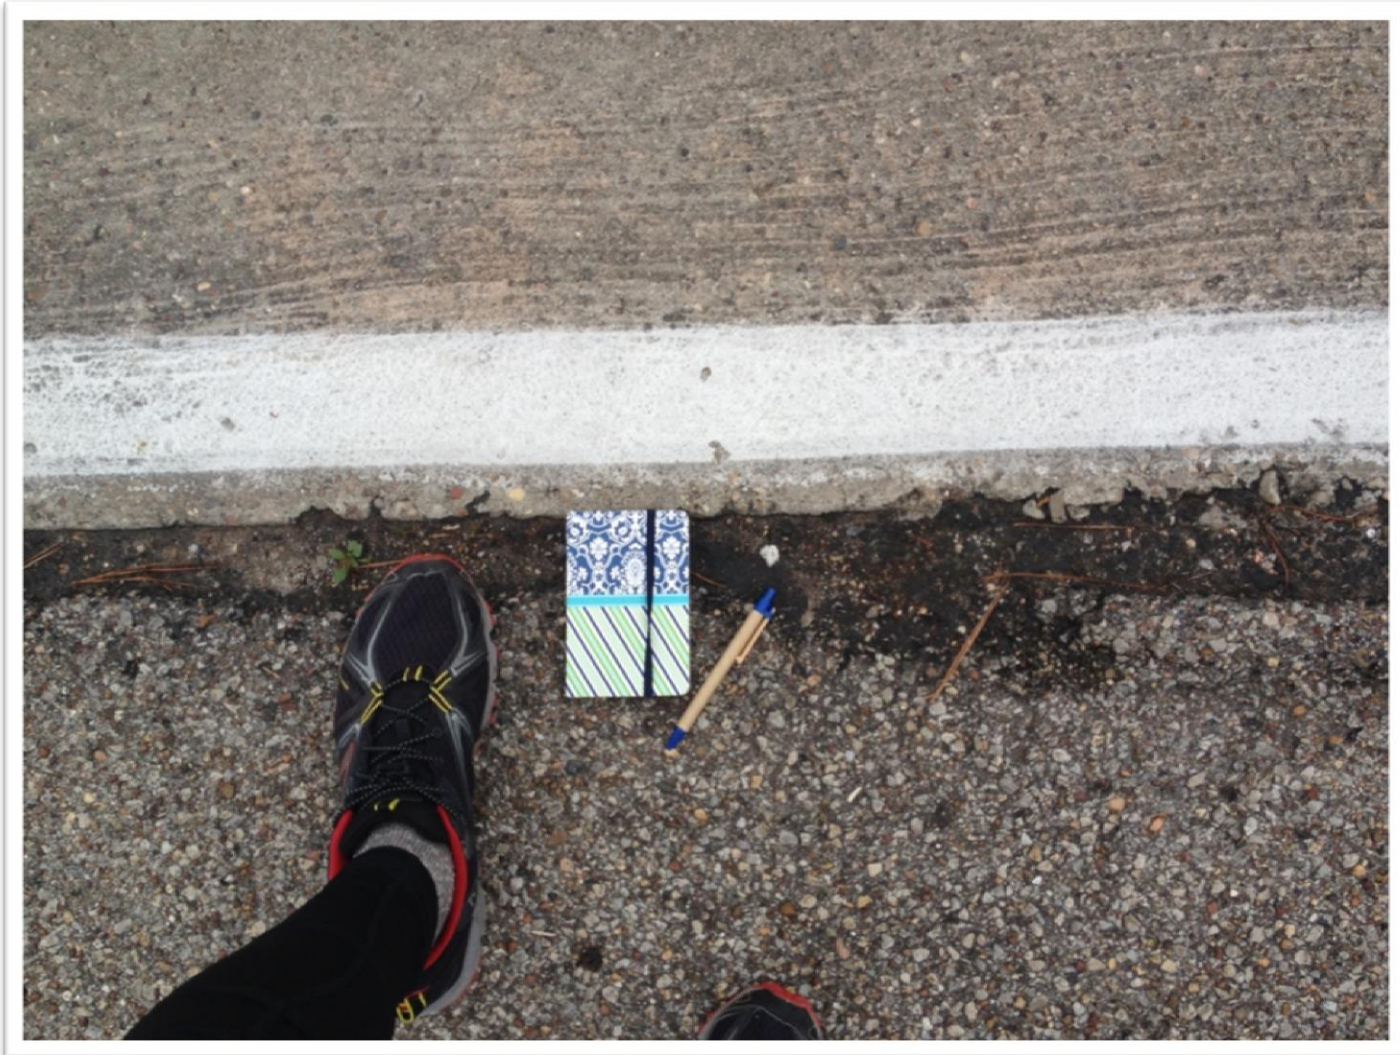
Location CC-14
Cochrans Crossing
Northbound

Hazard Type: Gap
Severity: 3

Gap 2.5 inches varying in width and depth

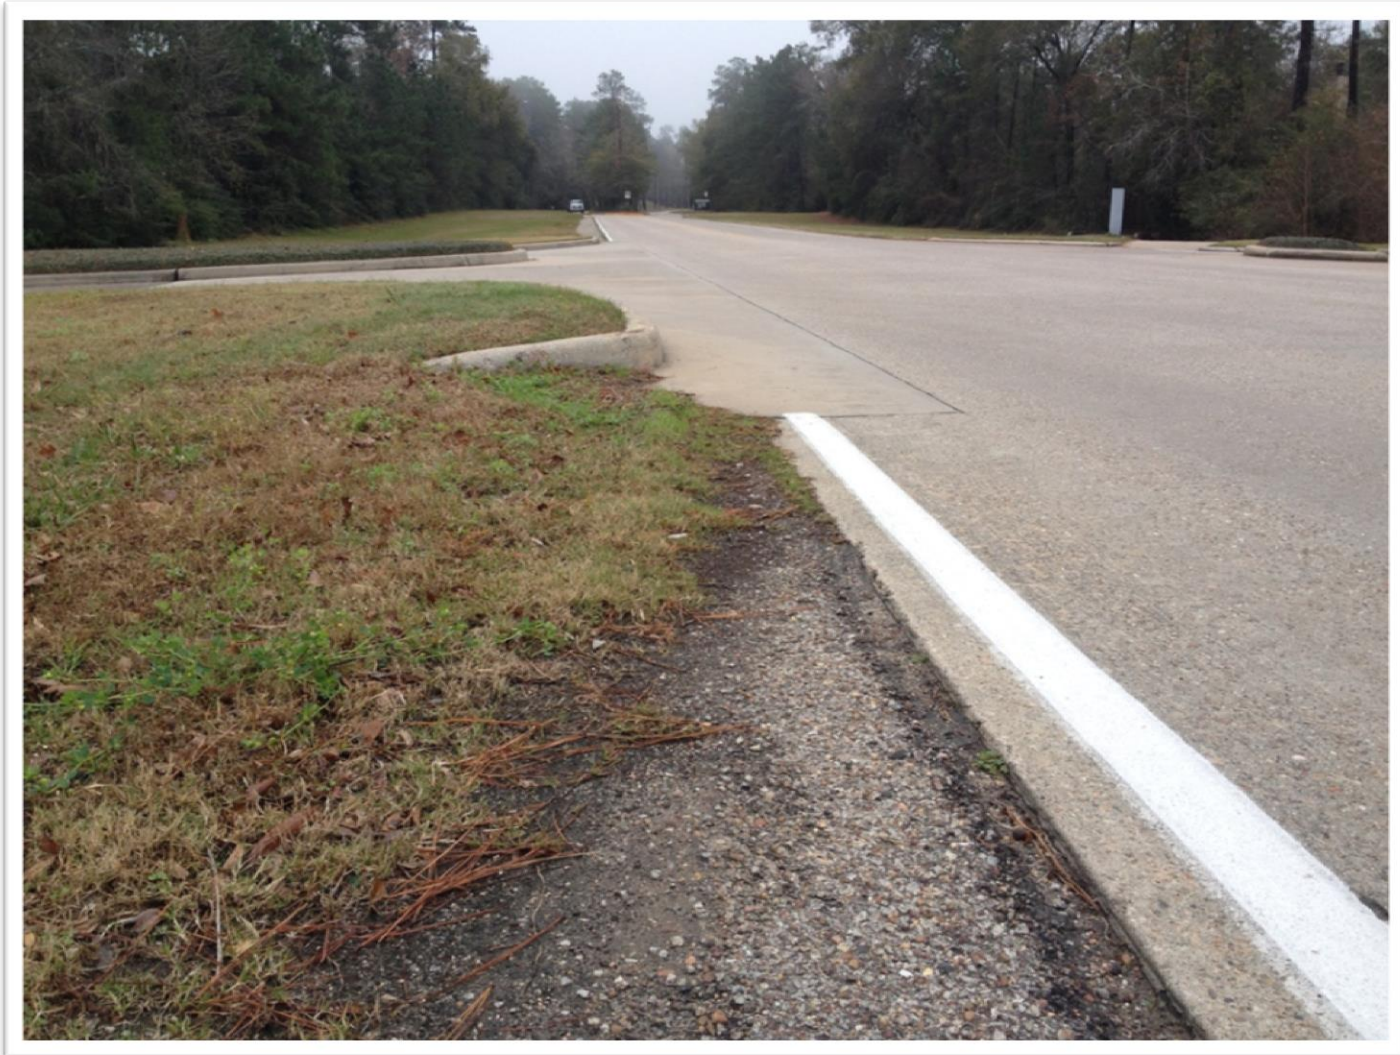
Location CC-15
Cochrans Crossing
Northbound

Hazard Type: Rough Area
Severity: 3

Grass overgrown covering shoulder next to
wide gap
