Road Shoulder Hazards along
Cochrans Crossing – January 2015

Hazards on road shoulders, that could pose a risk to cyclists, were identified in January 2015 by volunteers from Bike The Woodlands Coalition.

Cochrans Crossing Hazard Locations

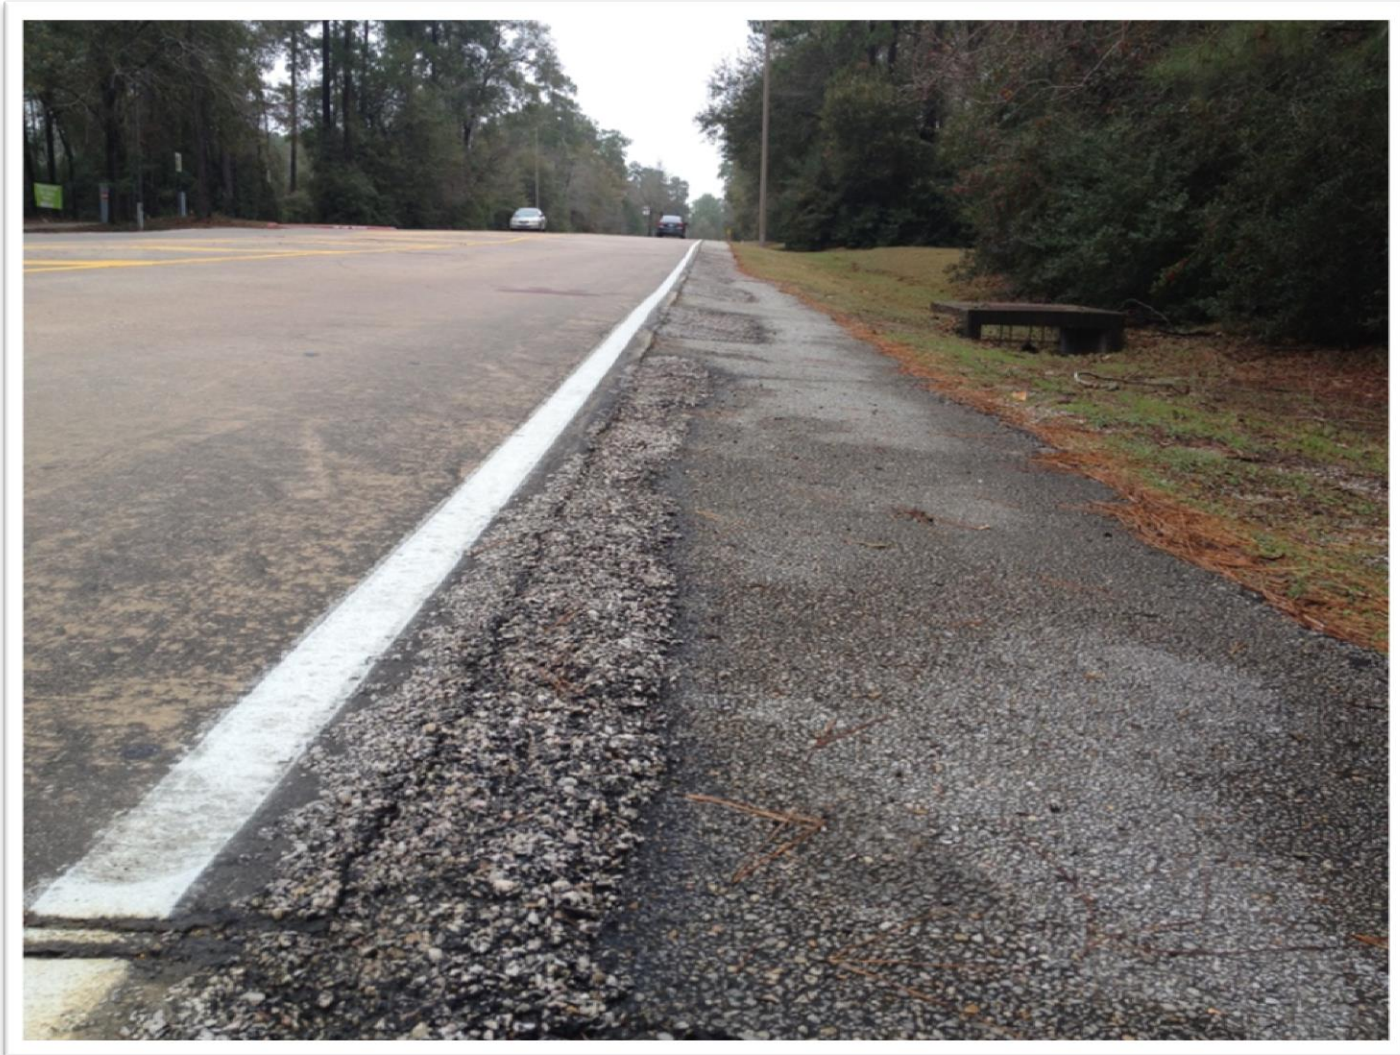
Location CC-16
Cochrans Crossing
Northbound

Hazard Type: Rough Area 120 feet of bad shoulder repair
Severity: 4

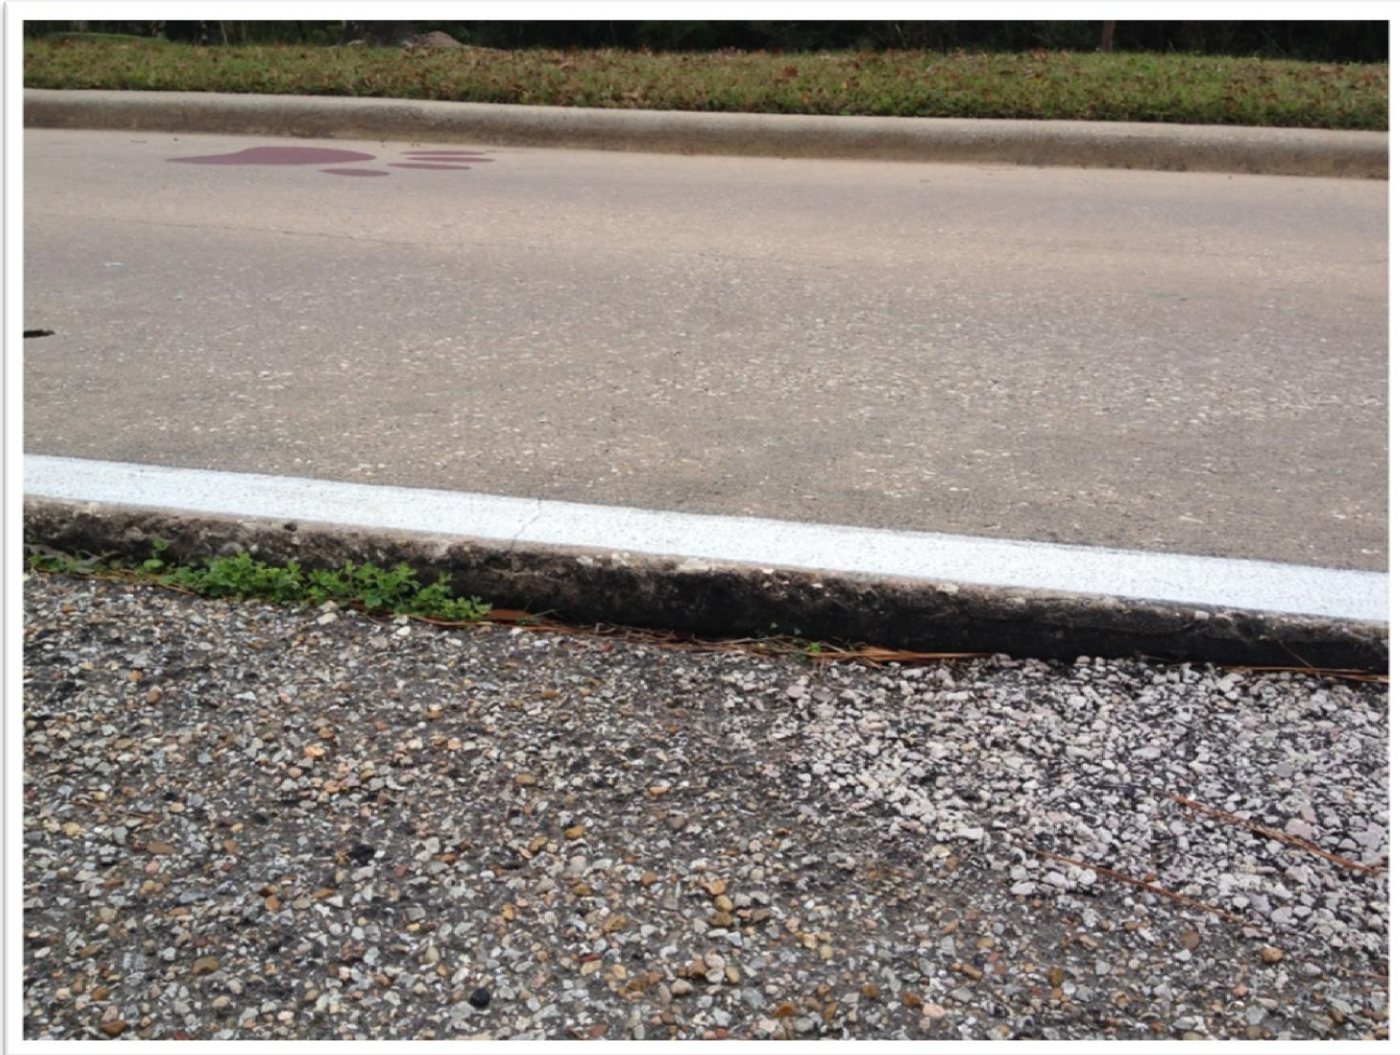
Location CC-17
Cochrans Crossing
Northbound

Hazard Type: Gap
Severity: 4

Large gap 2" plus across from school, church,
and park. NOTE: some of this near the school
and church has been marked with orange
paint, possibly for repair

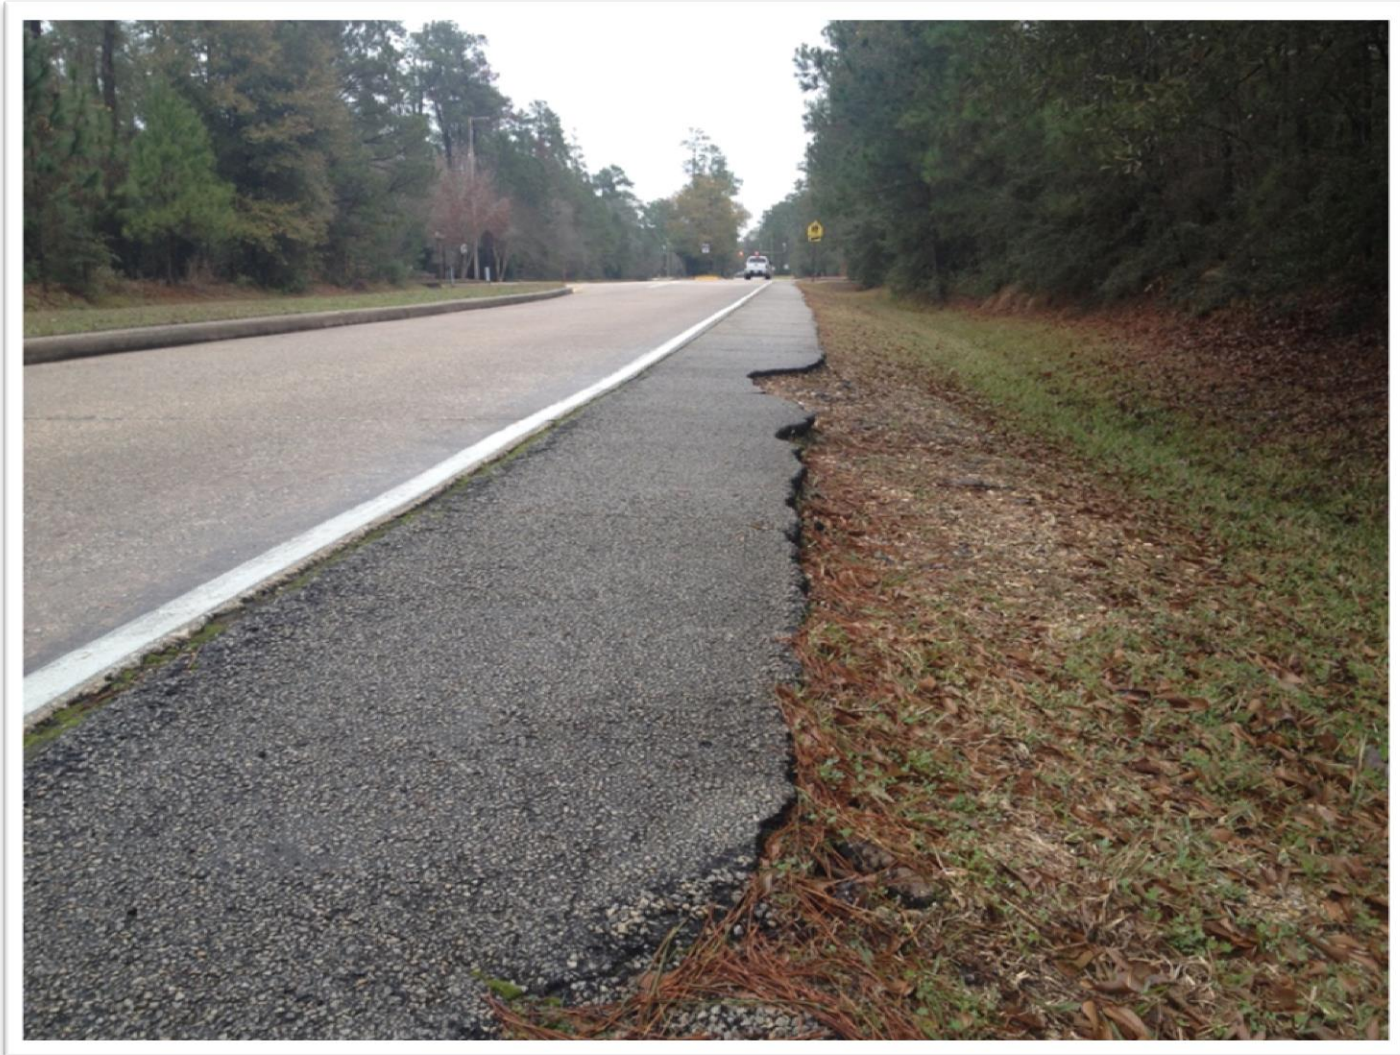
Location CC-18
Cochrans Crossing
Northbound

Hazard Type: Pothole
Severity: 3

Crumbling shoulder leaving pothole on edge
of shoulder

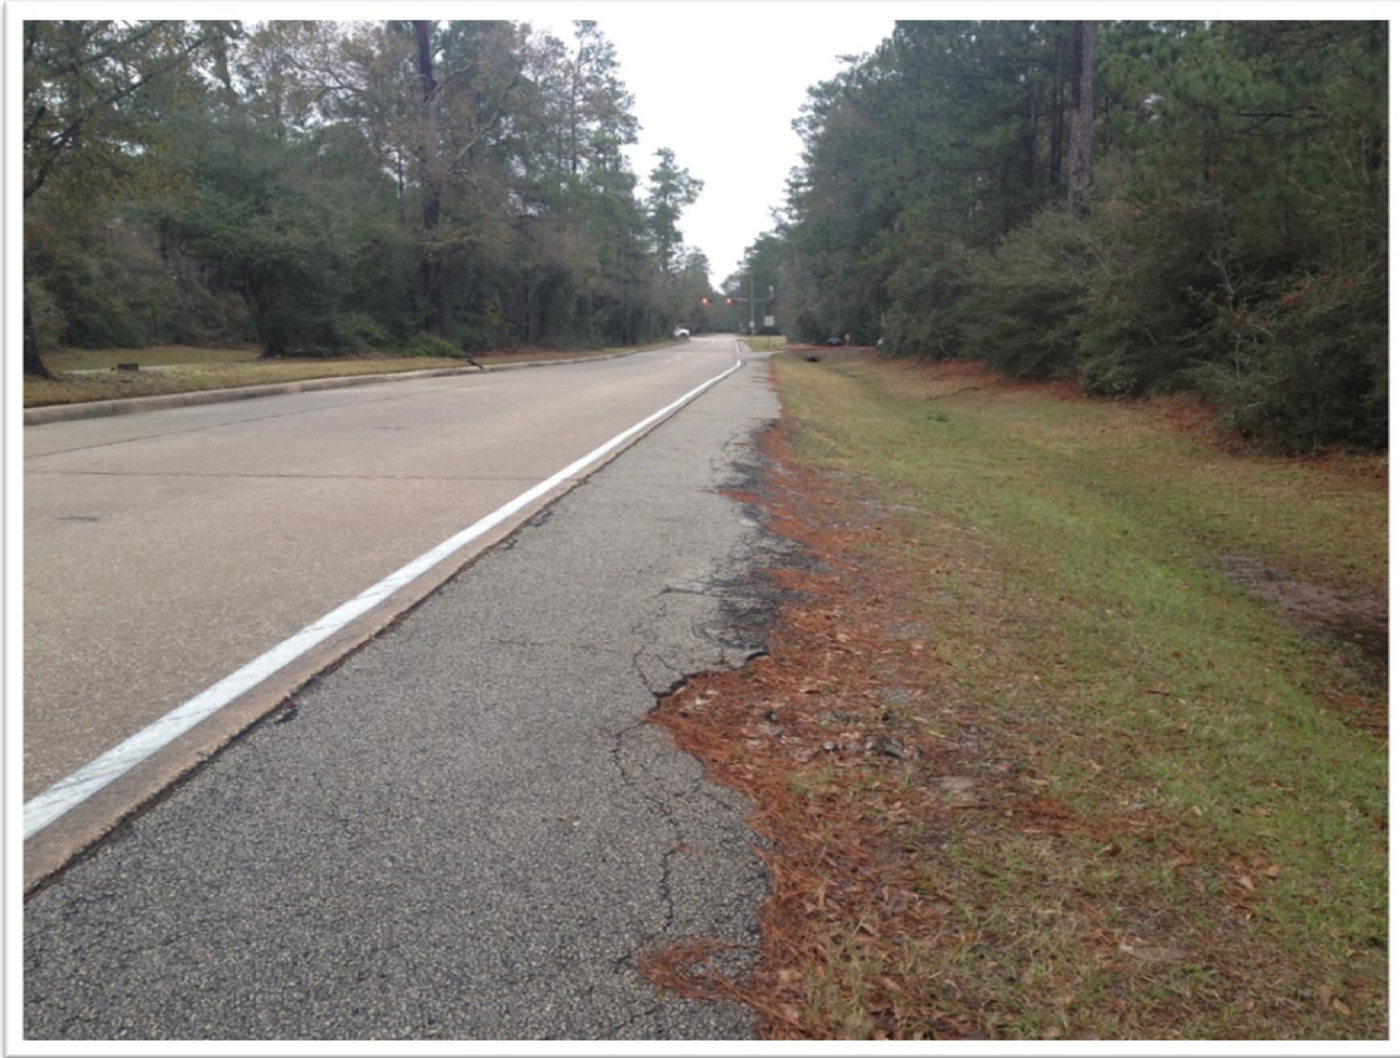
Location CC-19
Cochrans Crossing
Northbound

Hazard Type: Rough Area Crumbling, collapsing shoulder
Severity: 3
