Road Shoulder Hazards along
Shadowbend Place– January 2015

Hazards on road shoulders, that could pose a risk to cyclists, were identified in January 2015 by volunteers from Bike The Woodlands Coalition.

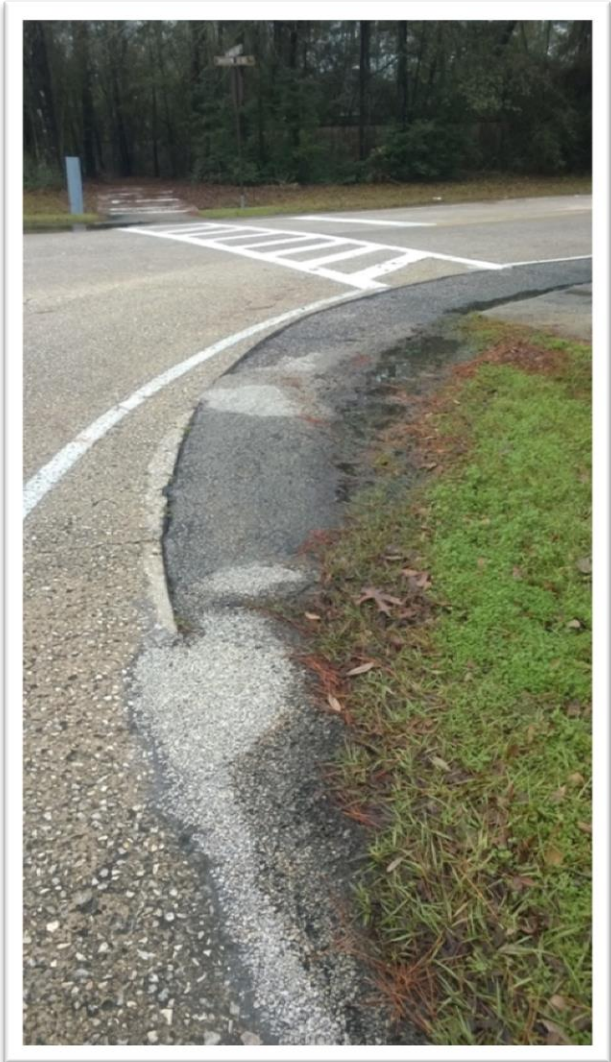
Location Sh-1
Shadowbend
Northbound

Hazard Type: Rough Area Rough, water-collection area at intersection
Severity: 2

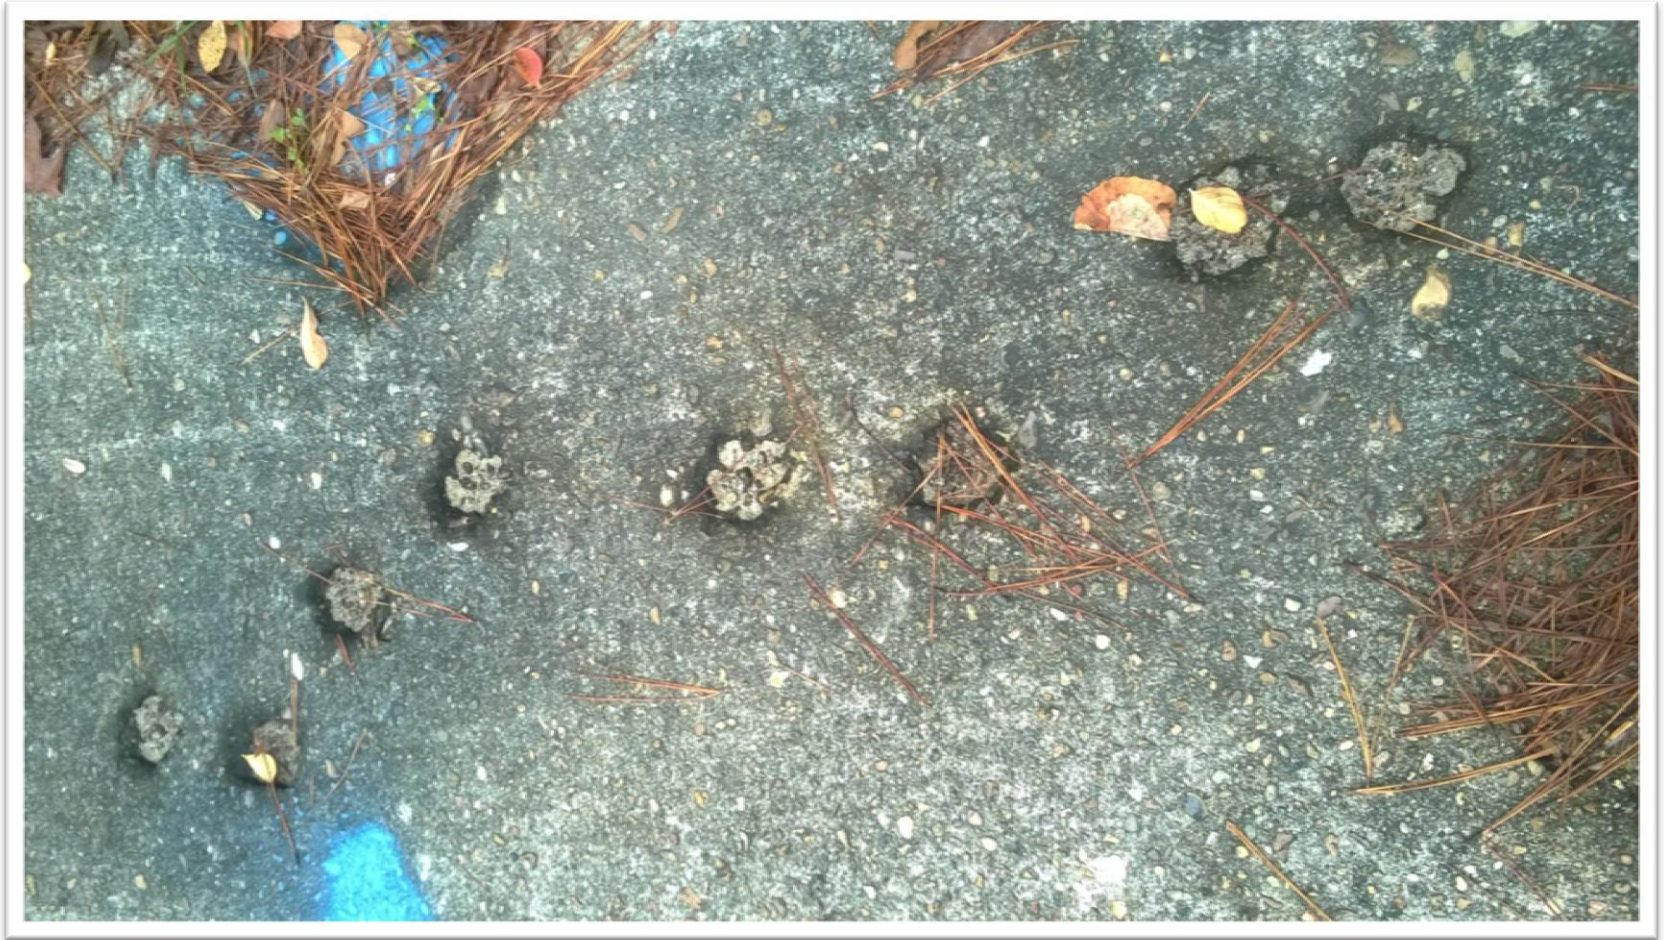
Location Sh-2
Shadowbend
Northbound

Hazard Type: Other
Severity: 0

Four legged pedestrian use - no hazard just
interest.

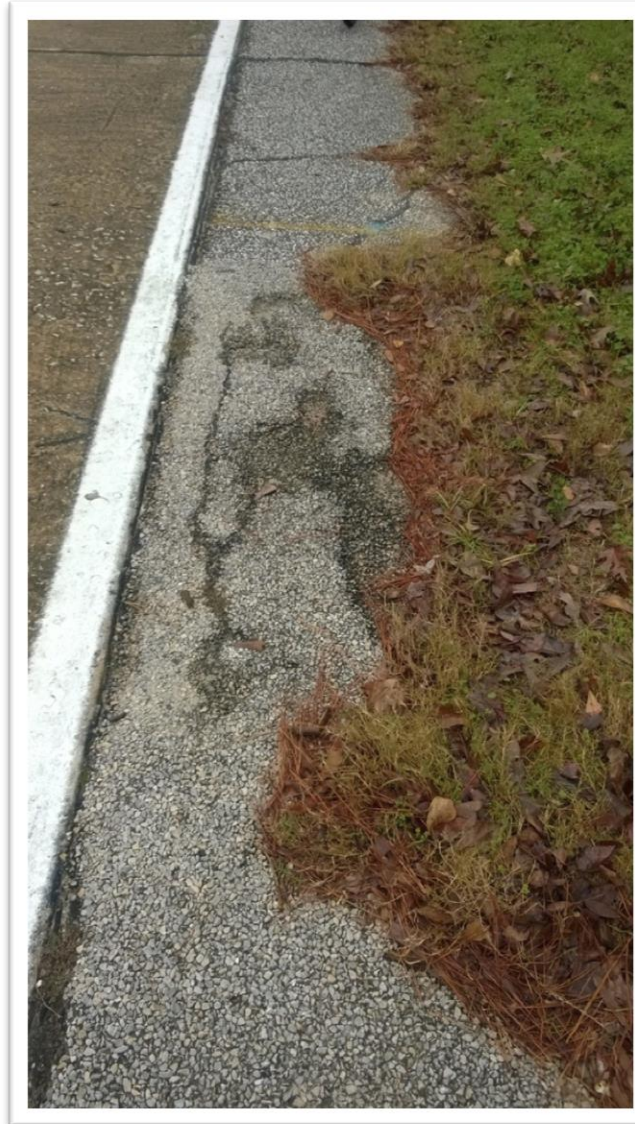
Location Sh-3
Shadowbend
Northbound

Hazard Type: Maintenance
Severity: 2

Could cause cyclist to move onto the roadway.

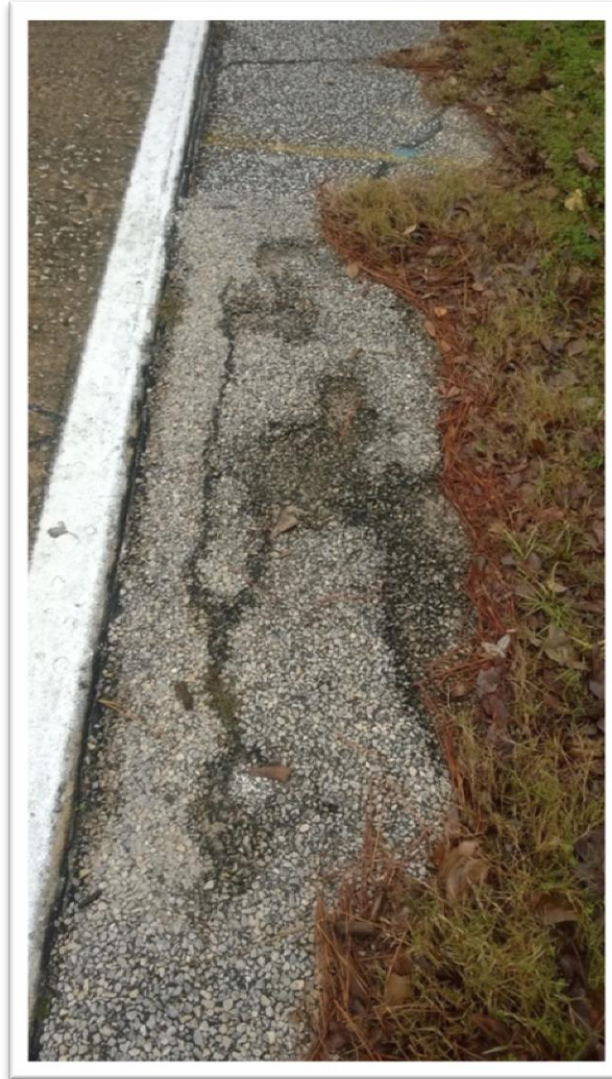
Location Sh-4
Shadowbend
Northbound

Hazard Type: Maintenance
Severity: 2

Could cause cyclist to move onto the roadway.

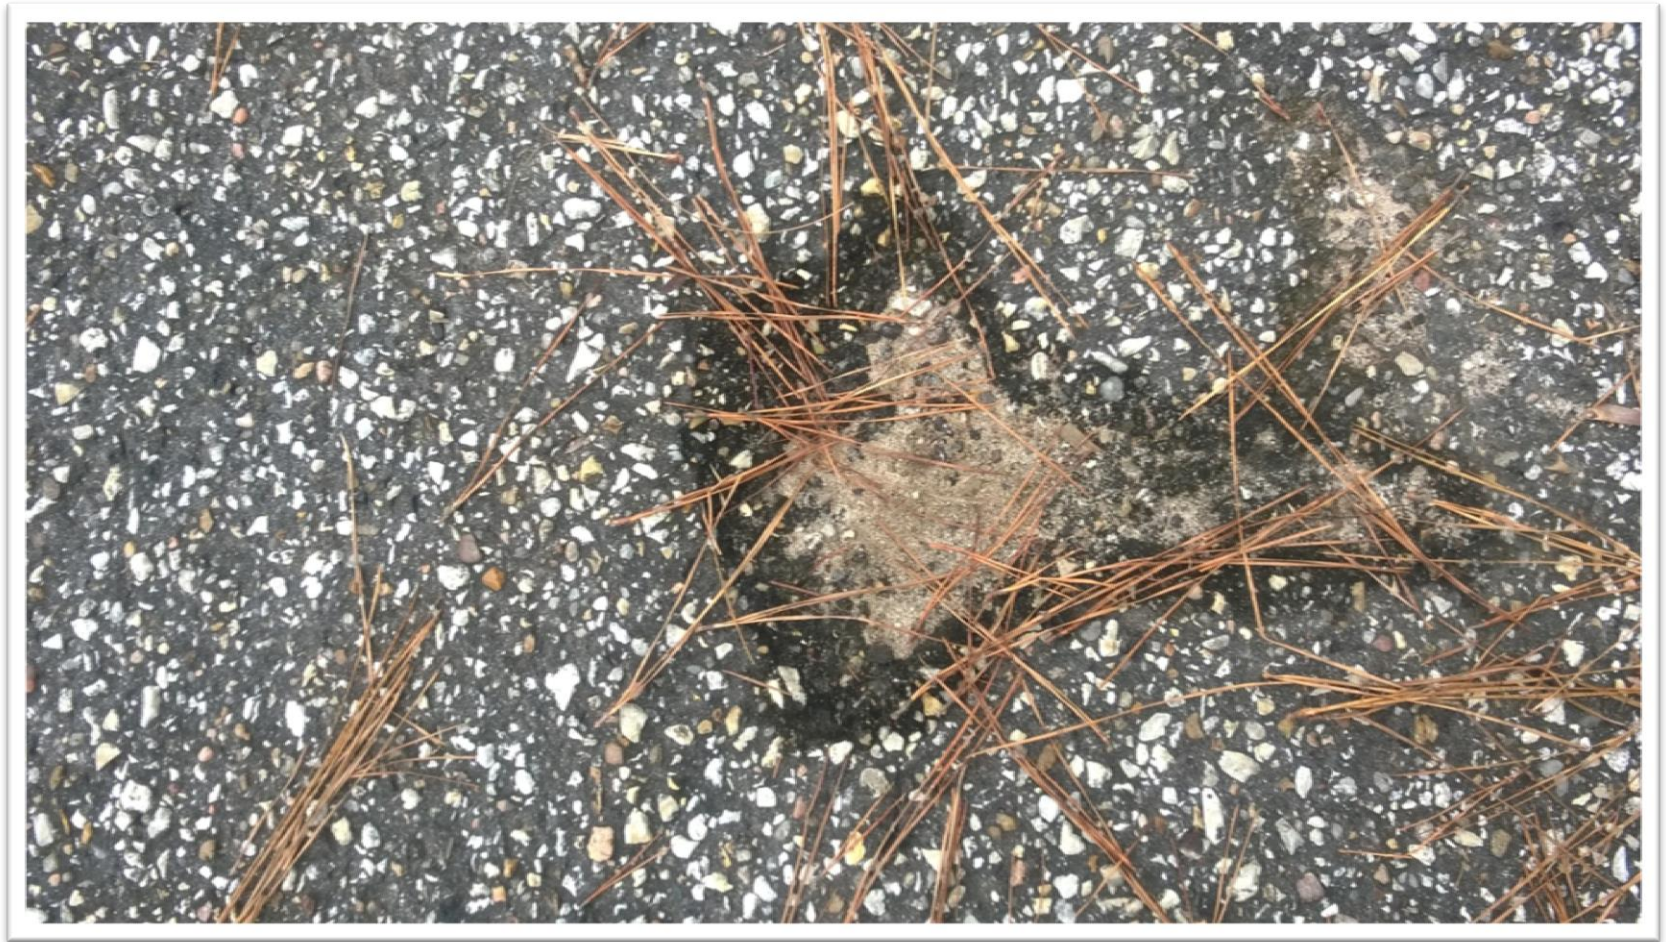
Location Sh-5
Shadowbend
Northbound

Hazard Type: Pothole
Severity: 2

Half Inch Deep Irregular Hole in Middle of
Shoulder - Photo 1

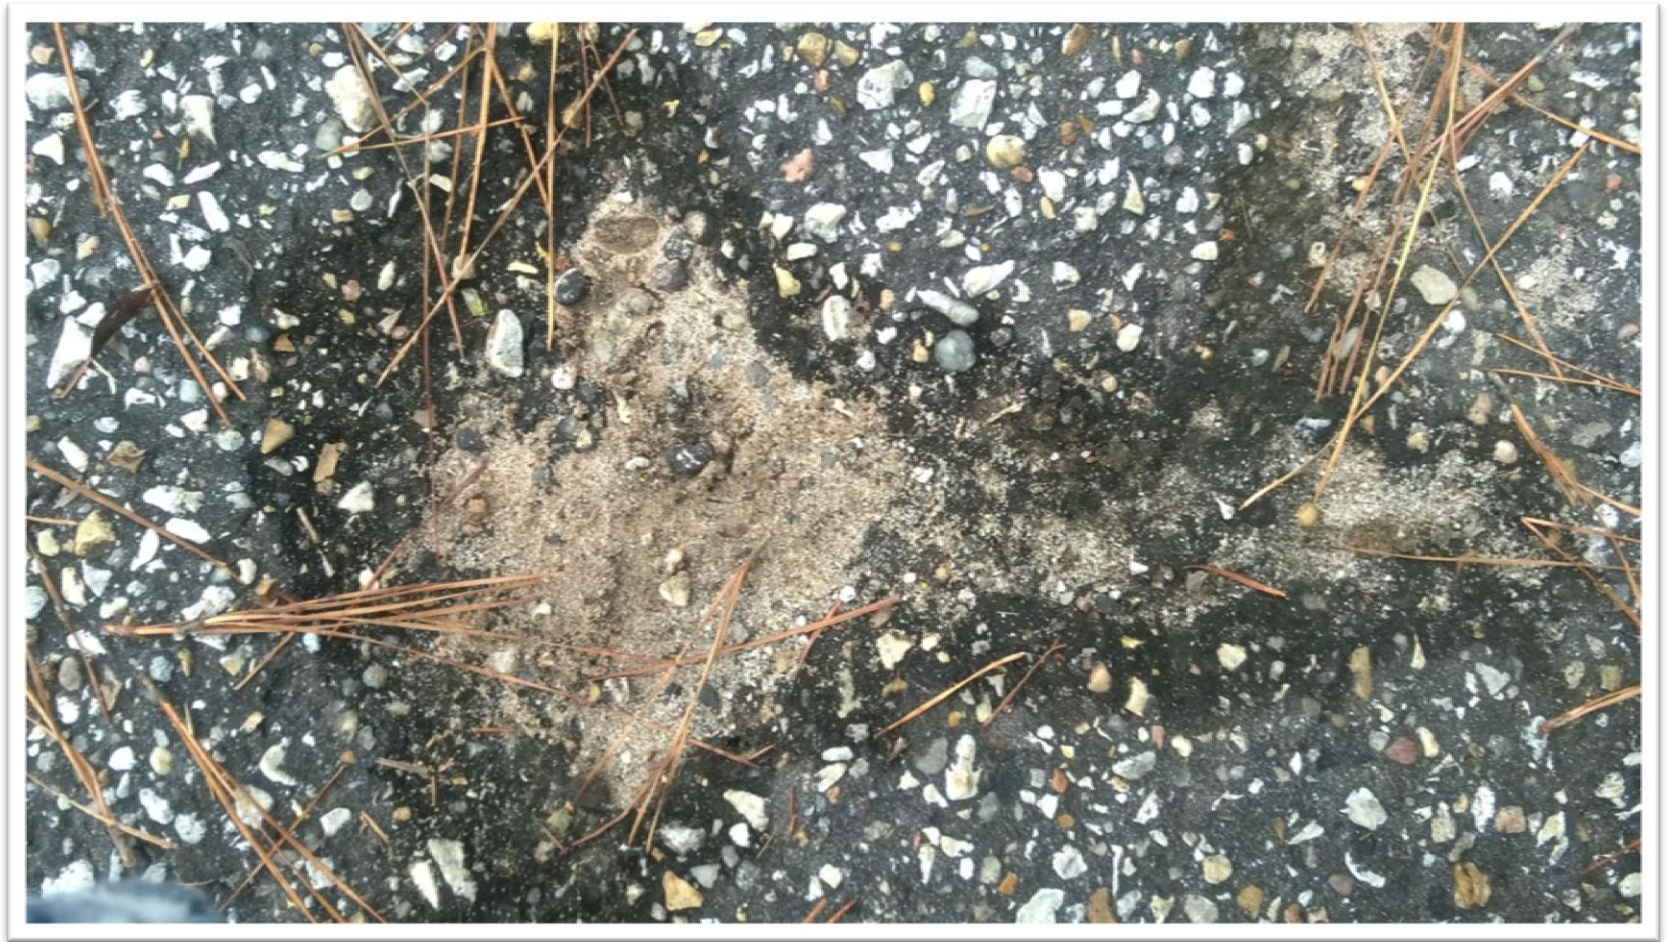
Location Sh-6
Shadowbend
Northbound

Hazard Type: Pothole
Severity: 2

Half Inch Deep Irregular Hole in Middle of
Shoulder-Photo 2

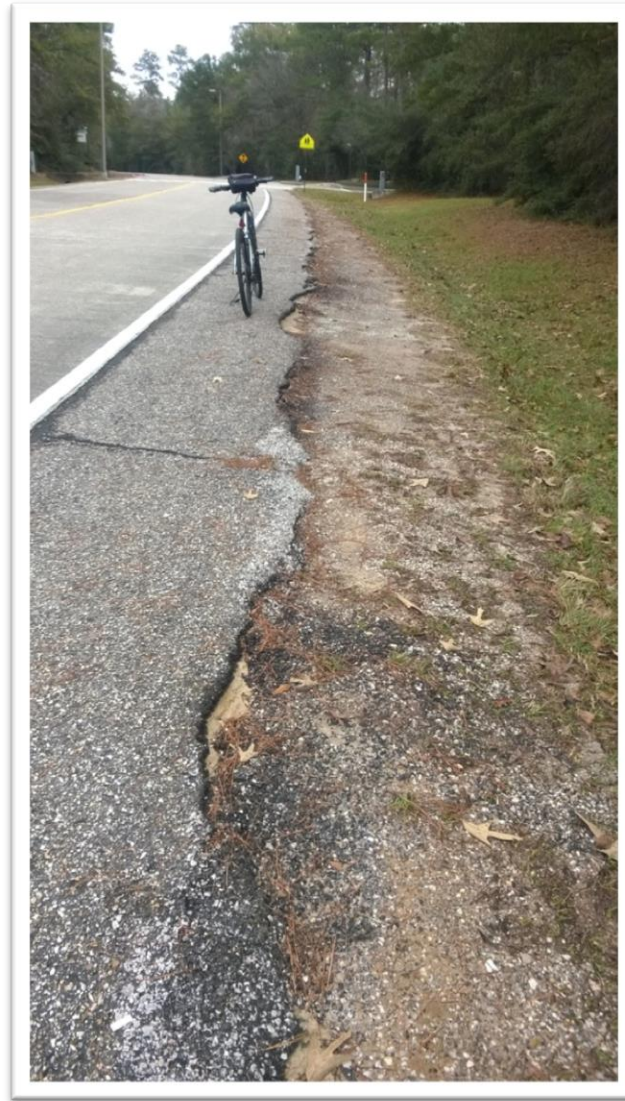
Location Sh-7
Shadowbend
Northbound

Hazard Type: Other
Severity: 2

Degraded Shoulder Edge 2" Dropoff
Locations for photos Sh-5 to Sh-10 are
within this shoulder section

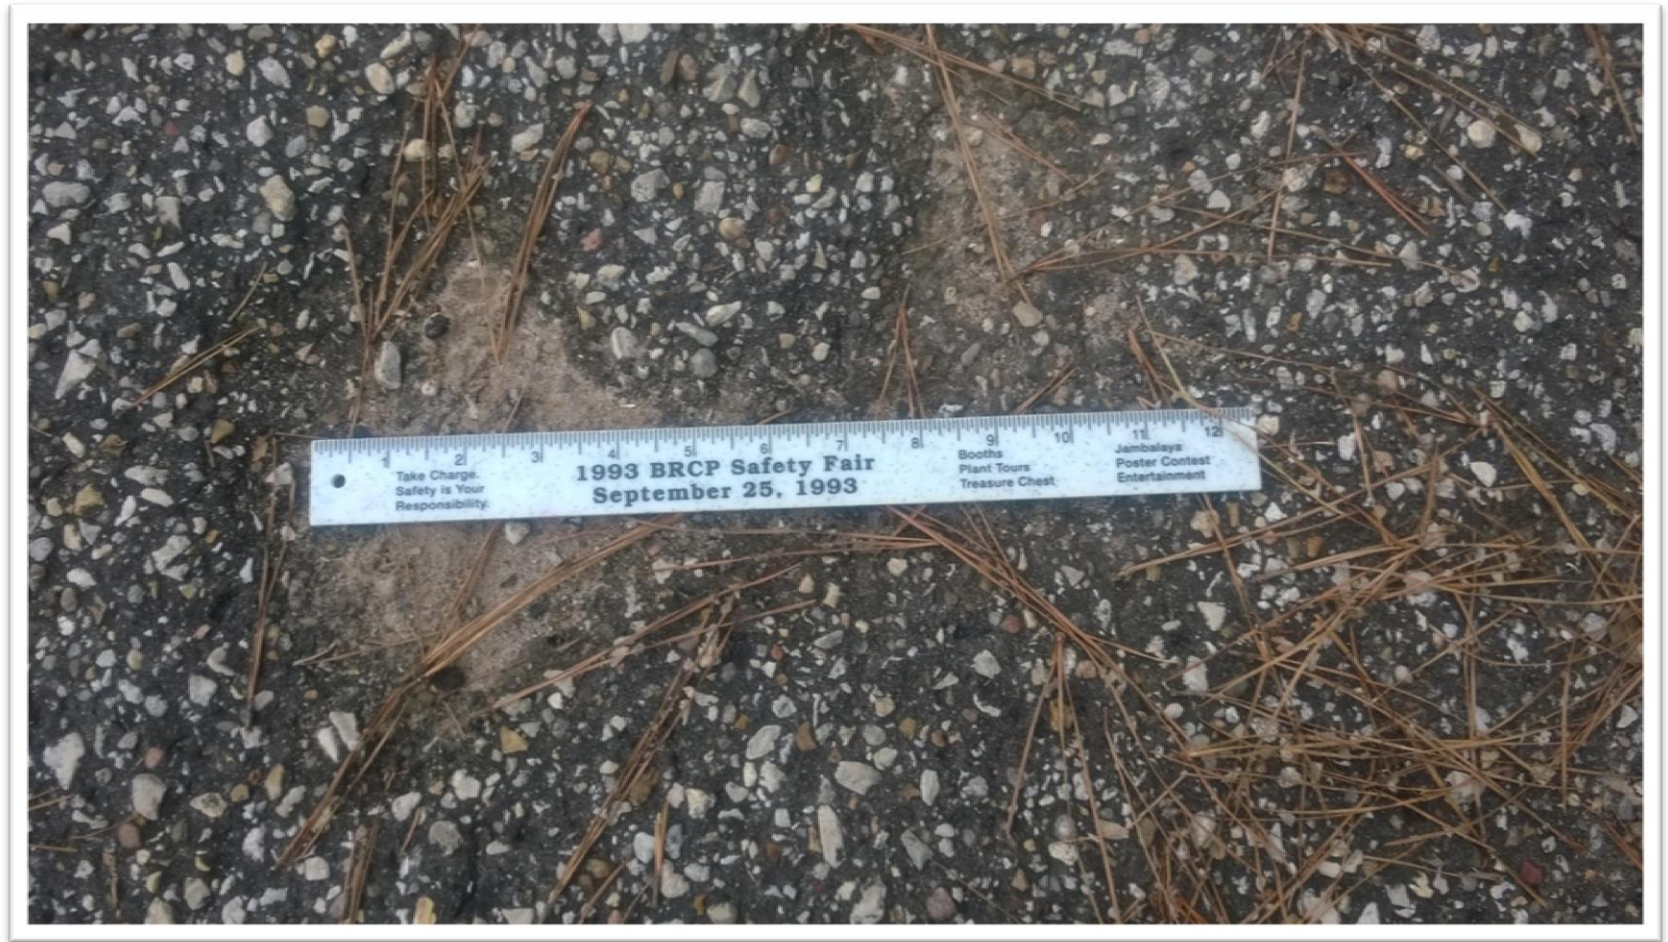
Location Sh-8
Shadowbend
Northbound

Hazard Type: Pothole
Severity: 2

Half Inch Deep Irregular Hole in Middle of
Shoulder Shown with Ruler Photo 3

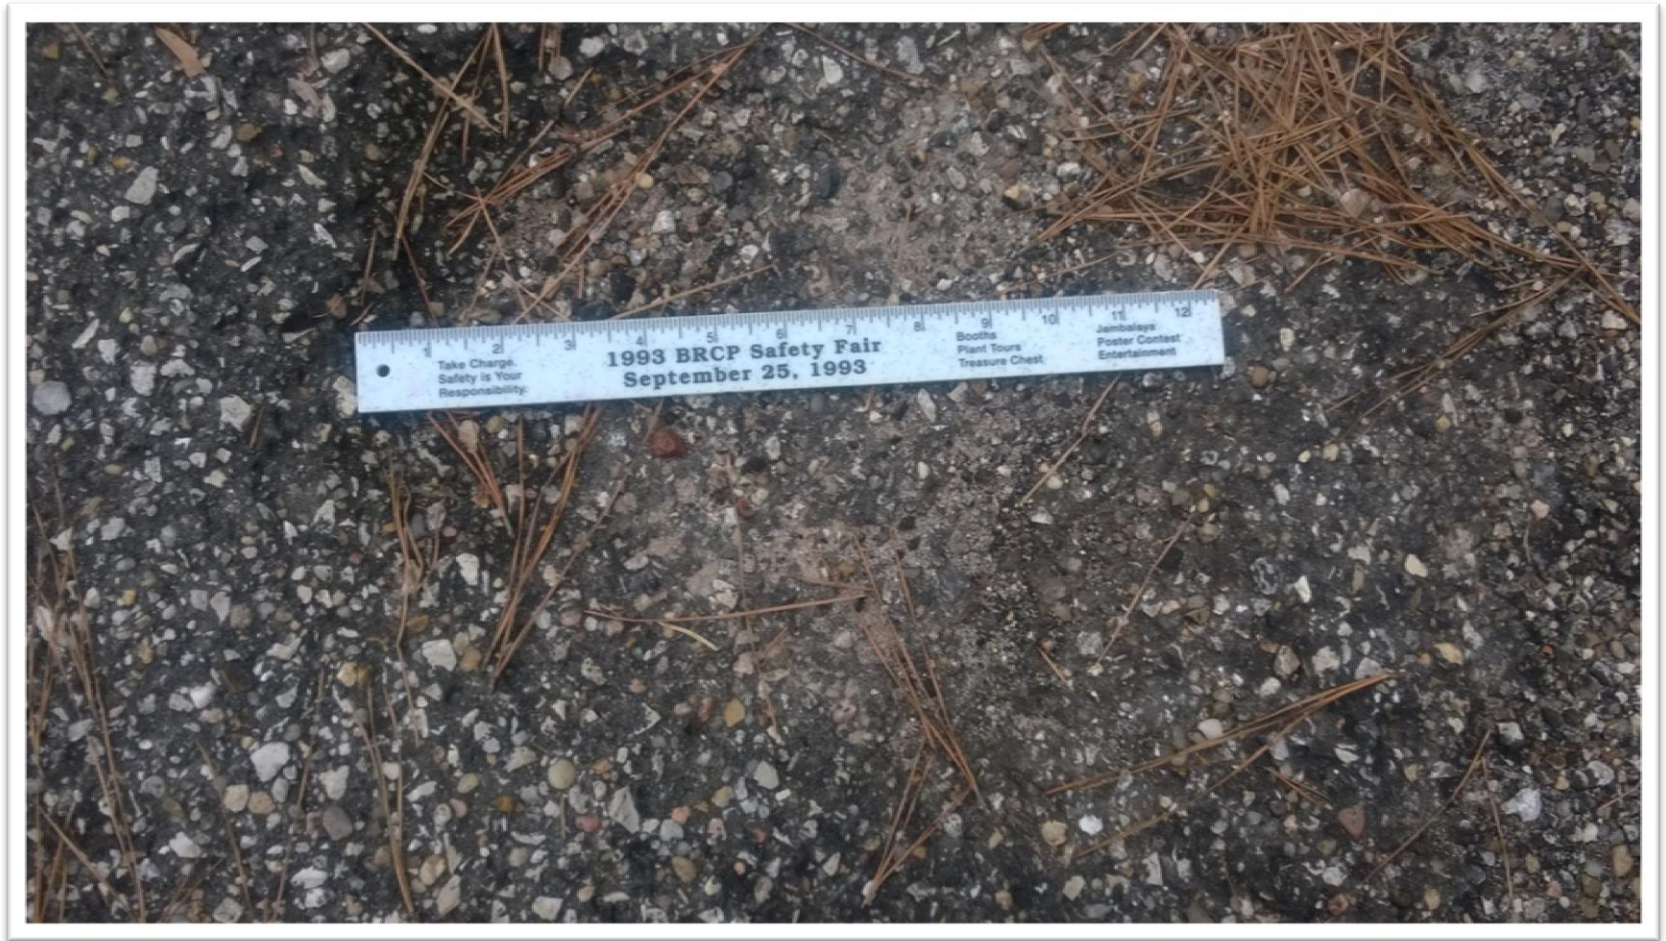
Location Sh-9
Shadowbend
Northbound

Hazard Type: Rough Area Subsidence with Ruler
Severity: 2

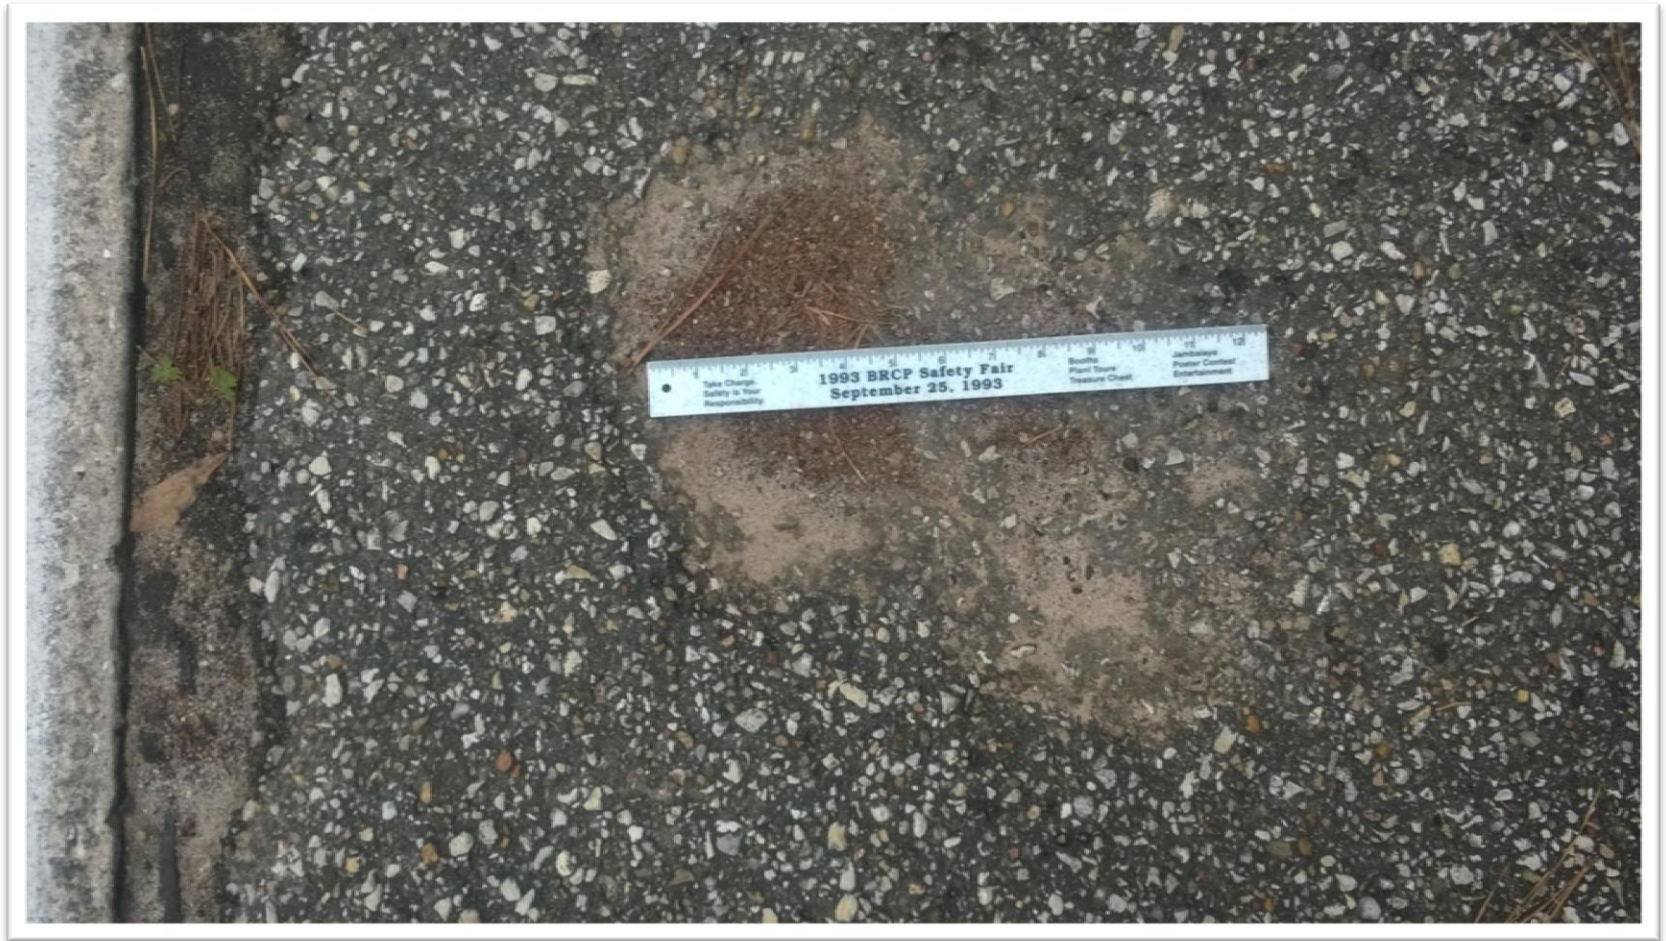
Location Sh-10
Shadowbend
Northbound

Hazard Type: Rough Area Hole near Sewer Drop with Ruler
Severity: 2

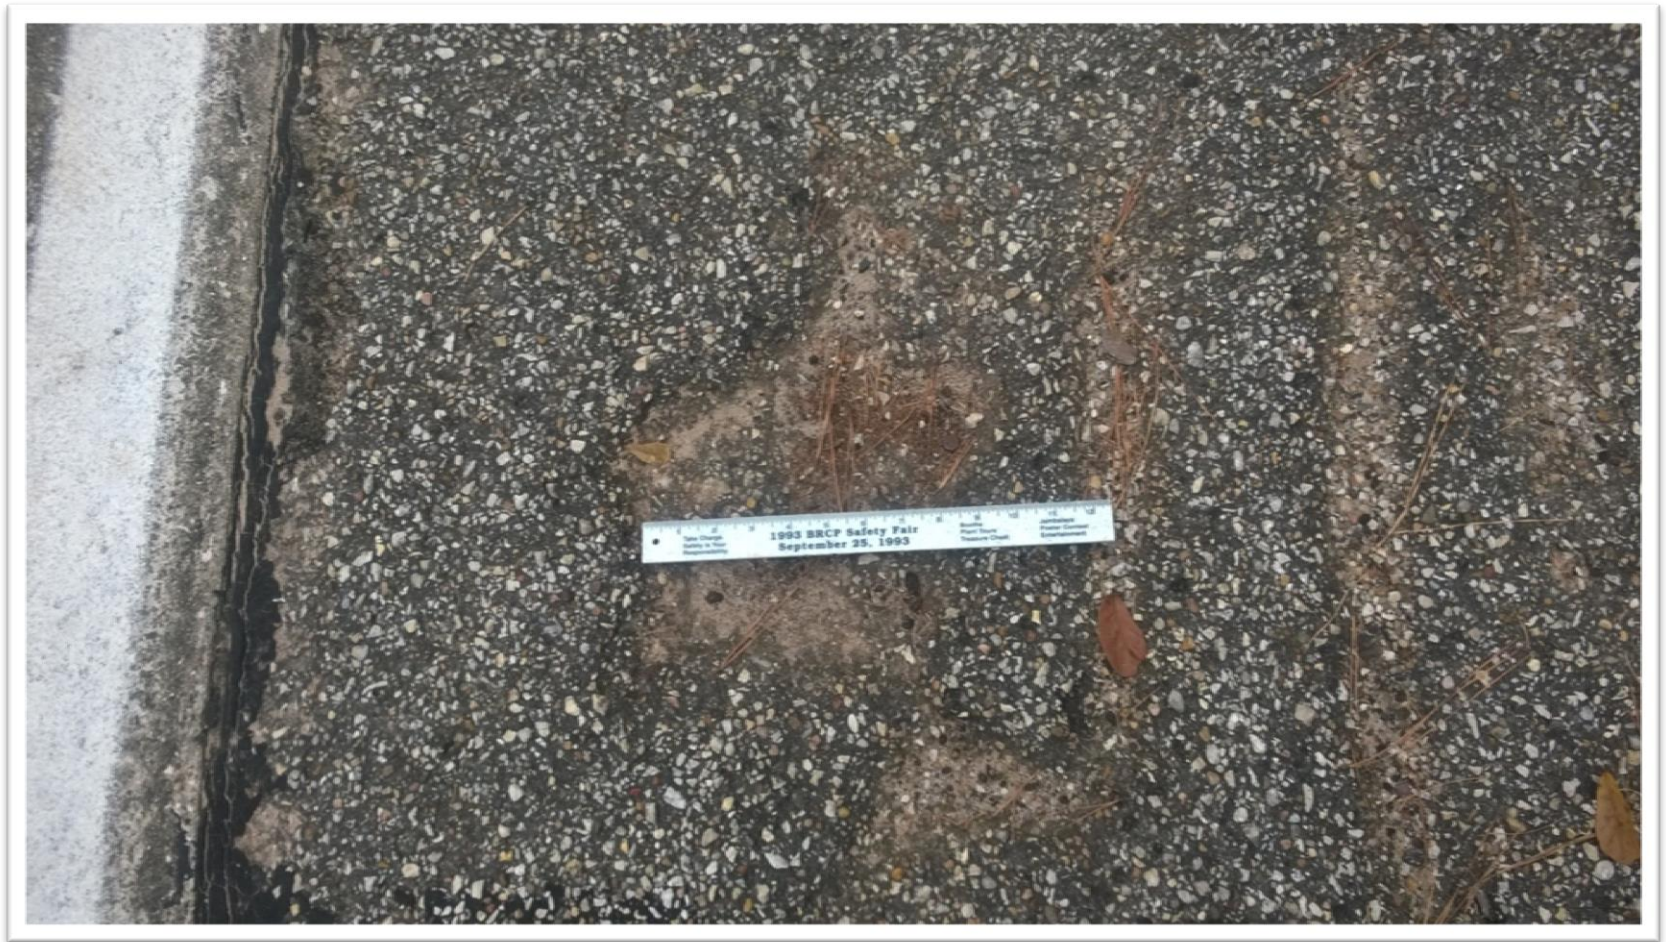
Location Sh-11
Shadowbend
Northbound

Hazard Type: Pothole
Severity: 2

Two 0.5 inch deep holes in shoulder plus gaps
Photo 2

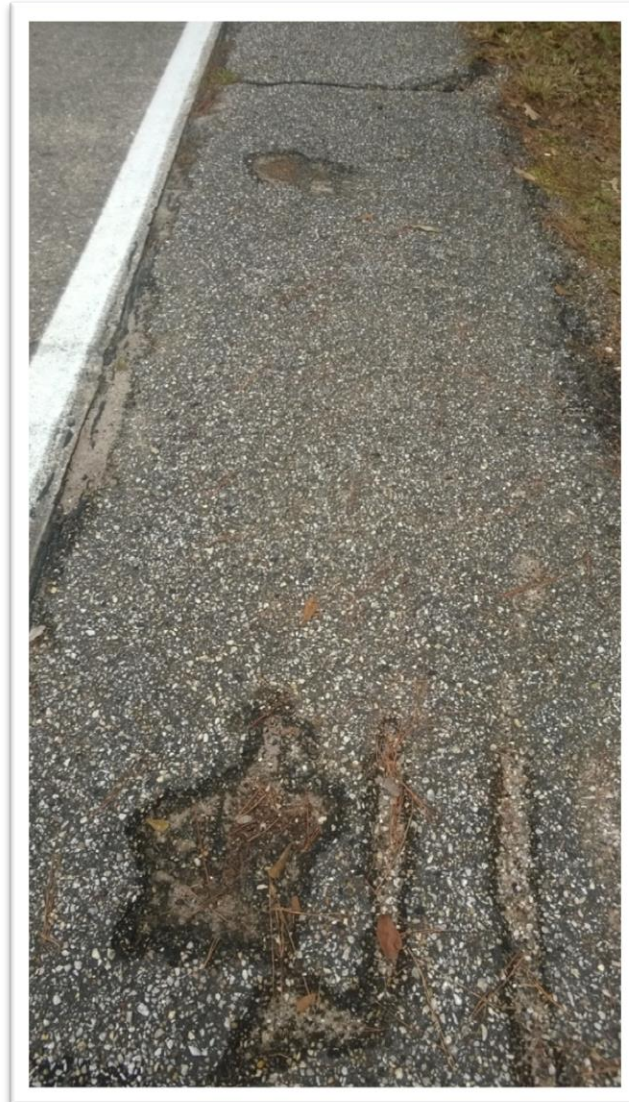
Location Sh-12
Shadowbend
Northbound

Hazard Type: Pothole
Severity: 2

Two 0.5 inch deep holes in shoulder plus gaps
Photo 1

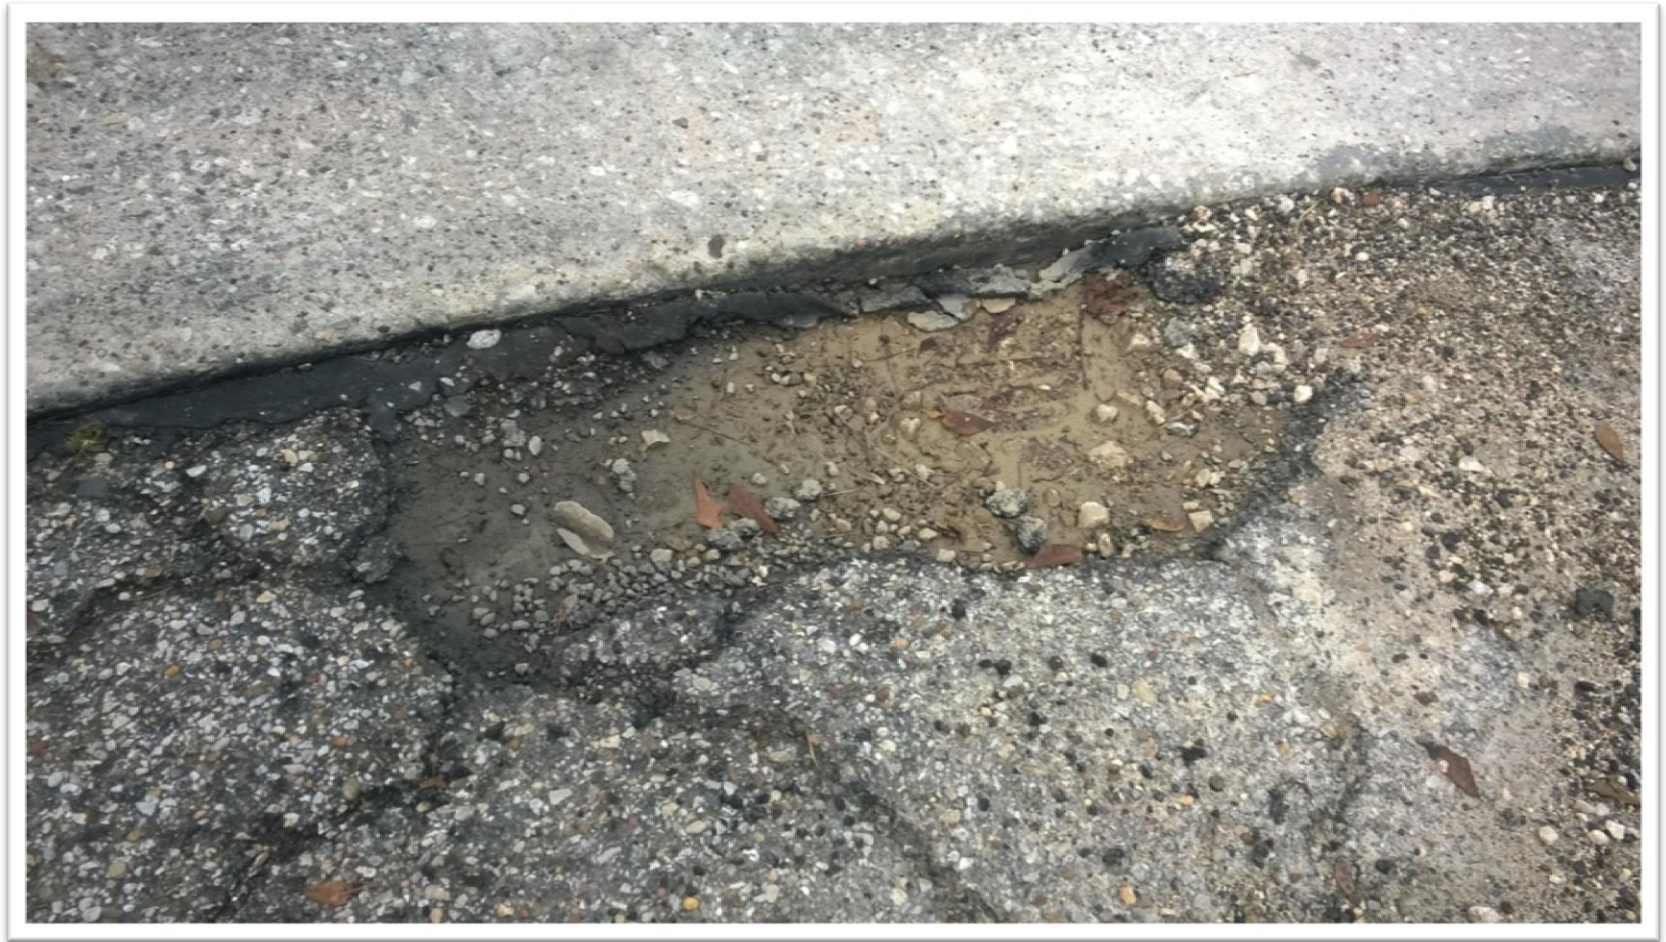
Location Sh-13
Shadowbend
Northbound

Hazard Type: Pothole
Severity: 4

3.5" drop from road surface to shoulder at
intersection with LW Photo 1

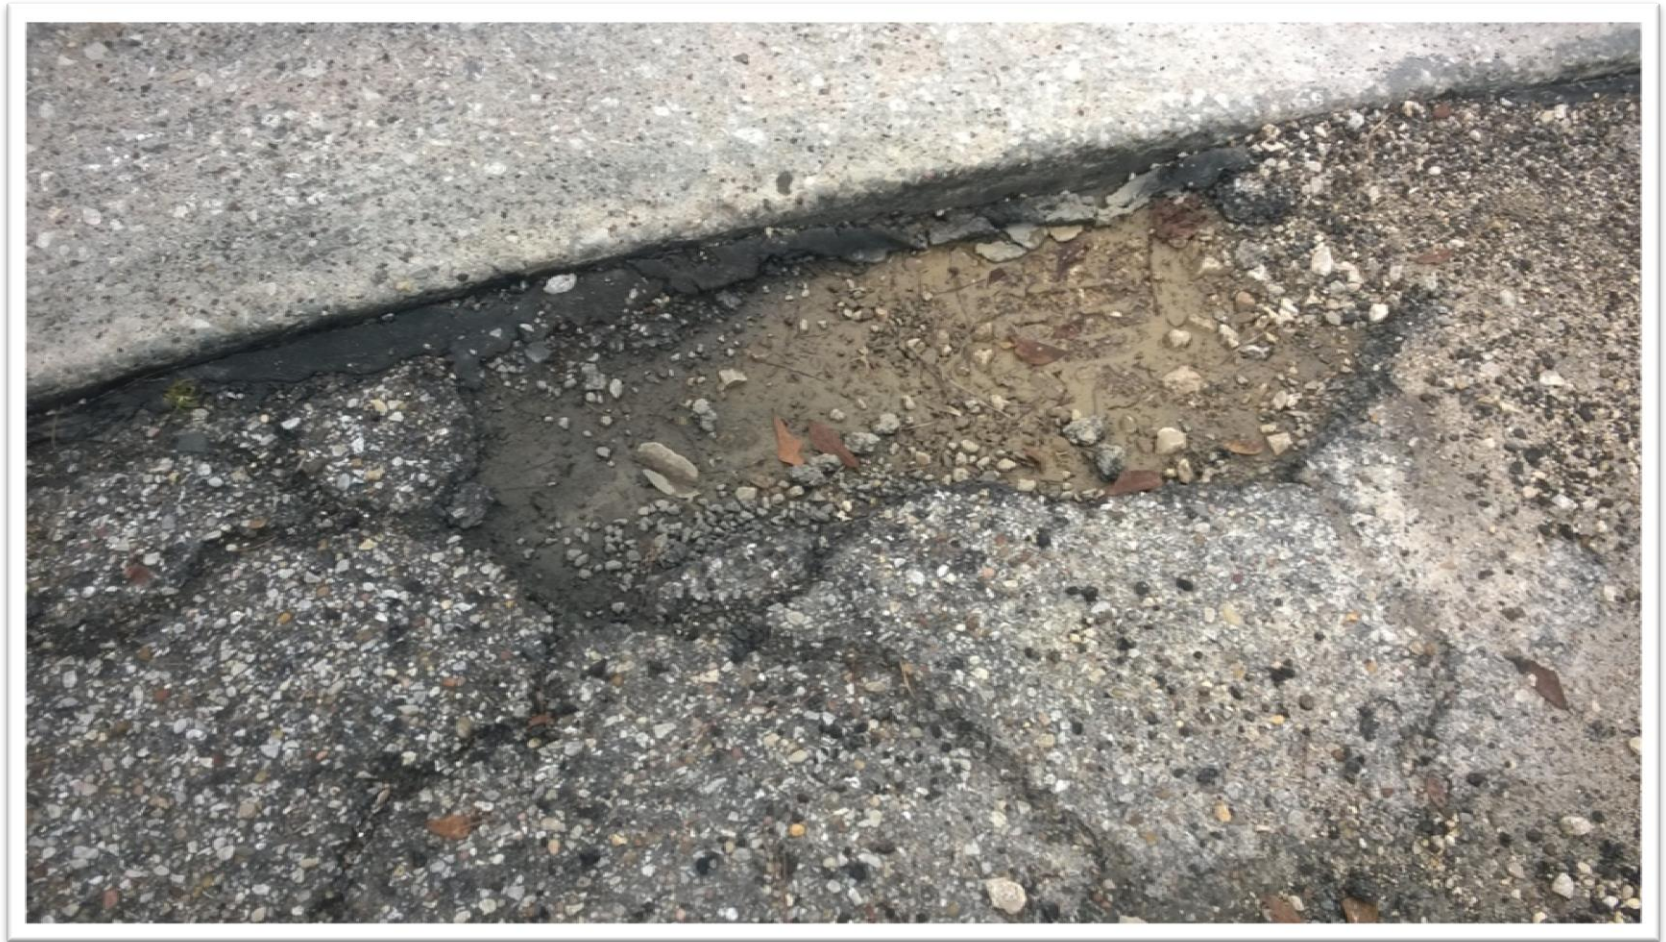
Location Sh-14
Shadowbend
Northbound

Hazard Type: Pothole
Severity: 4

3.5" drop from road surface to shoulder at
intersection with LW-Photo 2

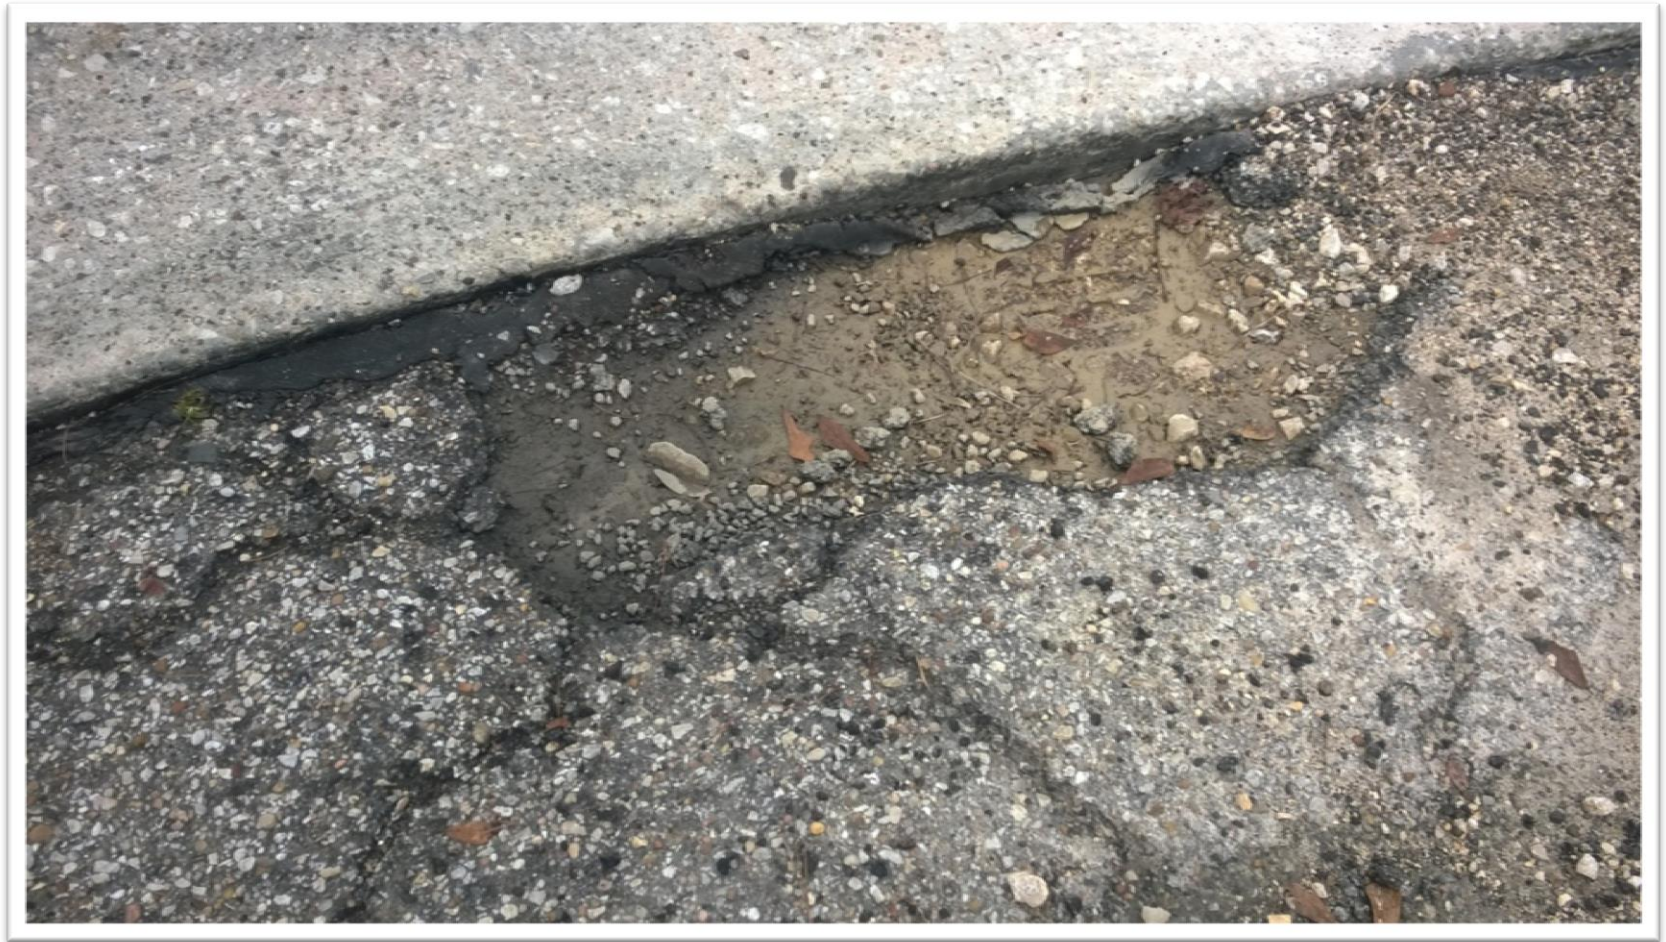
Location Sh-15
Shadowbend
Northbound

Hazard Type: Pothole
Severity: 4

3.5" drop from road surface to shoulder at
intersection with LW-Photo3

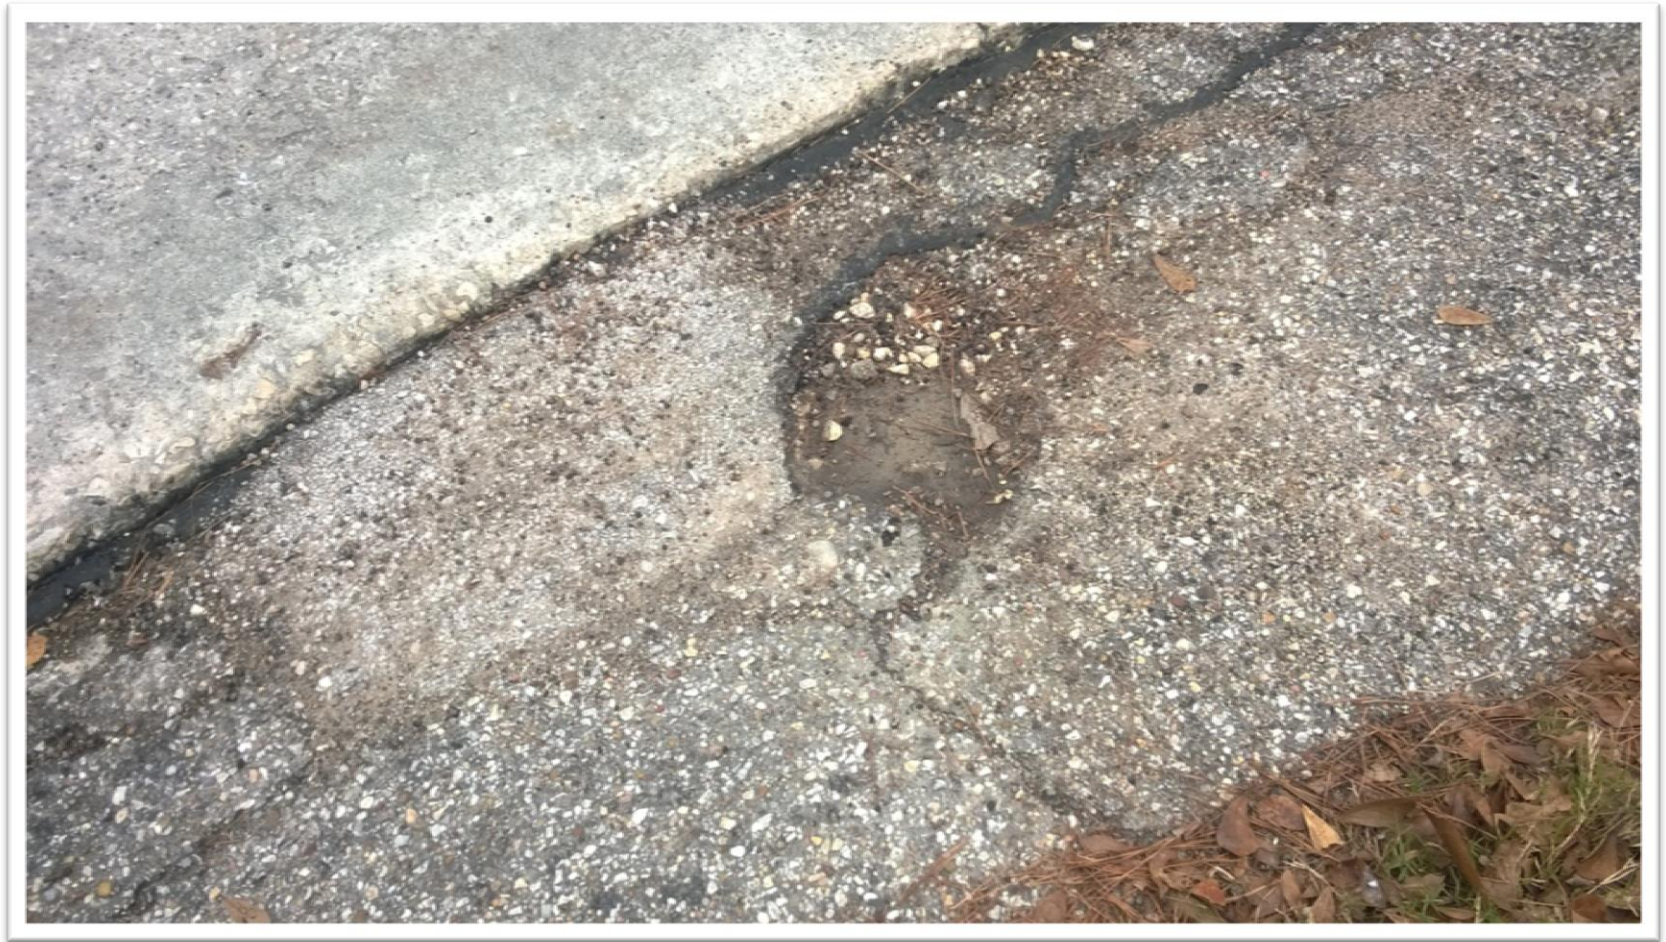
Location Sh-16
Shadowbend
Northbound

Hazard Type: Pothole
Severity: 4

3.5" drop from road surface to shoulder at
intersection with LW-Photo4

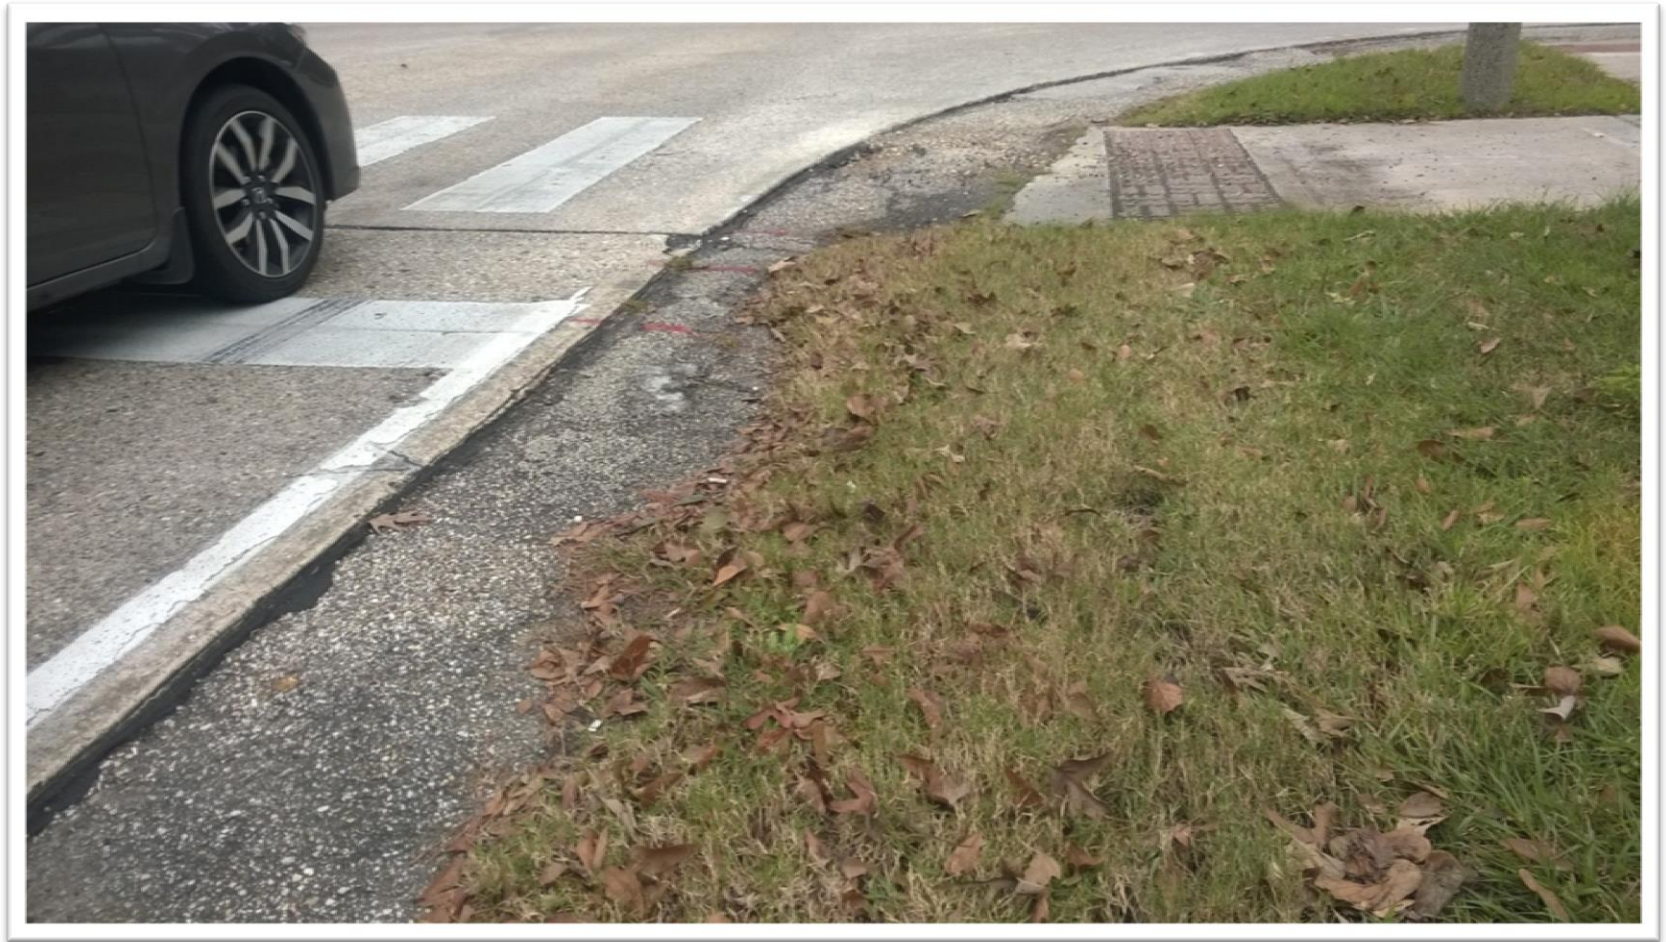
Location Sh-17
Shadowbend
Northbound

Hazard Type: Pothole
Severity: 4

3.5" drop from road surface to shoulder at
intersection with LW-Photo 5
