Road Shoulder Hazards along
Shadowbend Place– January 2015

Hazards on road shoulders, that could pose a risk to cyclists, were identified in January 2015 by volunteers from Bike The Woodlands Coalition.

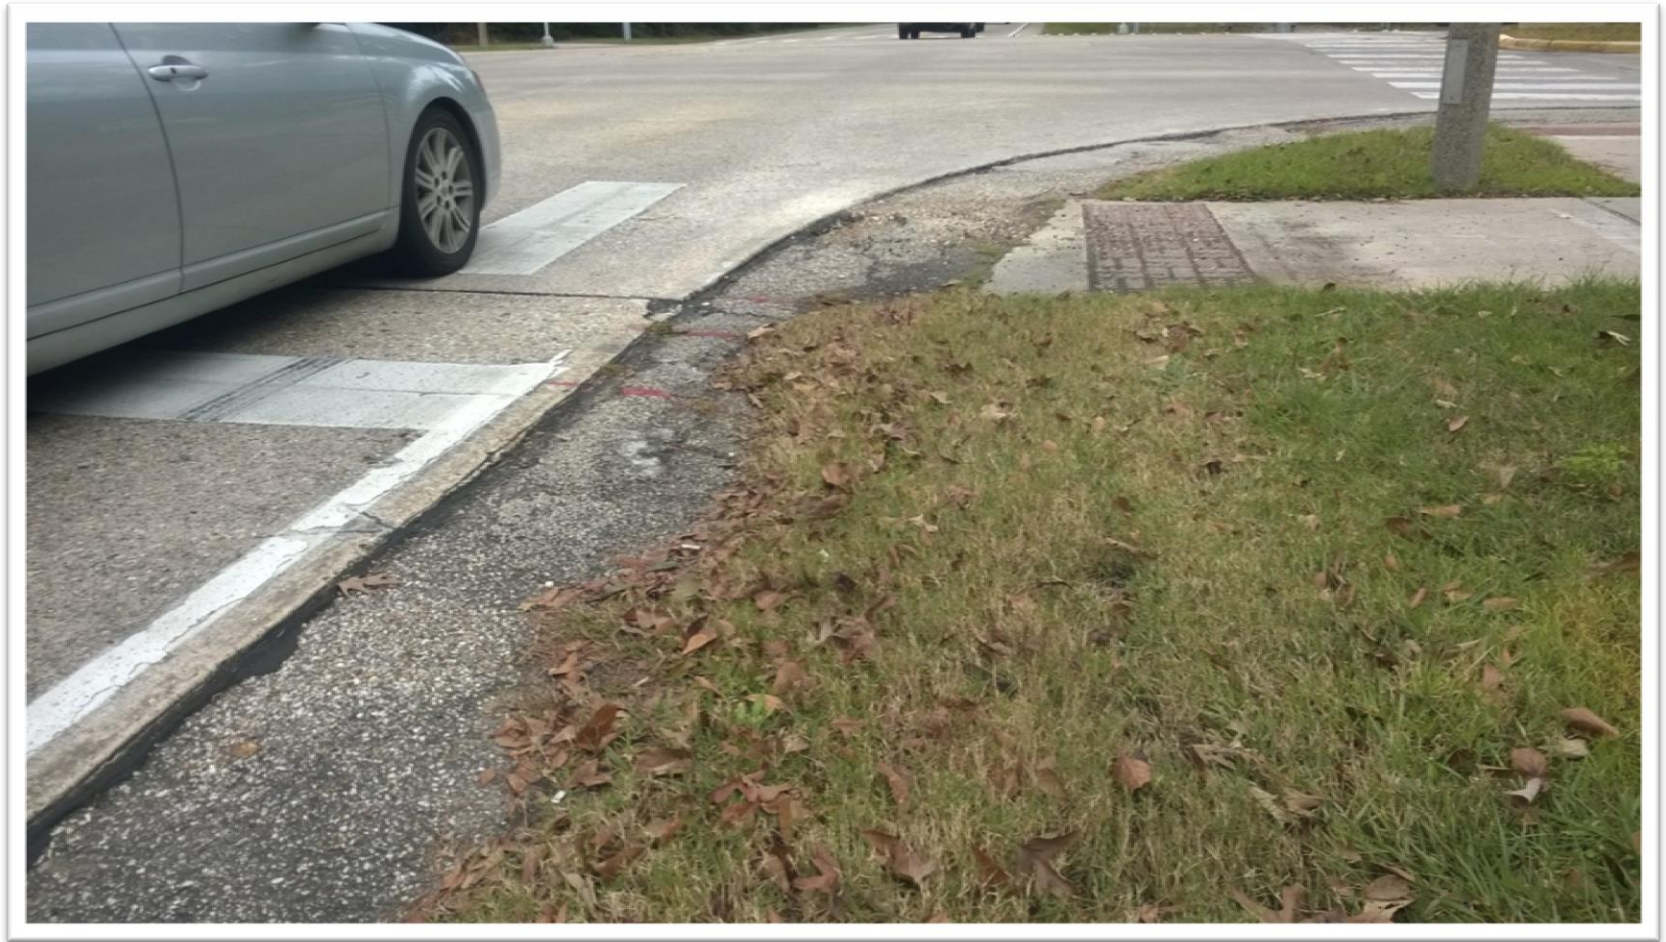
Location Sh-18
Shadowbend
Northbound

Hazard Type: Pothole
Severity: 4

3.5" drop from road surface to shoulder at
intersection with LW-Photo 6

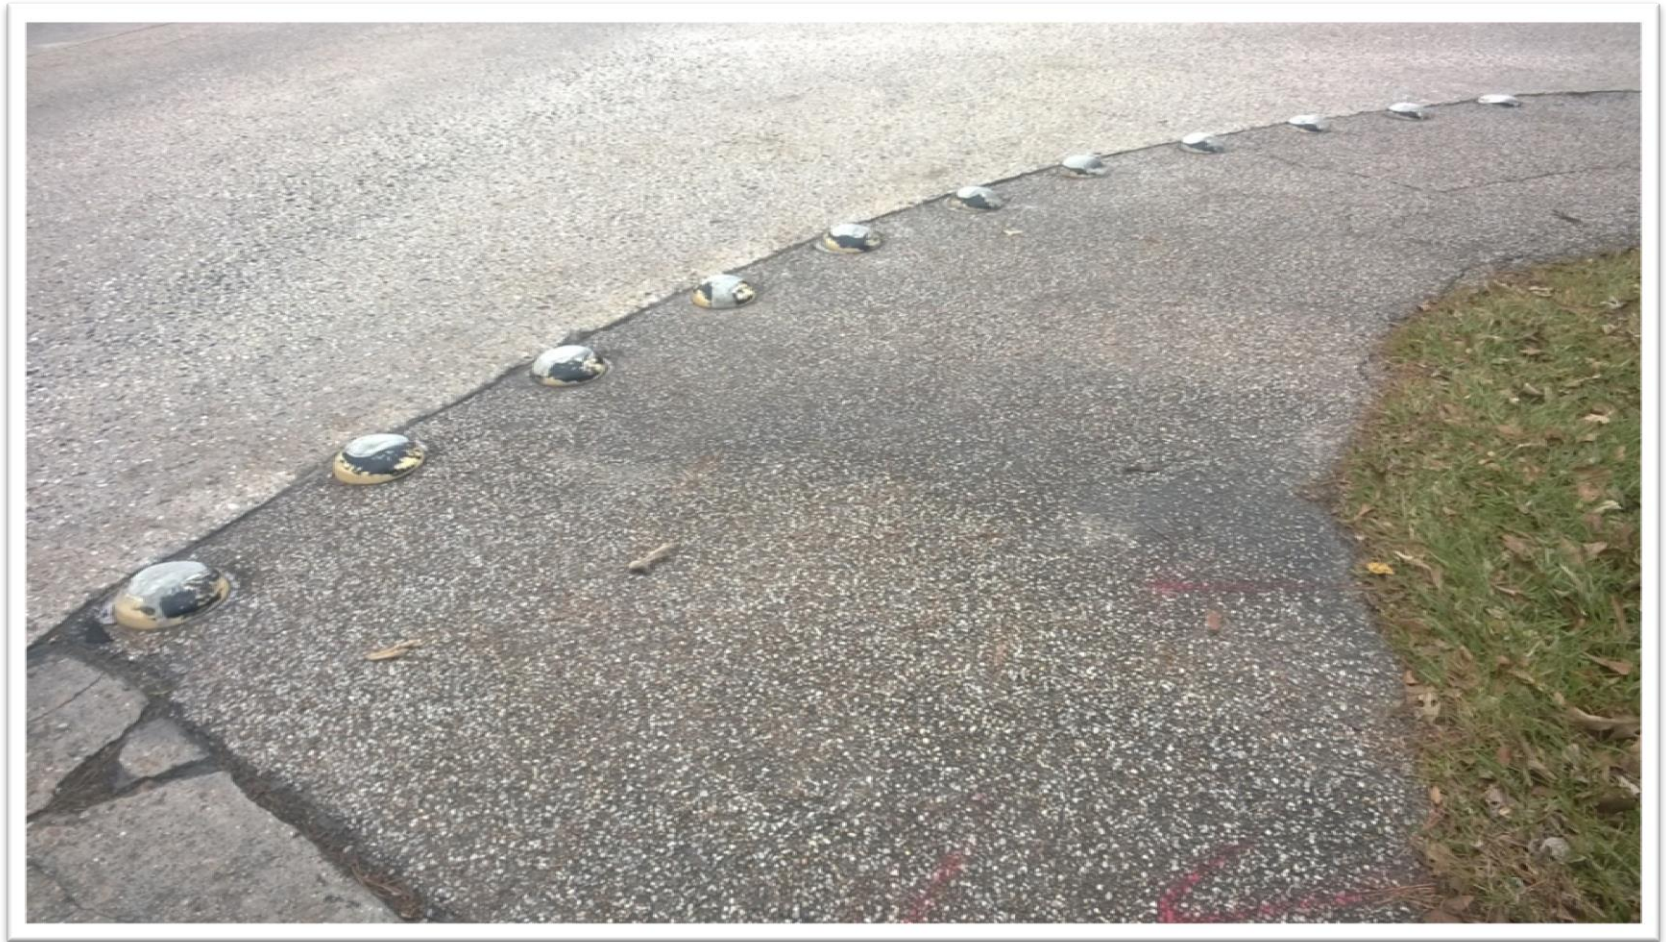
Location Sh-19
Shadowbend
Northbound

Hazard Type: Other
Severity: 2

Intersection Traffic Control Studs

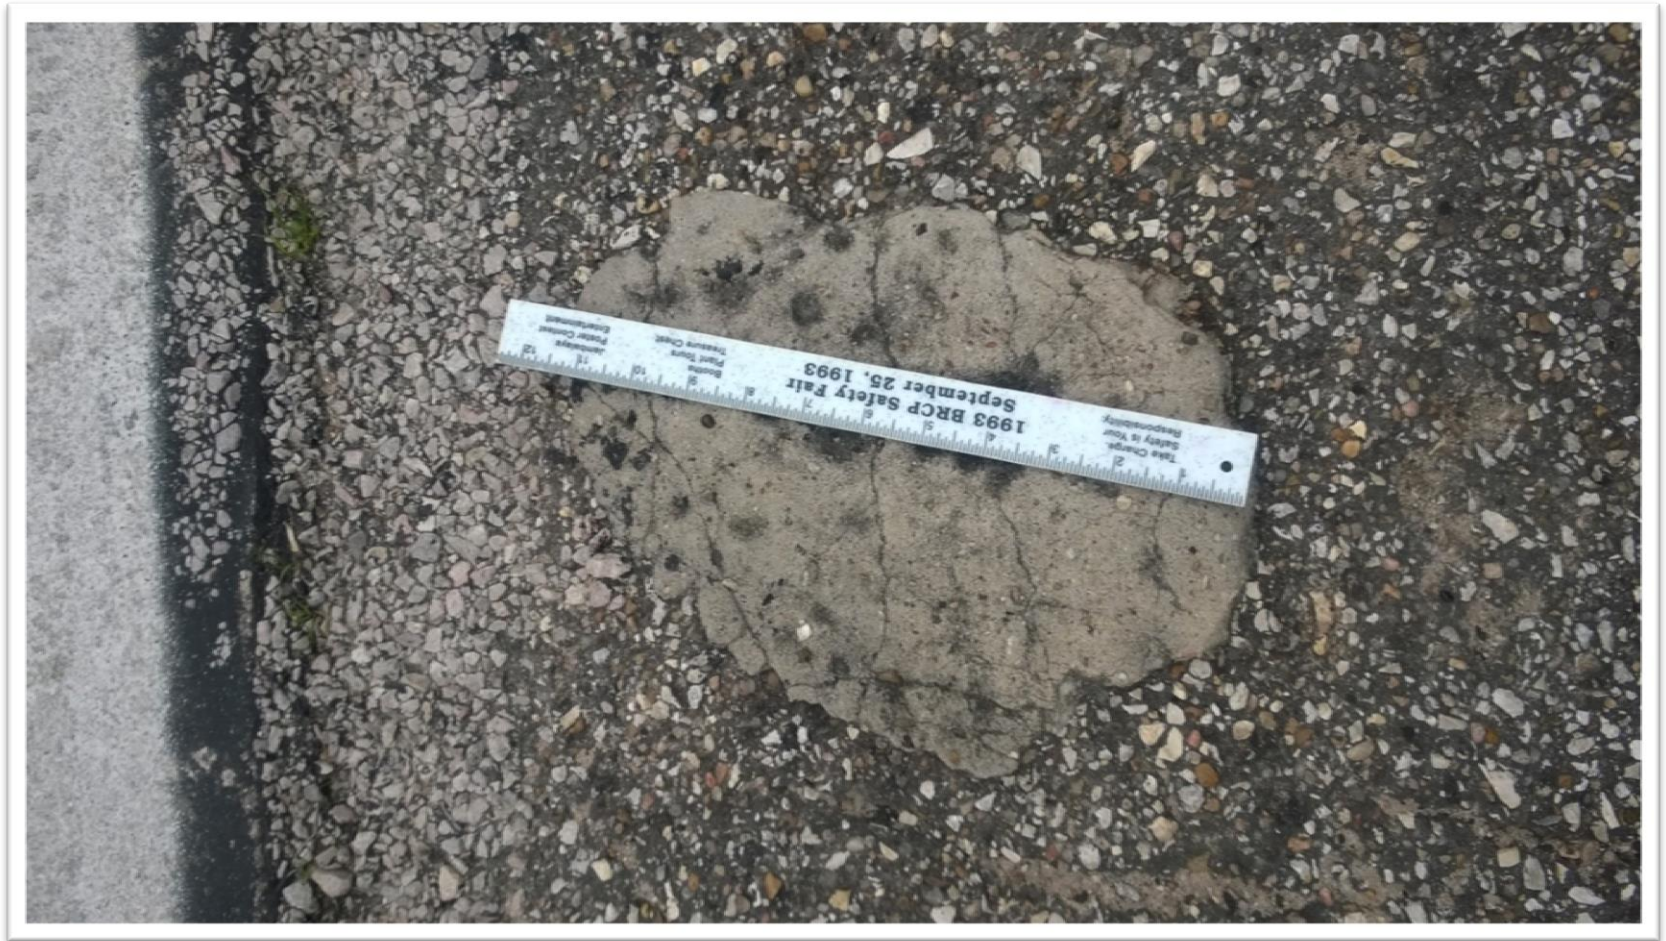
Location Sh-21
Shadowbend
Northbound

Hazard Type: Other
Severity: 2

Overlay Patch 1" thick

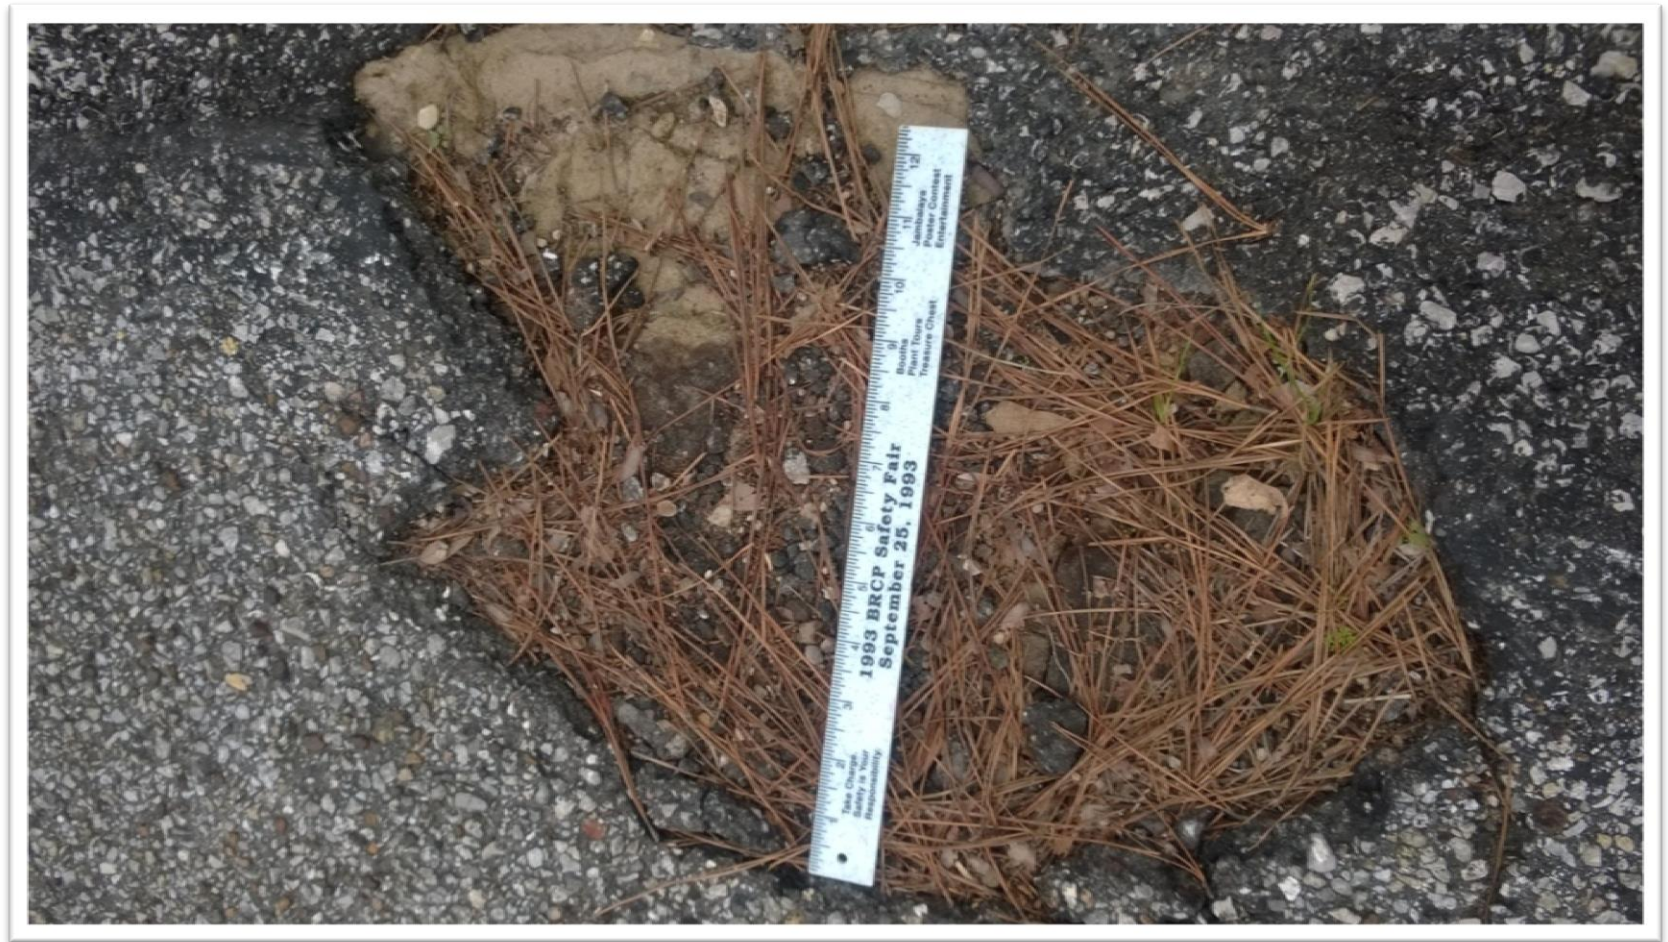
Location Sh-23
Shadowbend
Northbound

Hazard Type: Pothole
Severity: 2

Hole on edge of shoulder 1" deep

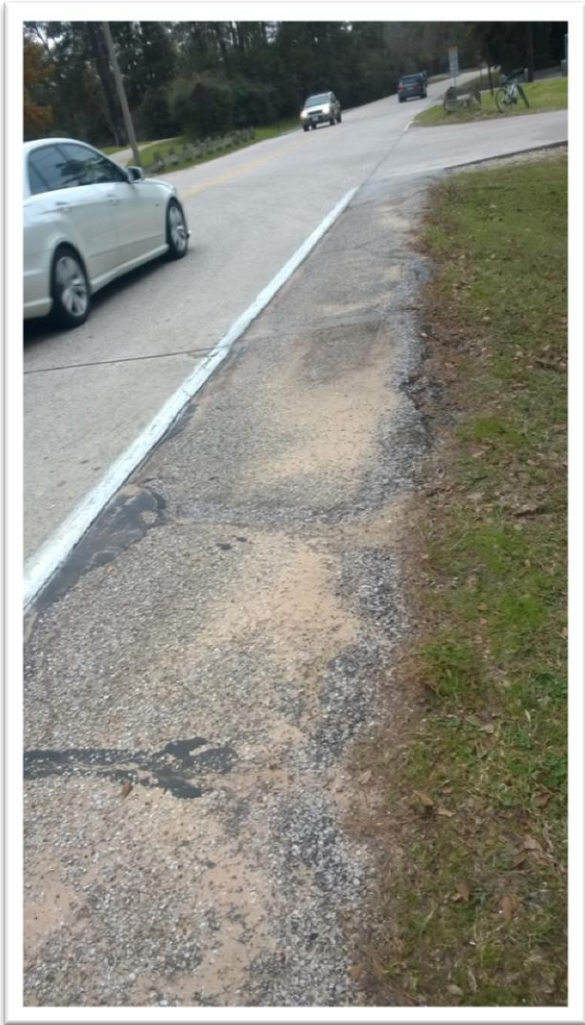
Location Sh-24
Shadowbend
Southbound

Hazard Type: Rough Area Rough surface north of Brickman entrance
Severity: 2

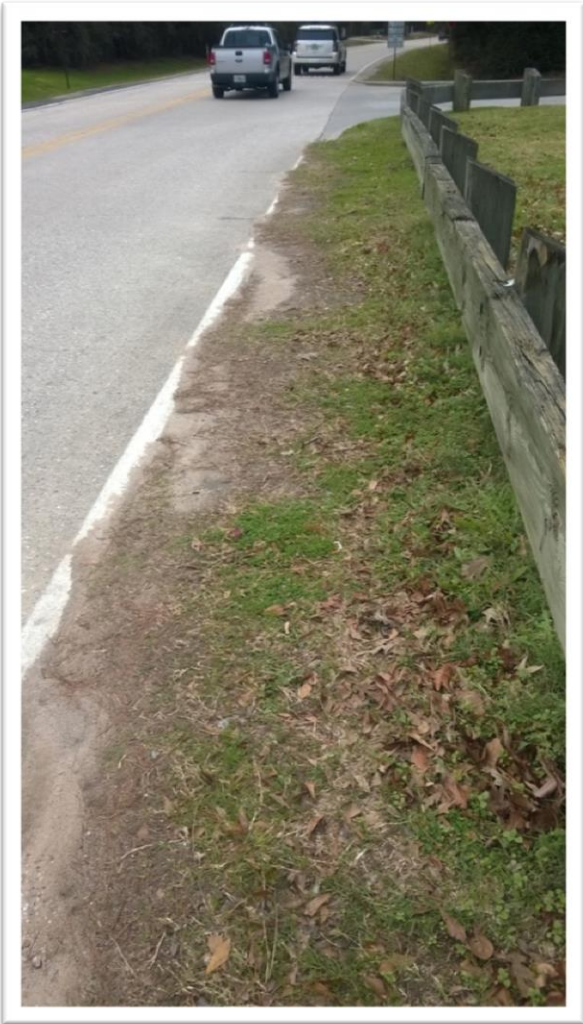
Location Sh-25
Shadowbend
Southbound

Hazard Type: Other
Severity: 3

Overgrown shoulder forces cyclist to road

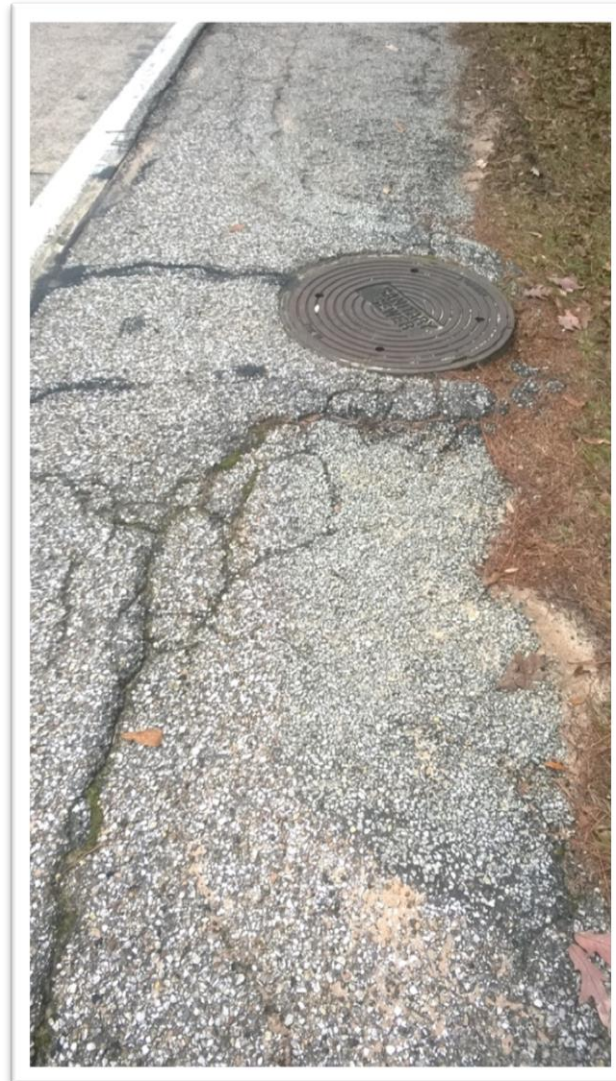
Location Sh-26
Shadowbend
Southbound

Hazard Type: Rough Area Sewer drop shoulder subsidence
Severity: 2

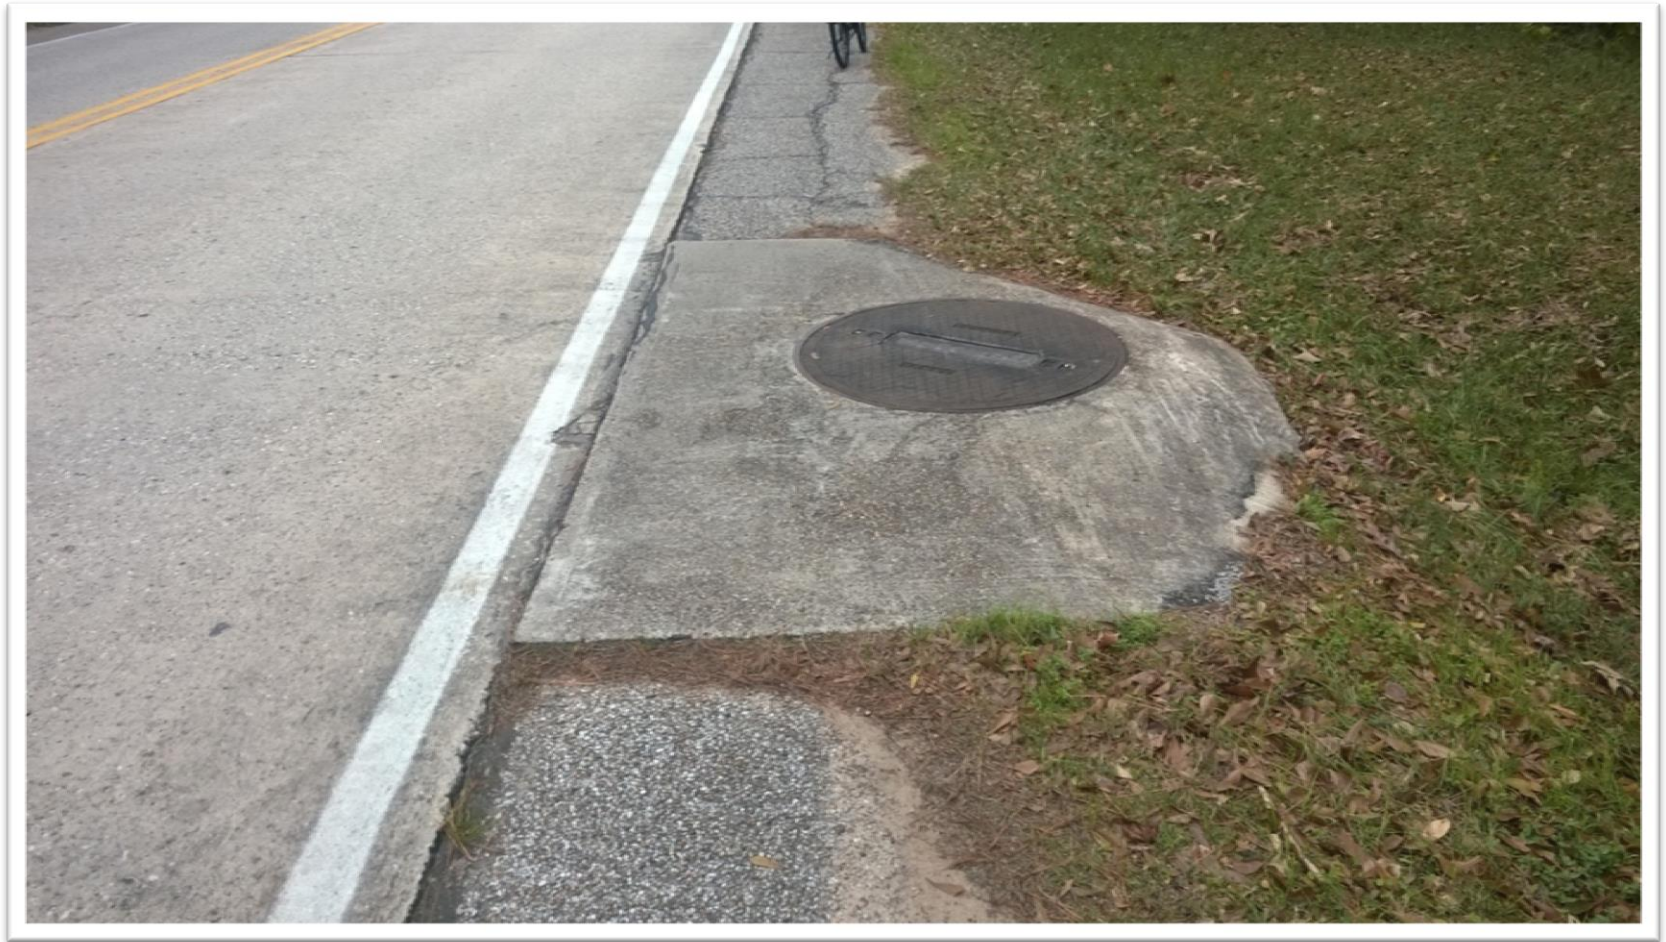
Location Sh-27
Shadowbend
Southbound

Hazard Type: Other
Severity: 2

Sewer Structure 1" above shoulder

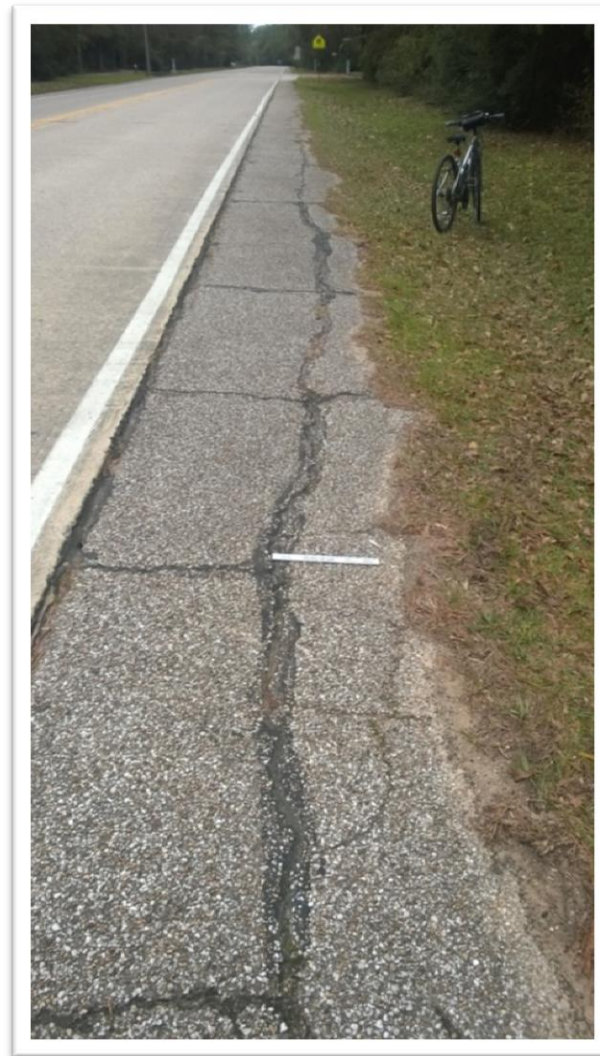
Location Sh-28
Shadowbend
Southbound

Hazard Type: Gap
Severity: 3

40' 1" gap on shoulder - photo 1

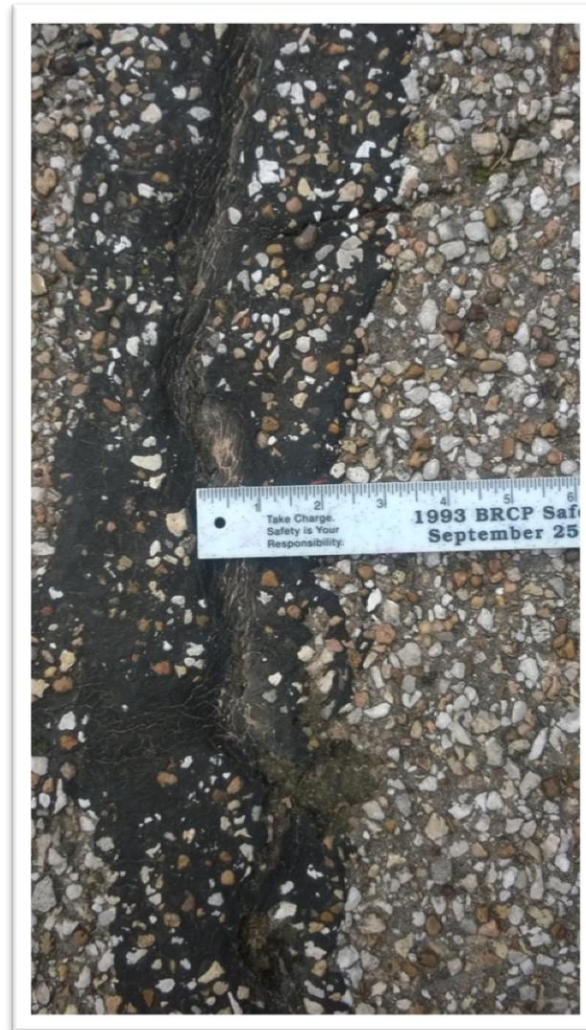
Location Sh-29
Shadowbend
Southbound

Hazard Type: Gap
Severity: 3

40' 1" gap on shoulder - photo 2

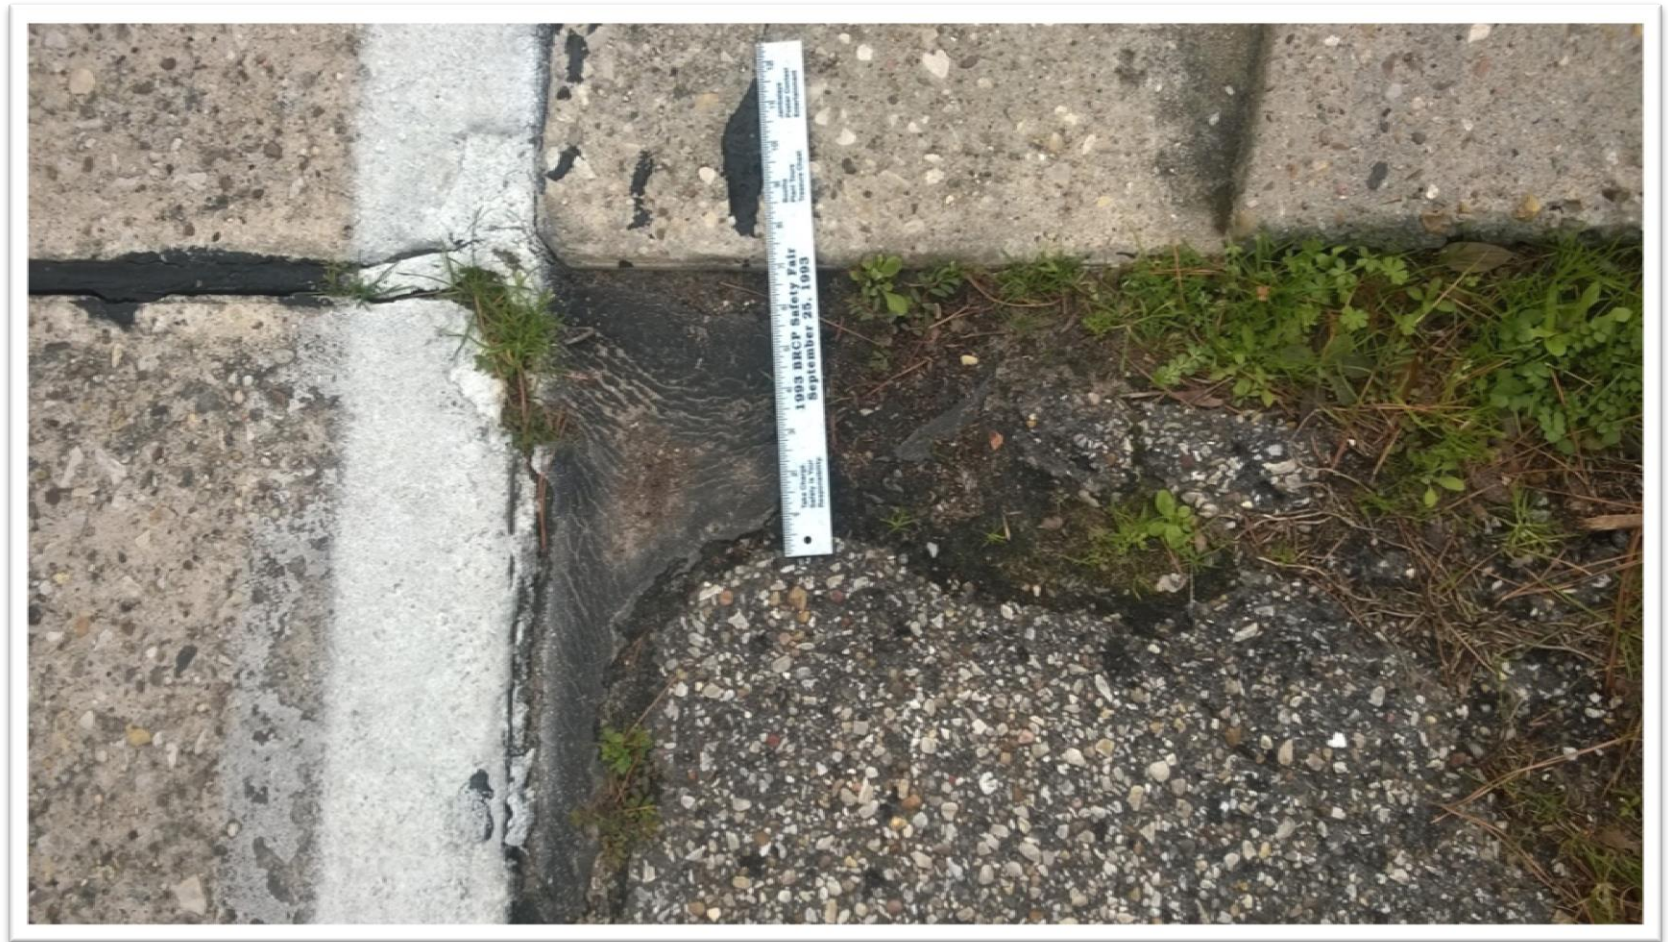
Location Sh-30
Shadowbend
Southbound

Hazard Type: Other
Severity: 2

Subsidence gap Turnstone Entrance from
Shadowbend- photo 1

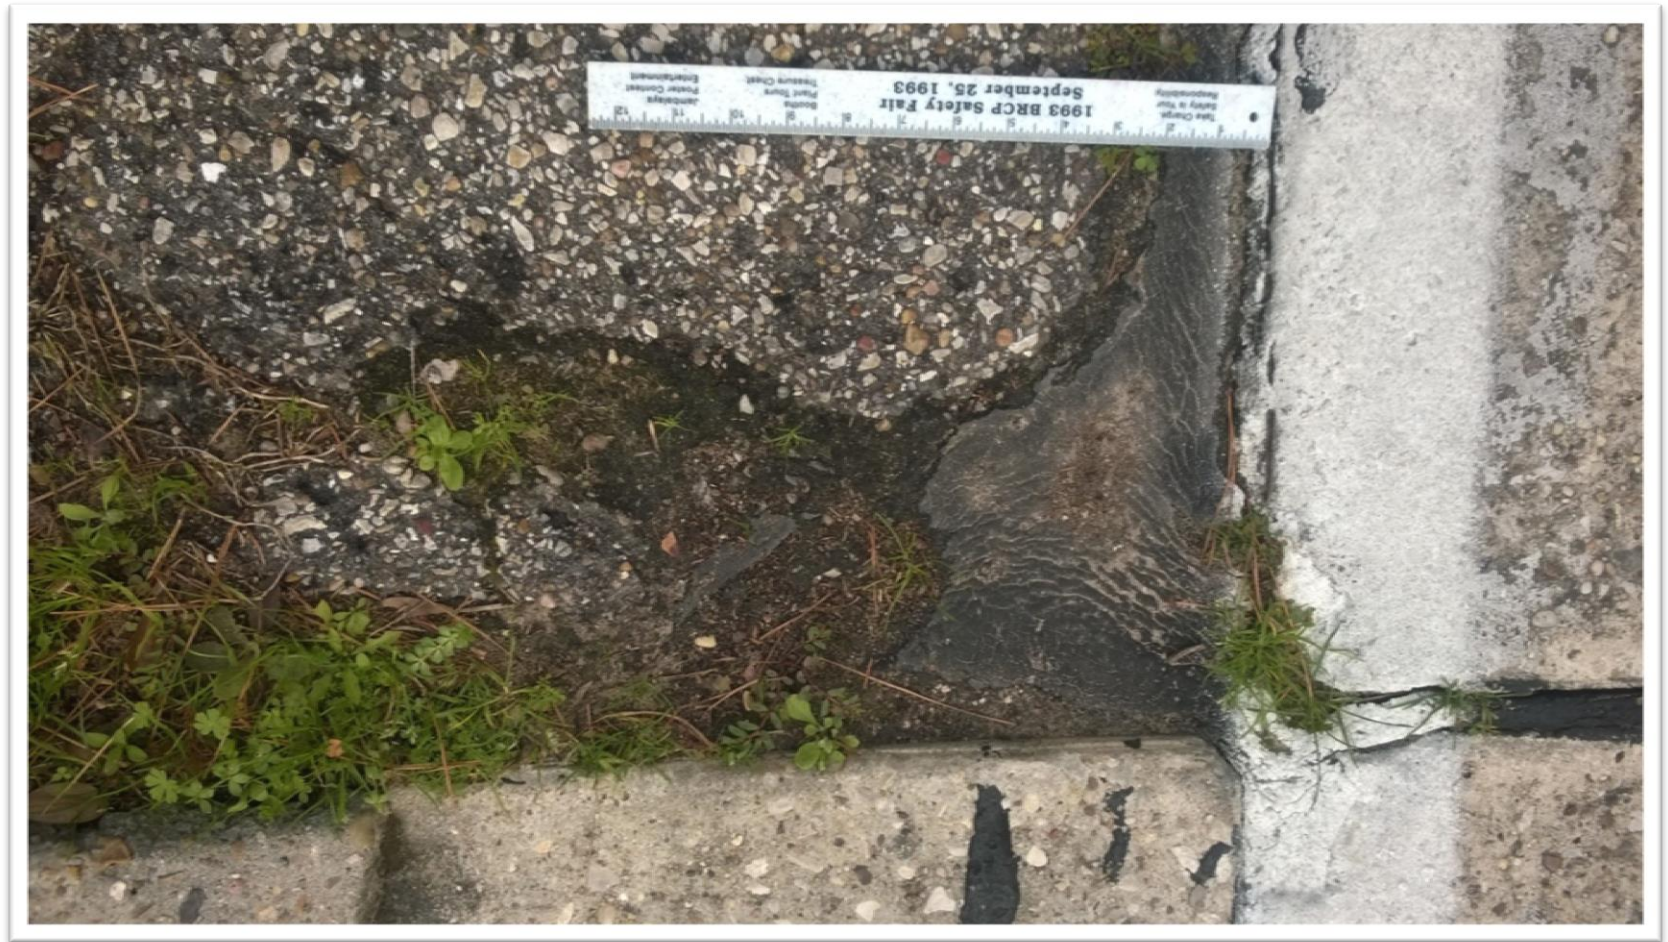
Location Sh-31
Shadowbend
Southbound

Hazard Type: Other
Severity: 2

Subsidence gap - Turnstone Entrance from
Shadowbend photo 2

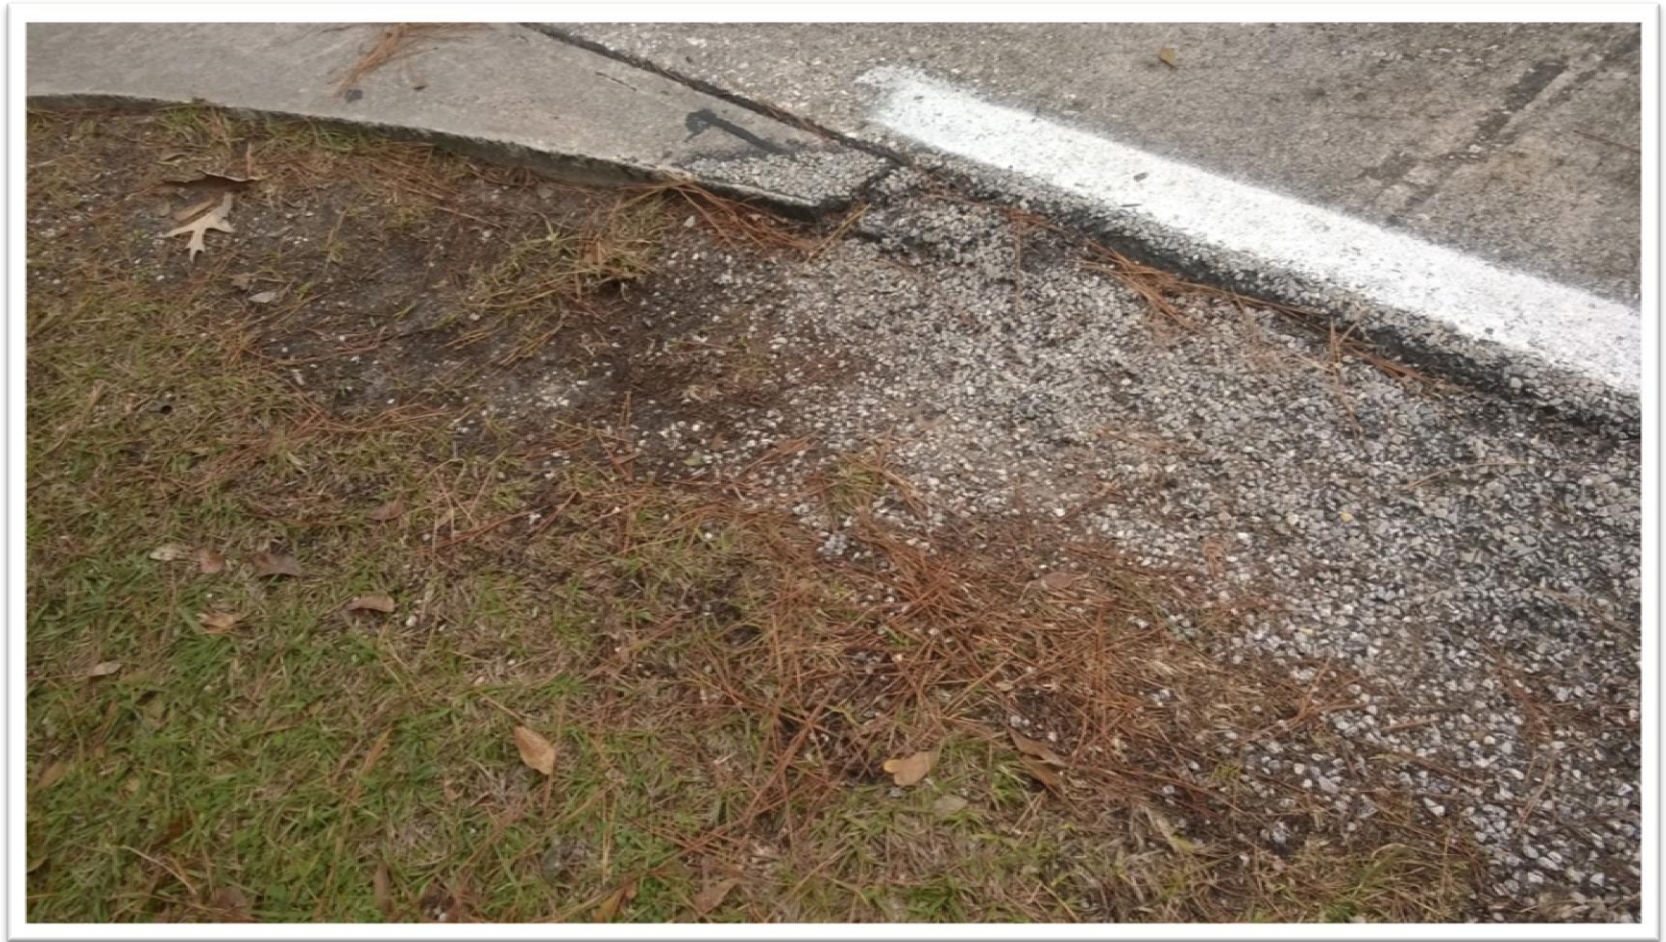
Location Sh-32
Shadowbend
Southbound

Hazard Type: Other
Severity: 3

2" drop off from Impact Celebration Church
Driveway to Degraded Shoulder - Photo 1

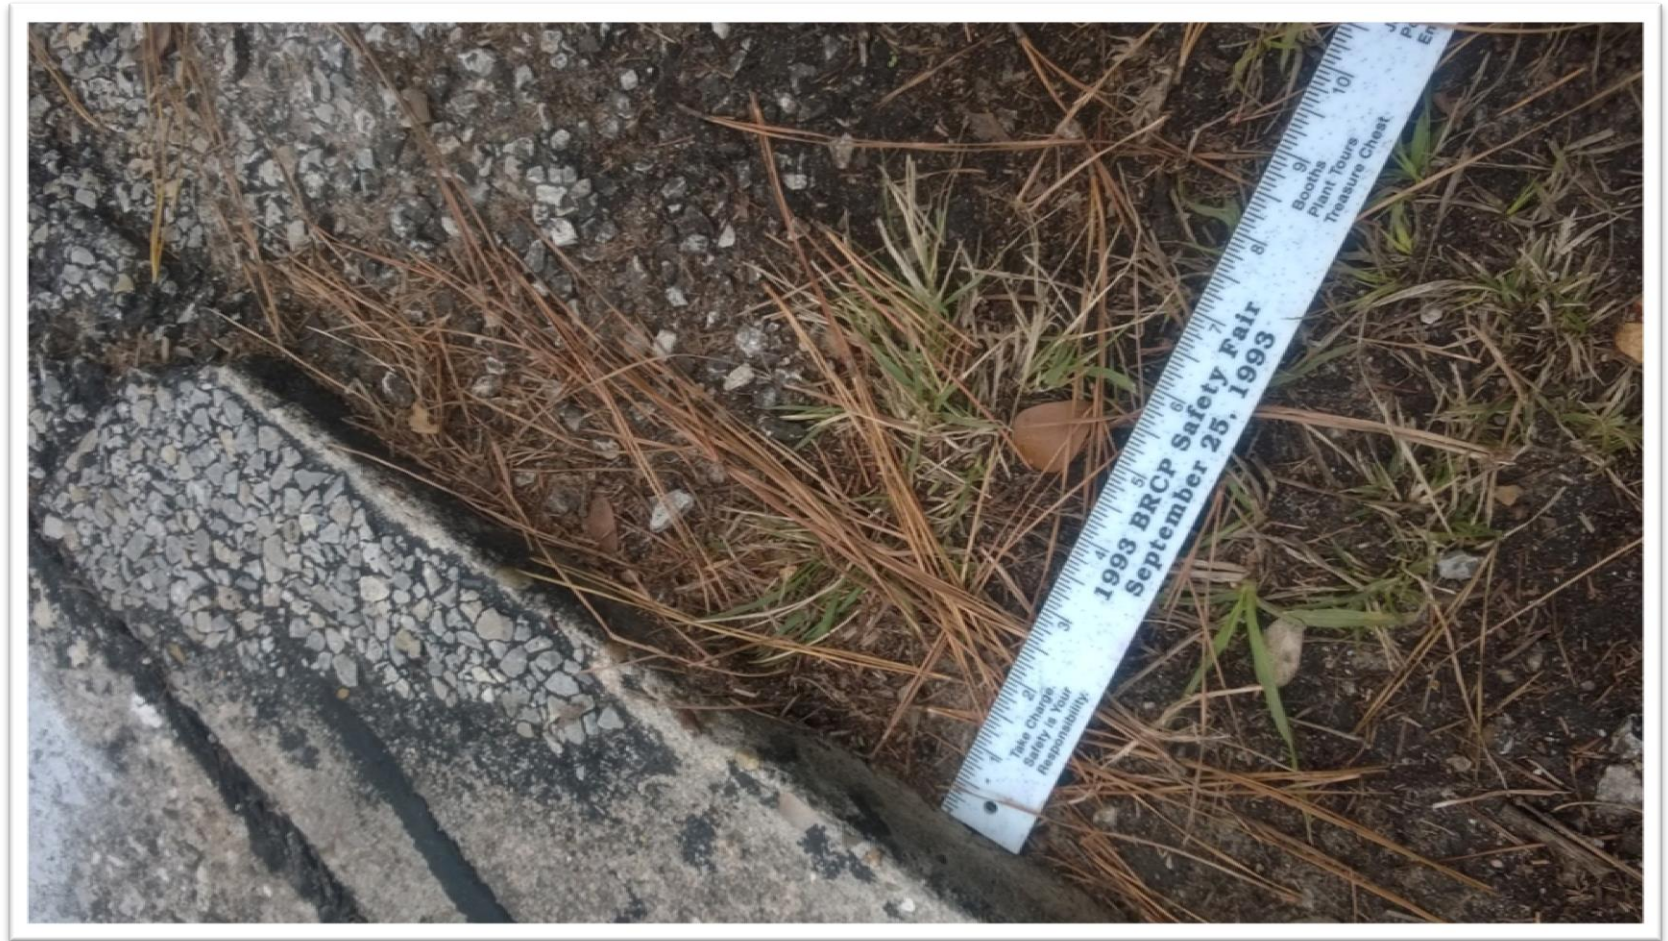
Location Sh-33
Shadowbend
Southbound

Hazard Type: Other
Severity: 3

2" drop off from Impact Celebration Church
Driveway to Degraded Shoulder - Photo 2

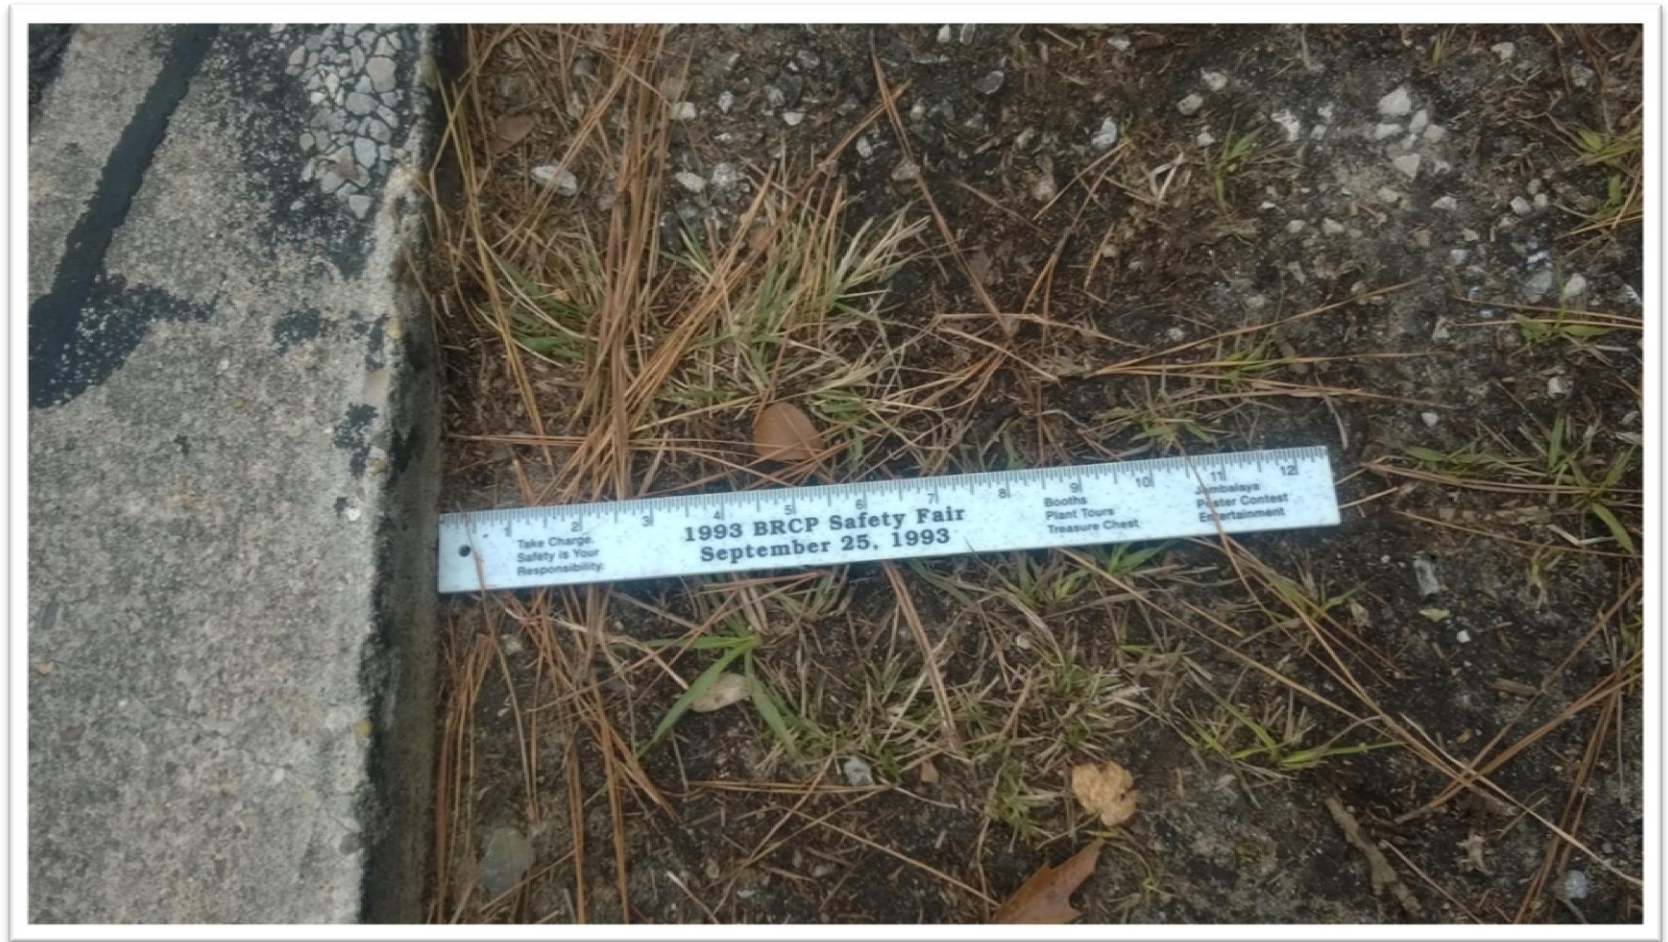
Location Sh-34
Shadowbend
Southbound

Hazard Type: Other
Severity: 3

2" drop off from Impact Celebration Church
Driveway to Degraded Shoulder - Photo 3

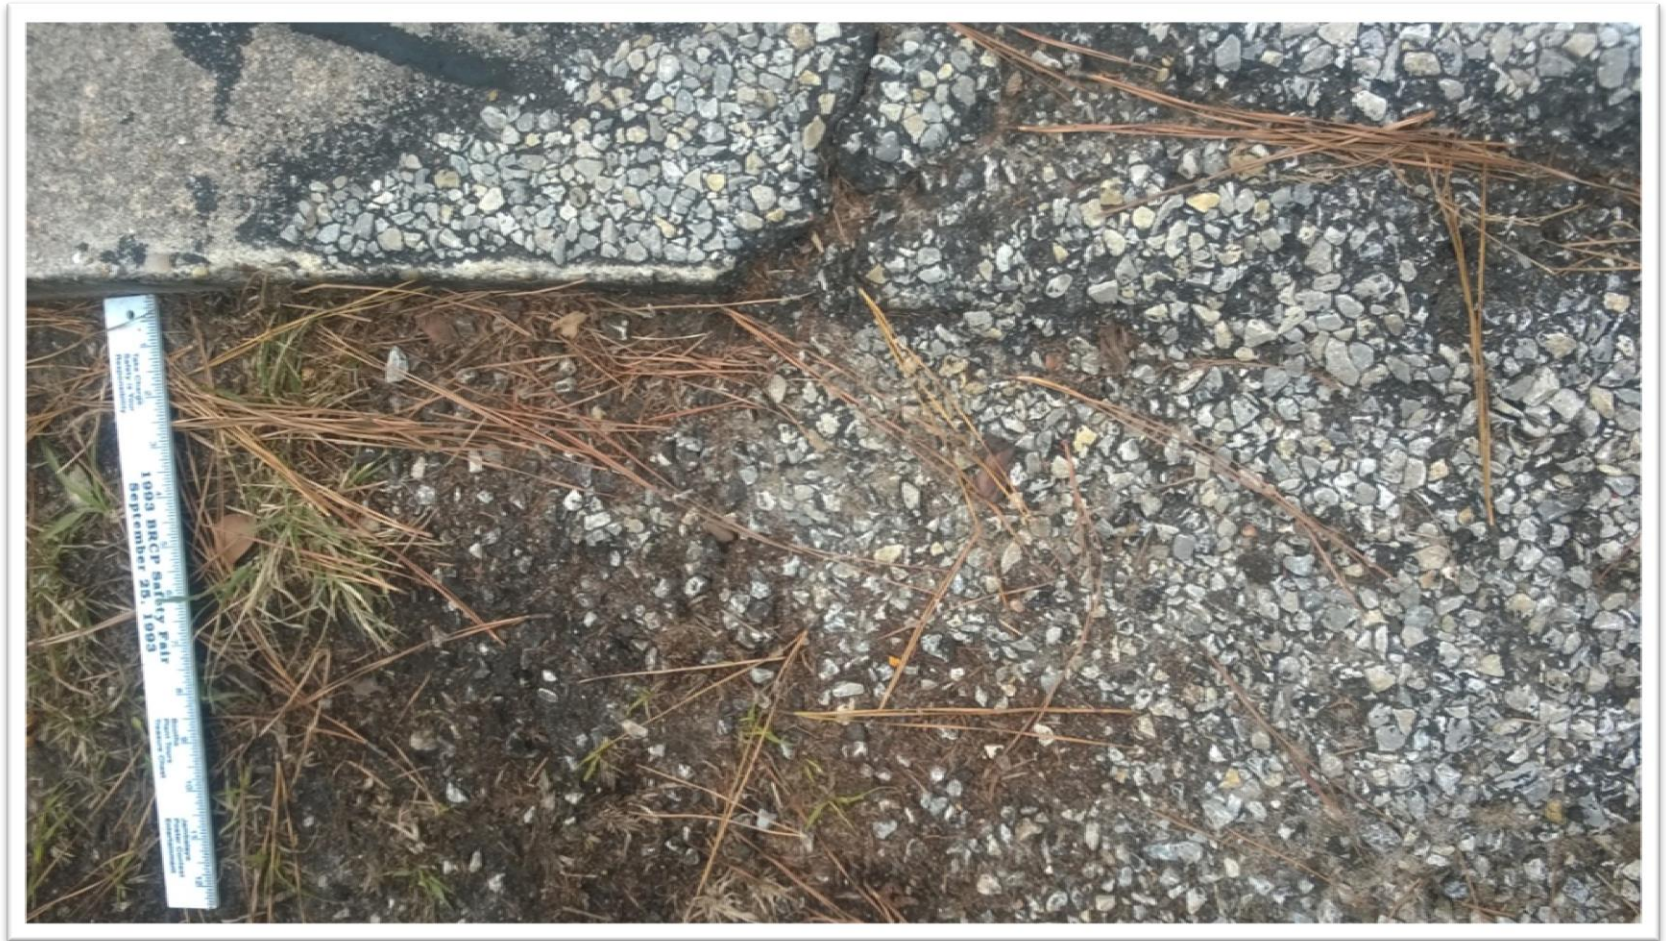
Location Sh-35
Shadowbend
Southbound

Hazard Type: Other
Severity: 3

2" drop off from Impact Celebration Church
Driveway to Degraded Shoulder - Photo 4

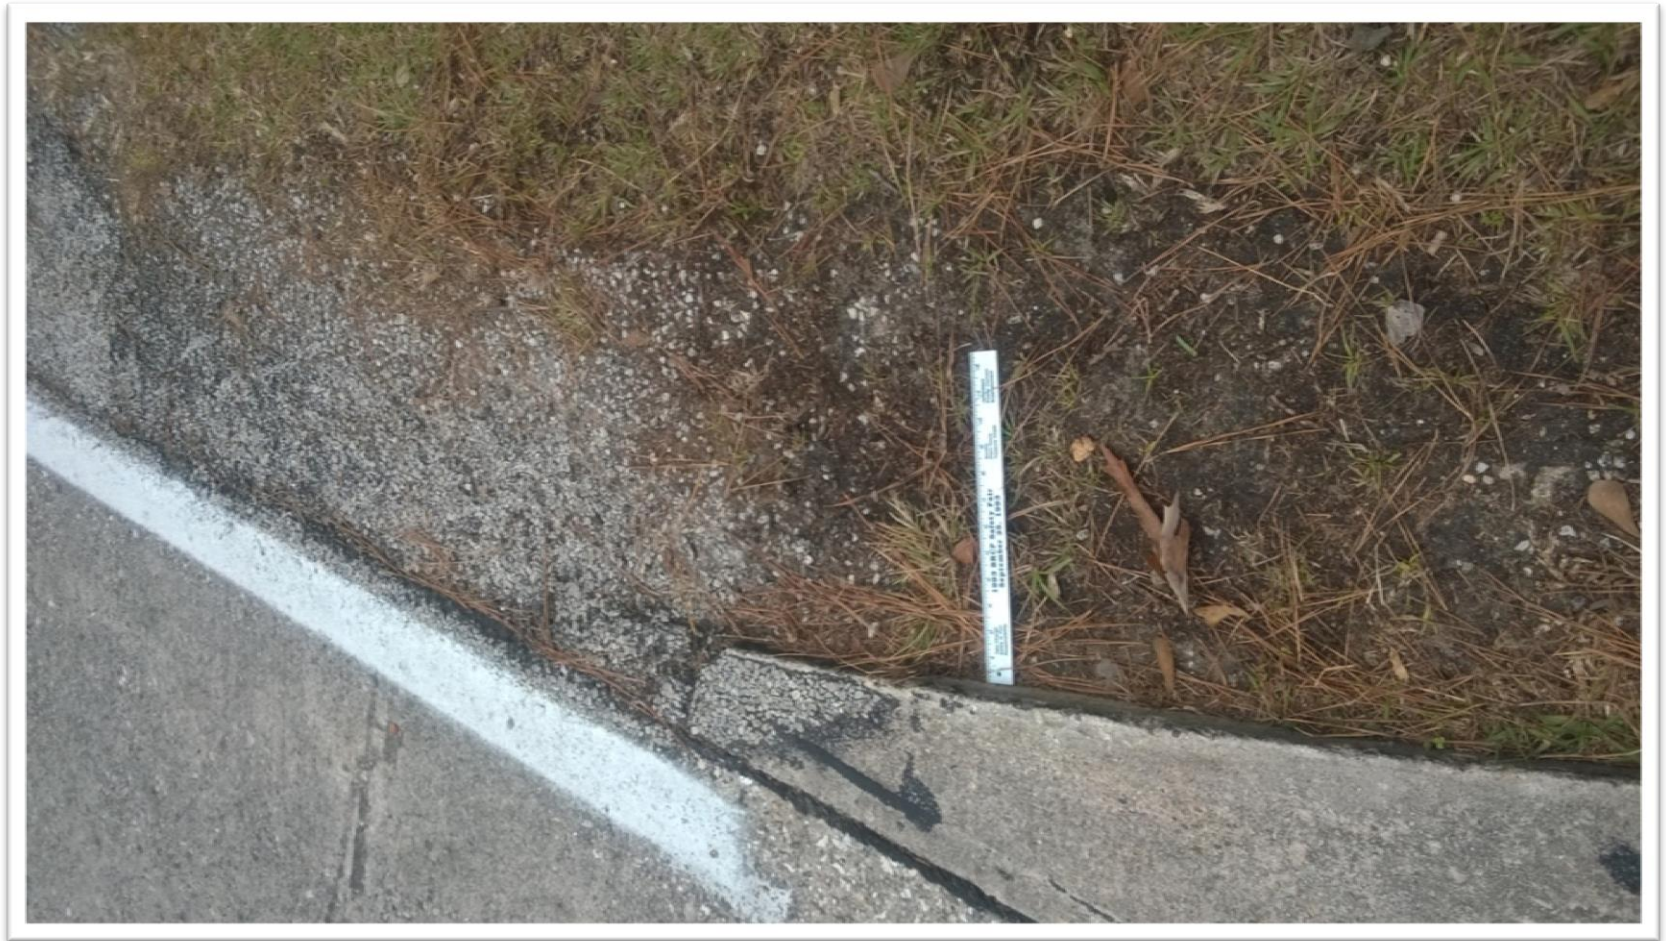
Location Sh-36
Shadowbend
Southbound

Hazard Type: Other
Severity: 3

2" drop off from Impact Celebration Church
Driveway to Degraded Shoulder - Photo 5
