Road Shoulder Hazards along
Shadowbend Place– January 2015

Hazards on road shoulders, that could pose a risk to cyclists, were identified in January 2015 by volunteers from Bike The Woodlands Coalition.

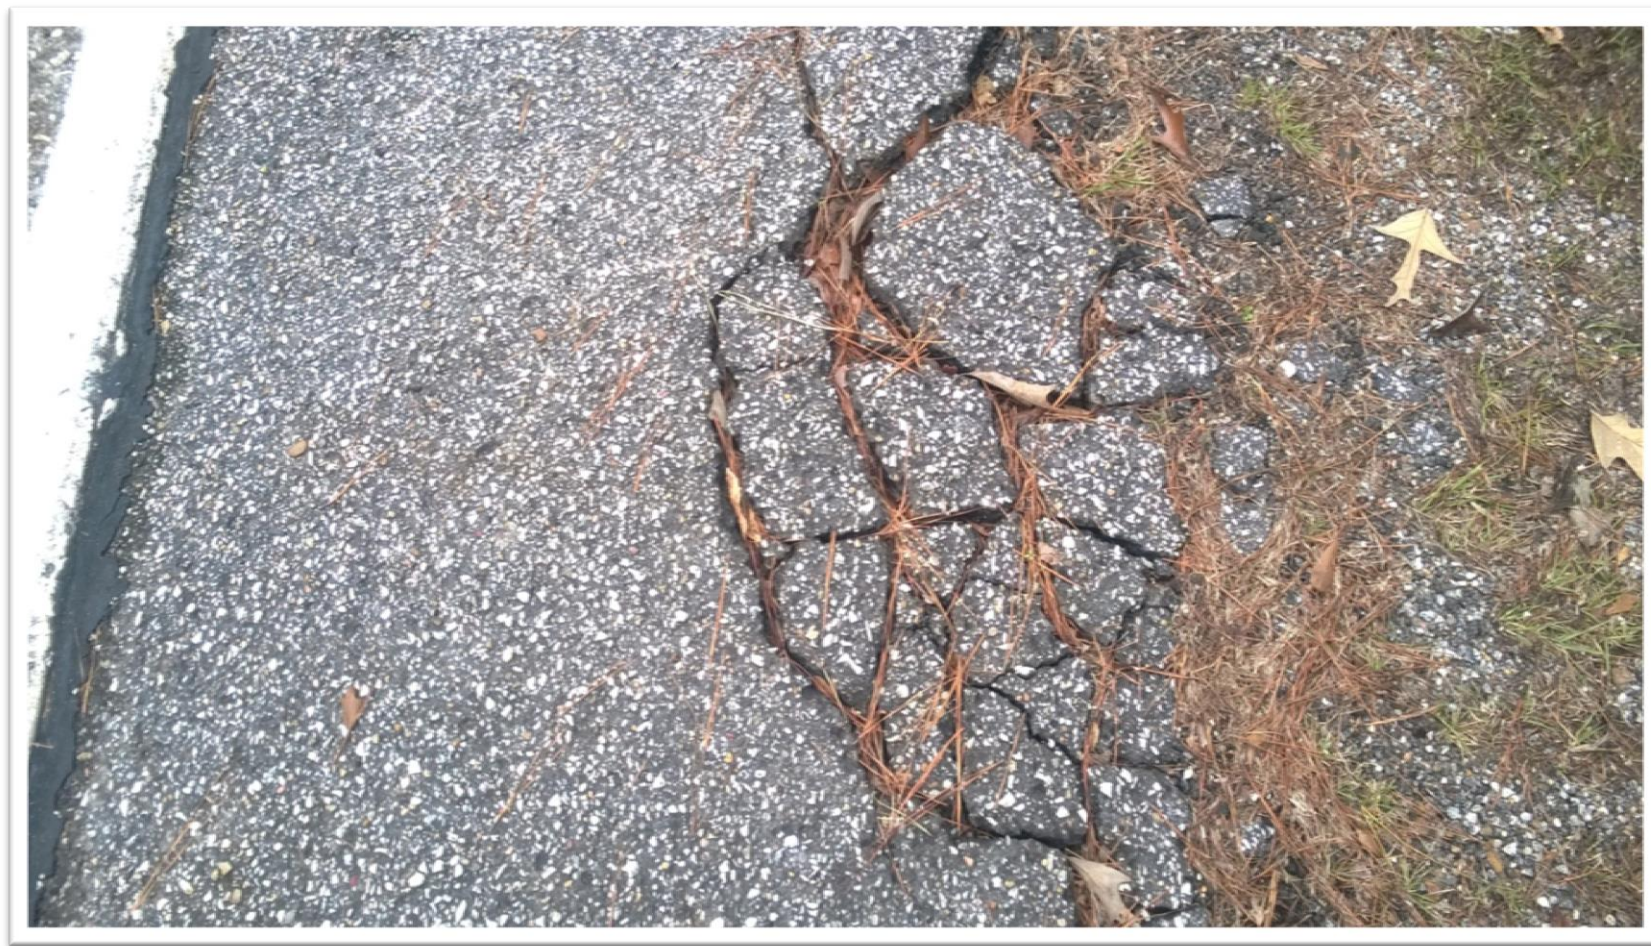
Location Sh-37
Shadowbend
Southbound

Hazard Type: Other
Severity: 3

Crumbling Shoulder

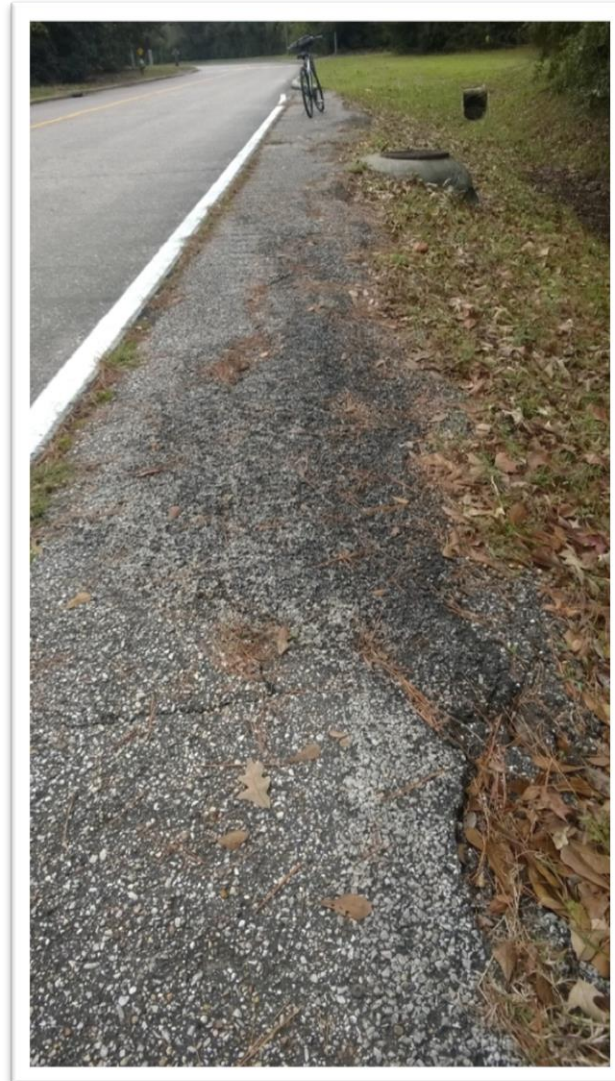
Location Sh-38
Shadowbend
Southbound

Hazard Type: Other
Severity: 2

Narrowed Degraded Shoulder

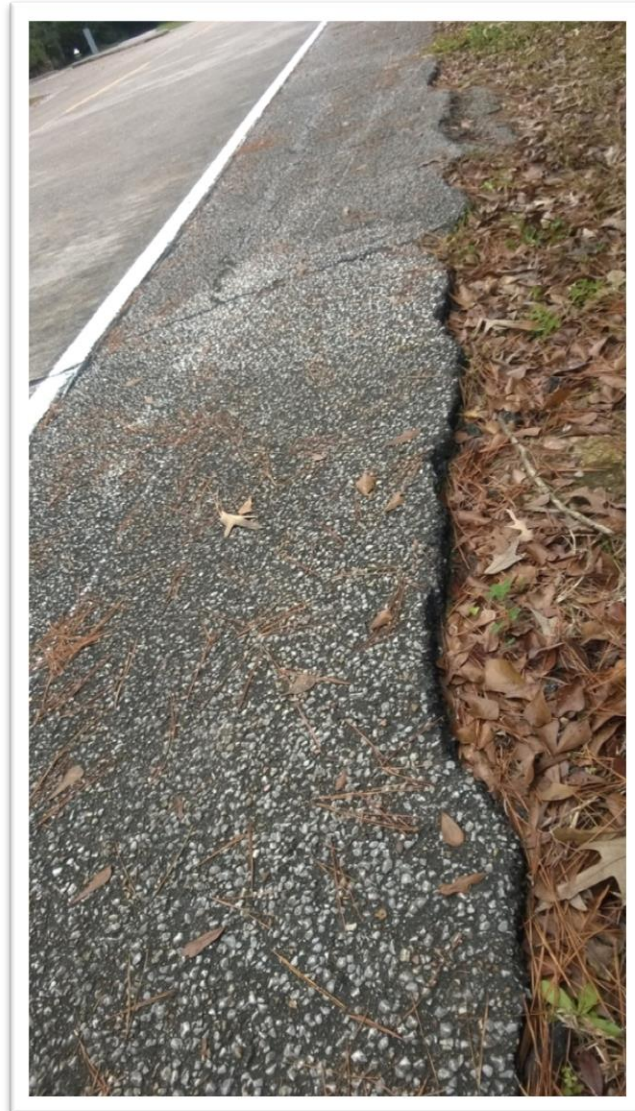
Location Sh-39
Shadowbend
Southbound

Hazard Type: Other
Severity: 2

Three inch drop off

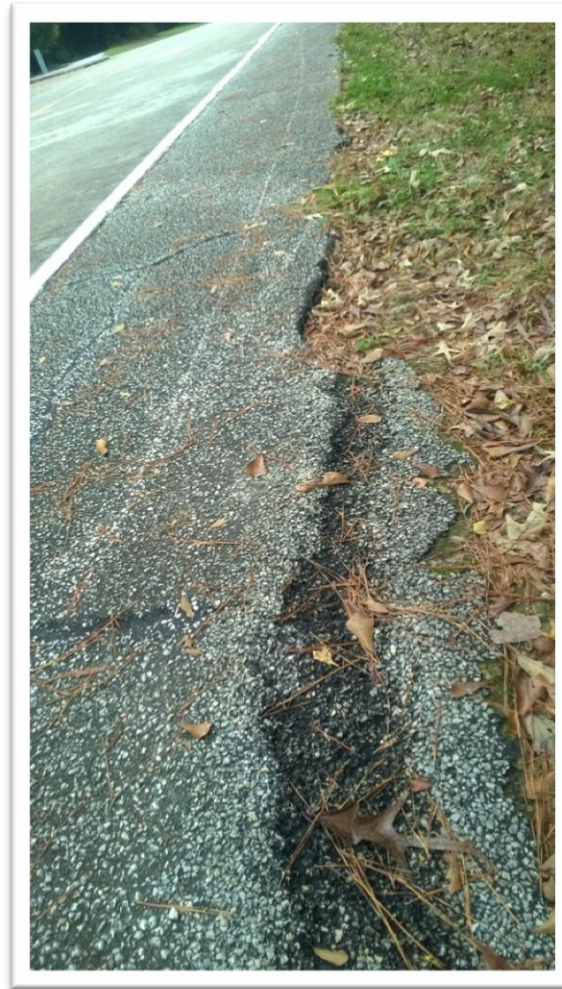
Location Sh-40
Shadowbend
Southbound

Hazard Type: Other
Severity: 2

Three inch drop off
and degradation
along the outer
shoulder edge

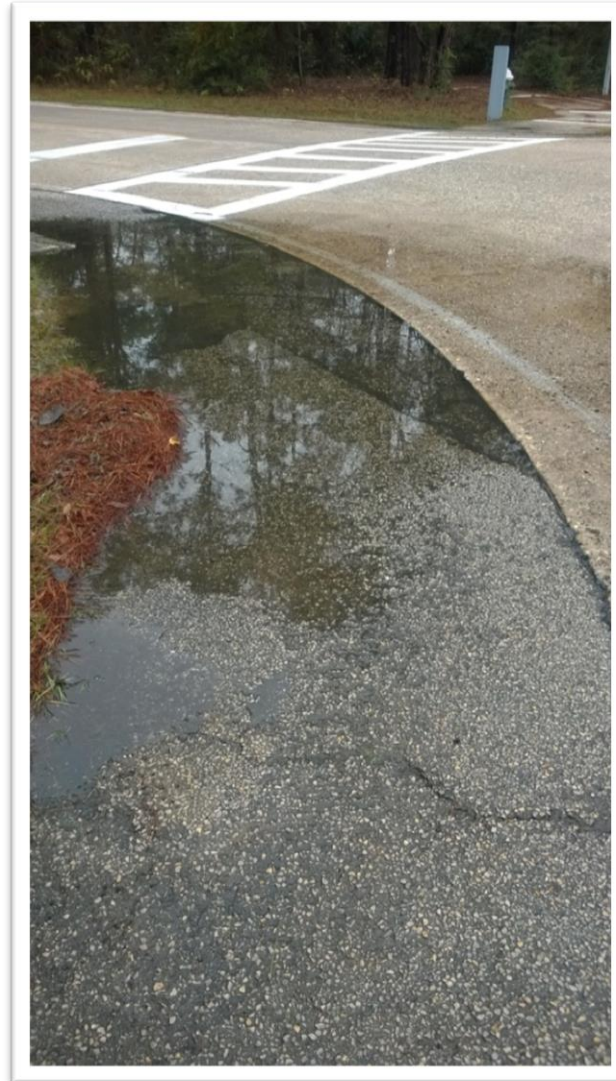
Location Sh-41
Shadowbend
Southbound

Hazard Type: Maintenance
Severity: 3

Subsided hard surface that collects water at
intersection

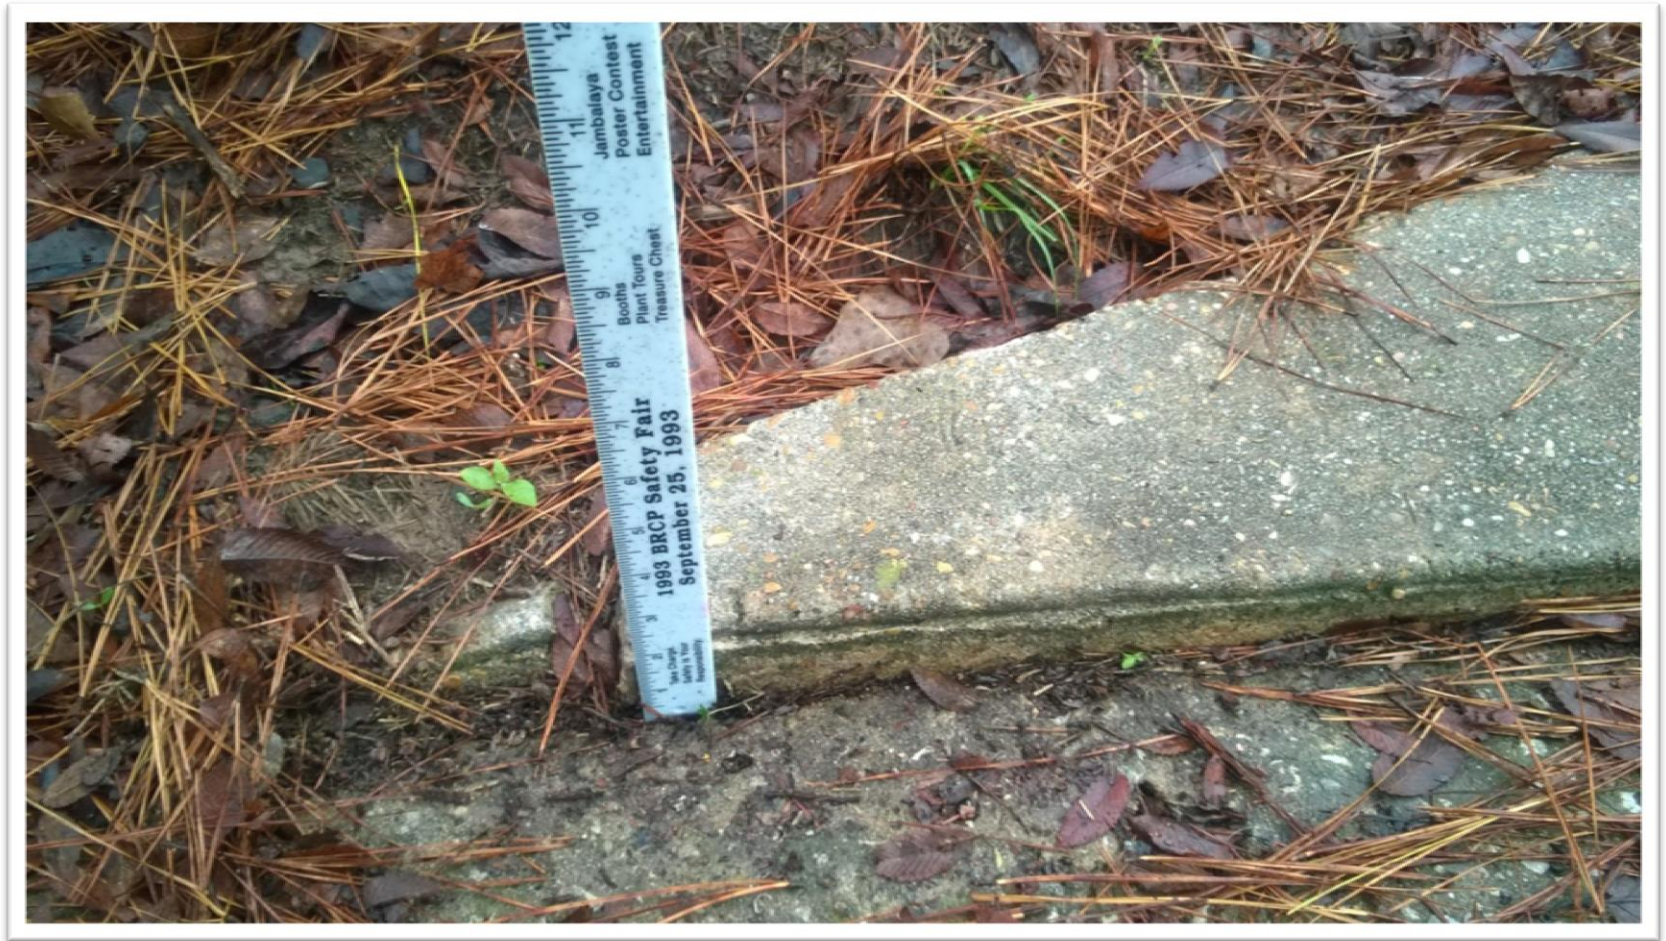
Location Sh-42
Shadowbend
pathway

Hazard Type: Other
Severity: 3

2" elevation change between sections at
School Crossing - Photo 1

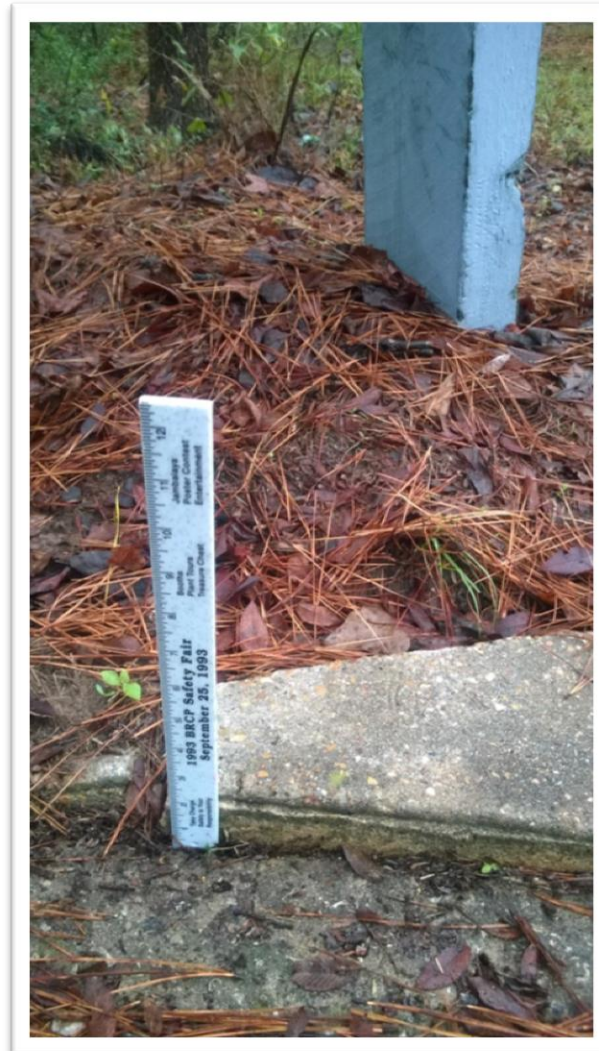
Location Sh-43
Shadowbend
pathway

Hazard Type: Other
Severity: 3

2" elevation change between sections at
School Crossing - Photo 2

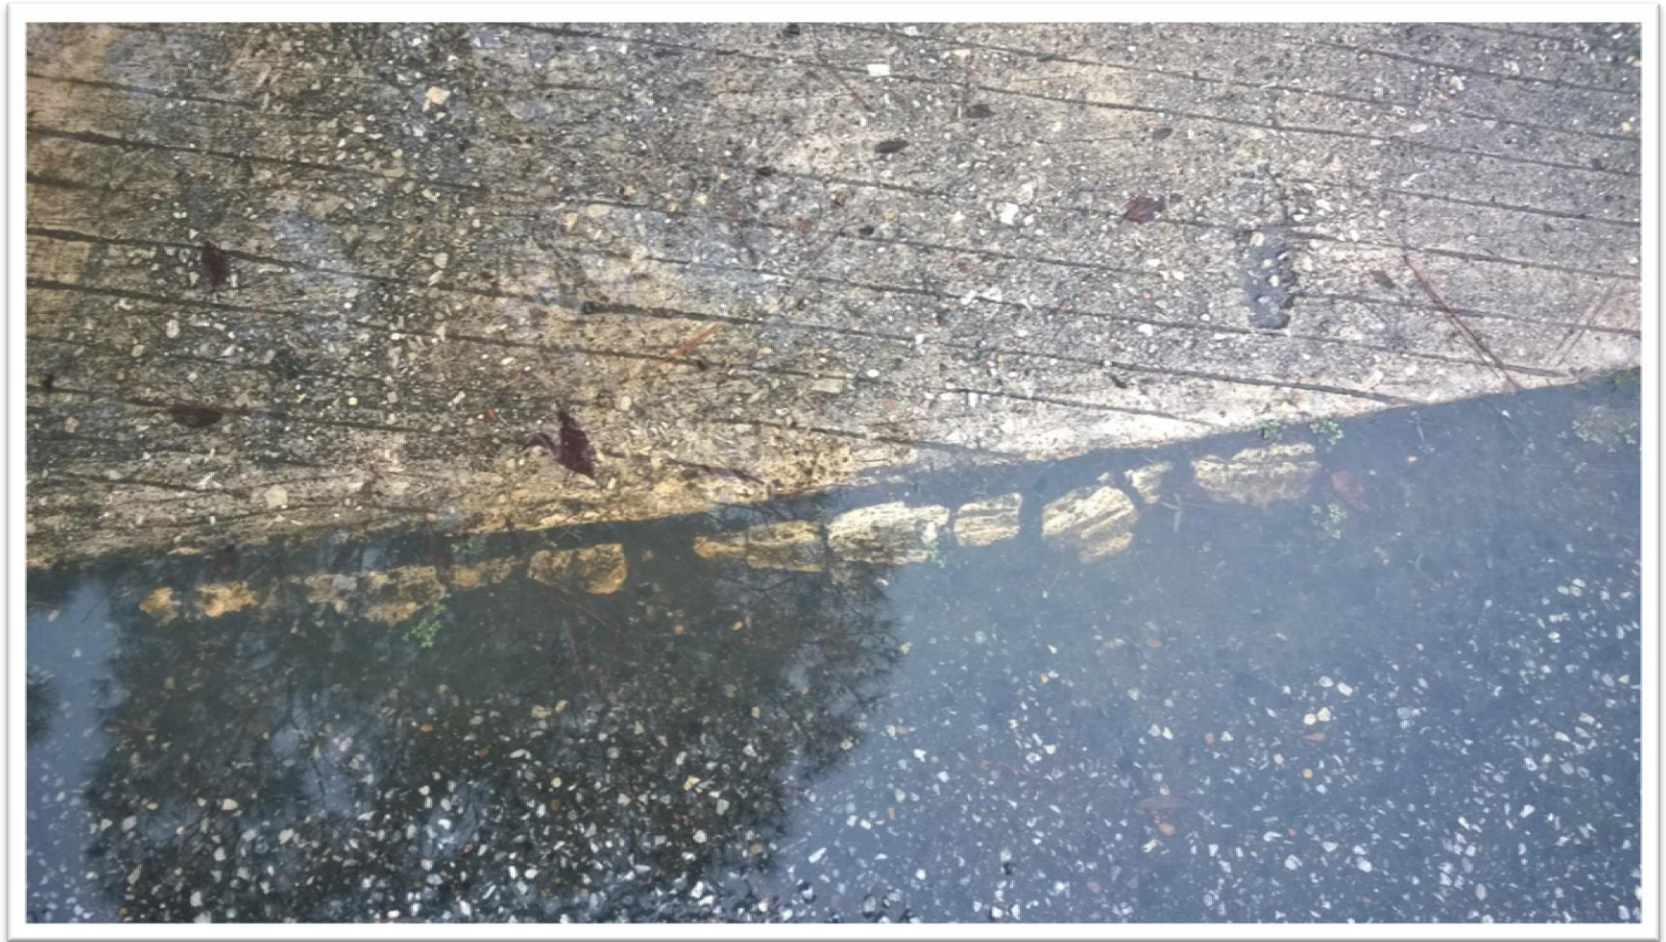
Location Sh-44
Shadowbend
pathway

Hazard Type: Rough Area
Severity: 2

Rough, water collecting area at intersection -
Photo 1

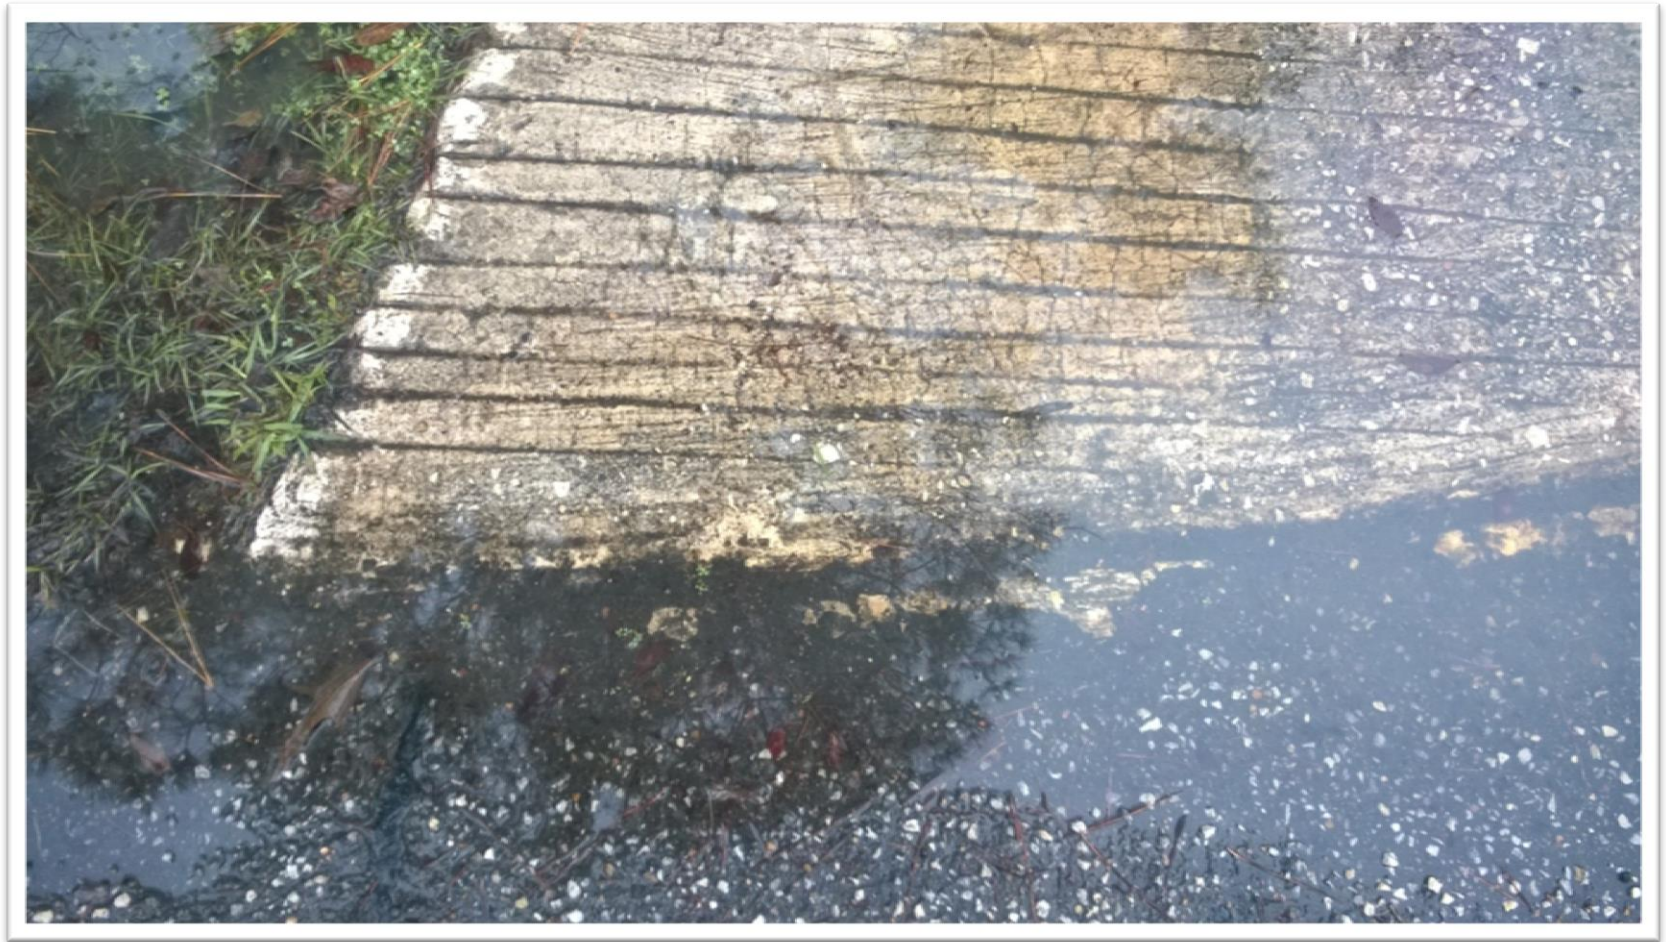
Location Sh-45
Shadowbend
pathway

Hazard Type: Rough Area
Severity: 2

Rough, water collecting area at intersection -
Photo-2

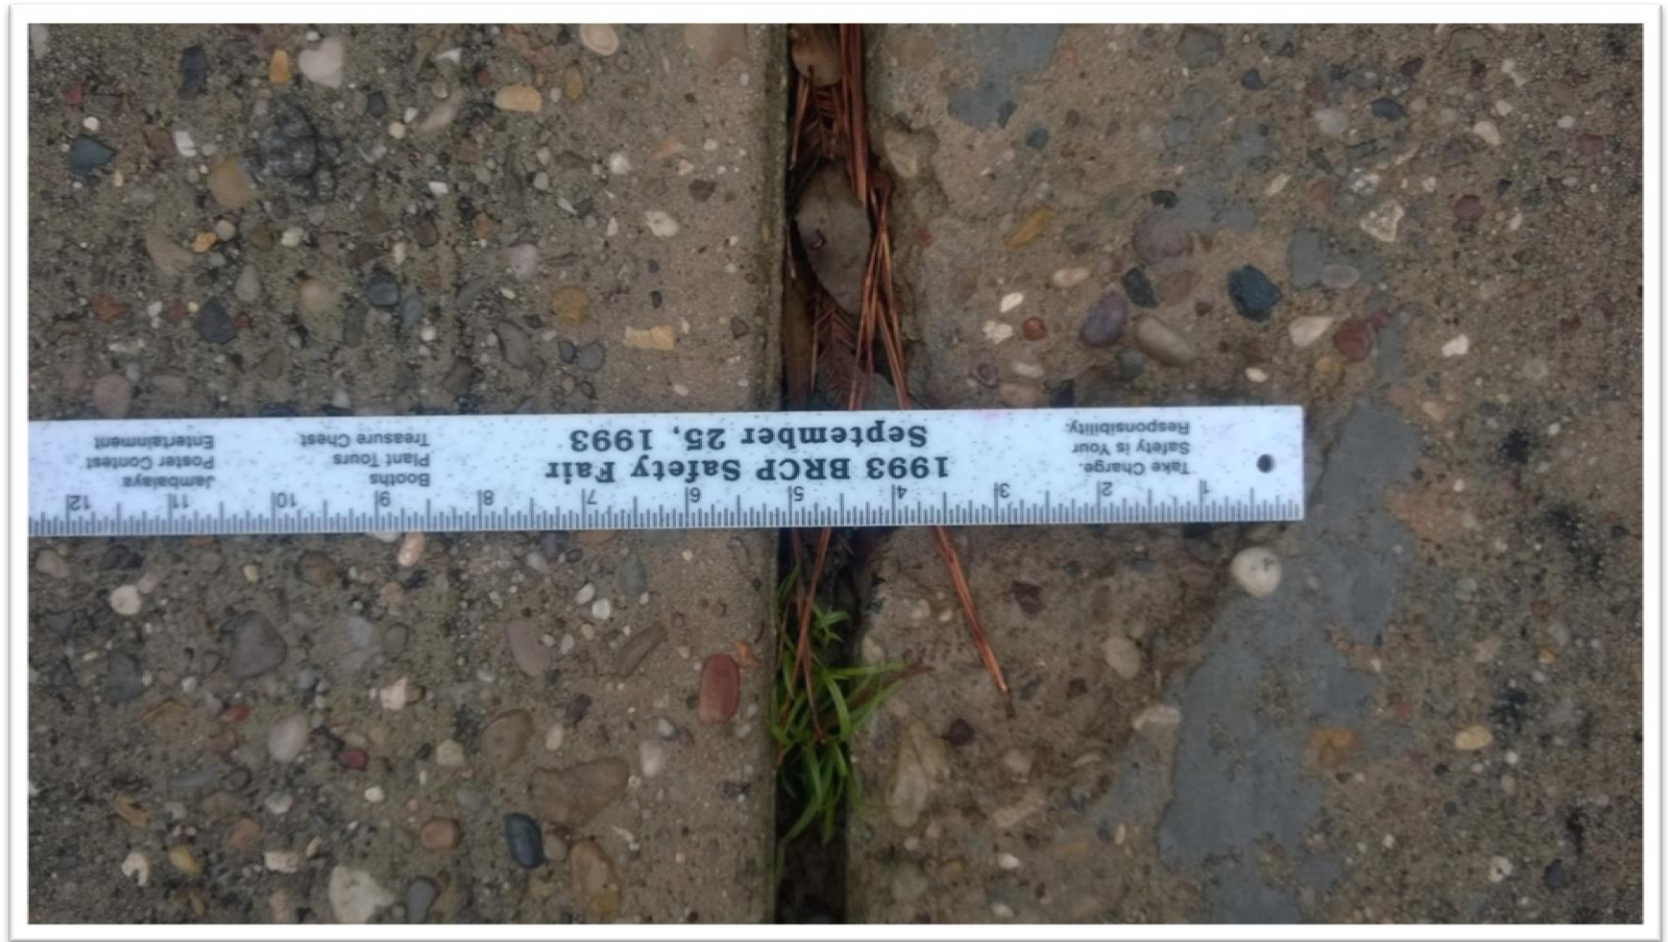
Location Sh-46
Shadowbend
pathway

Hazard Type: Pothole
Severity: 2

Divot with Exposed Metal Bolt - Photo 1

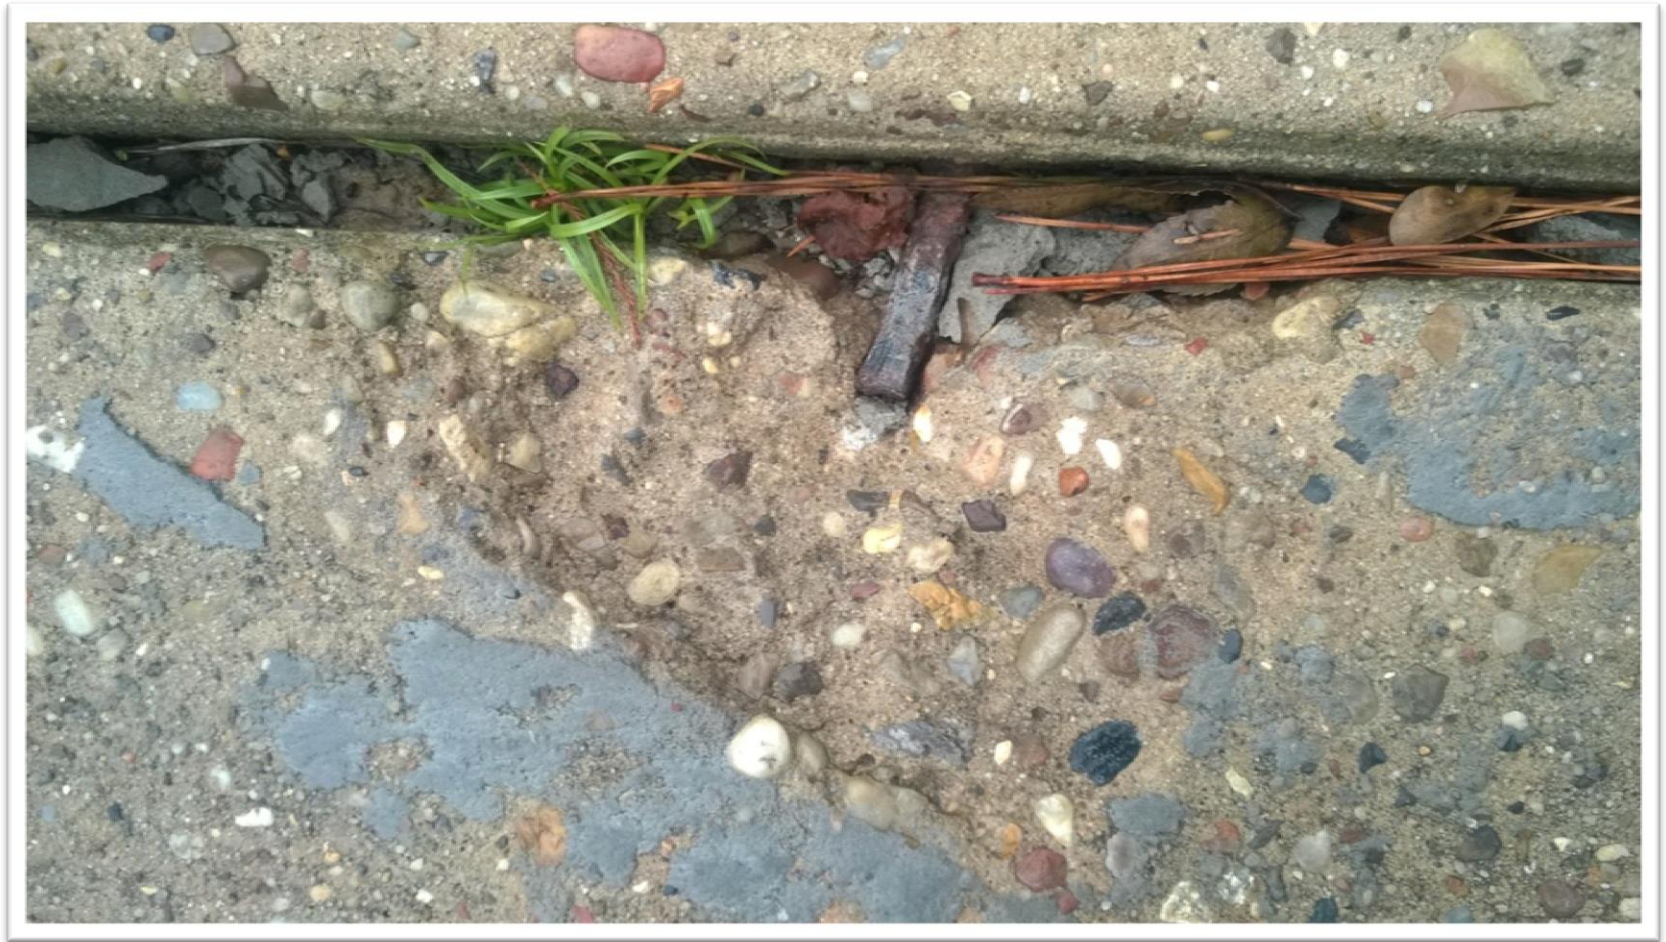
Location Sh-47
Shadowbend
pathway

Hazard Type: Pothole
Severity: 2

Divot with Exposed Metal Bolt - Photo 2

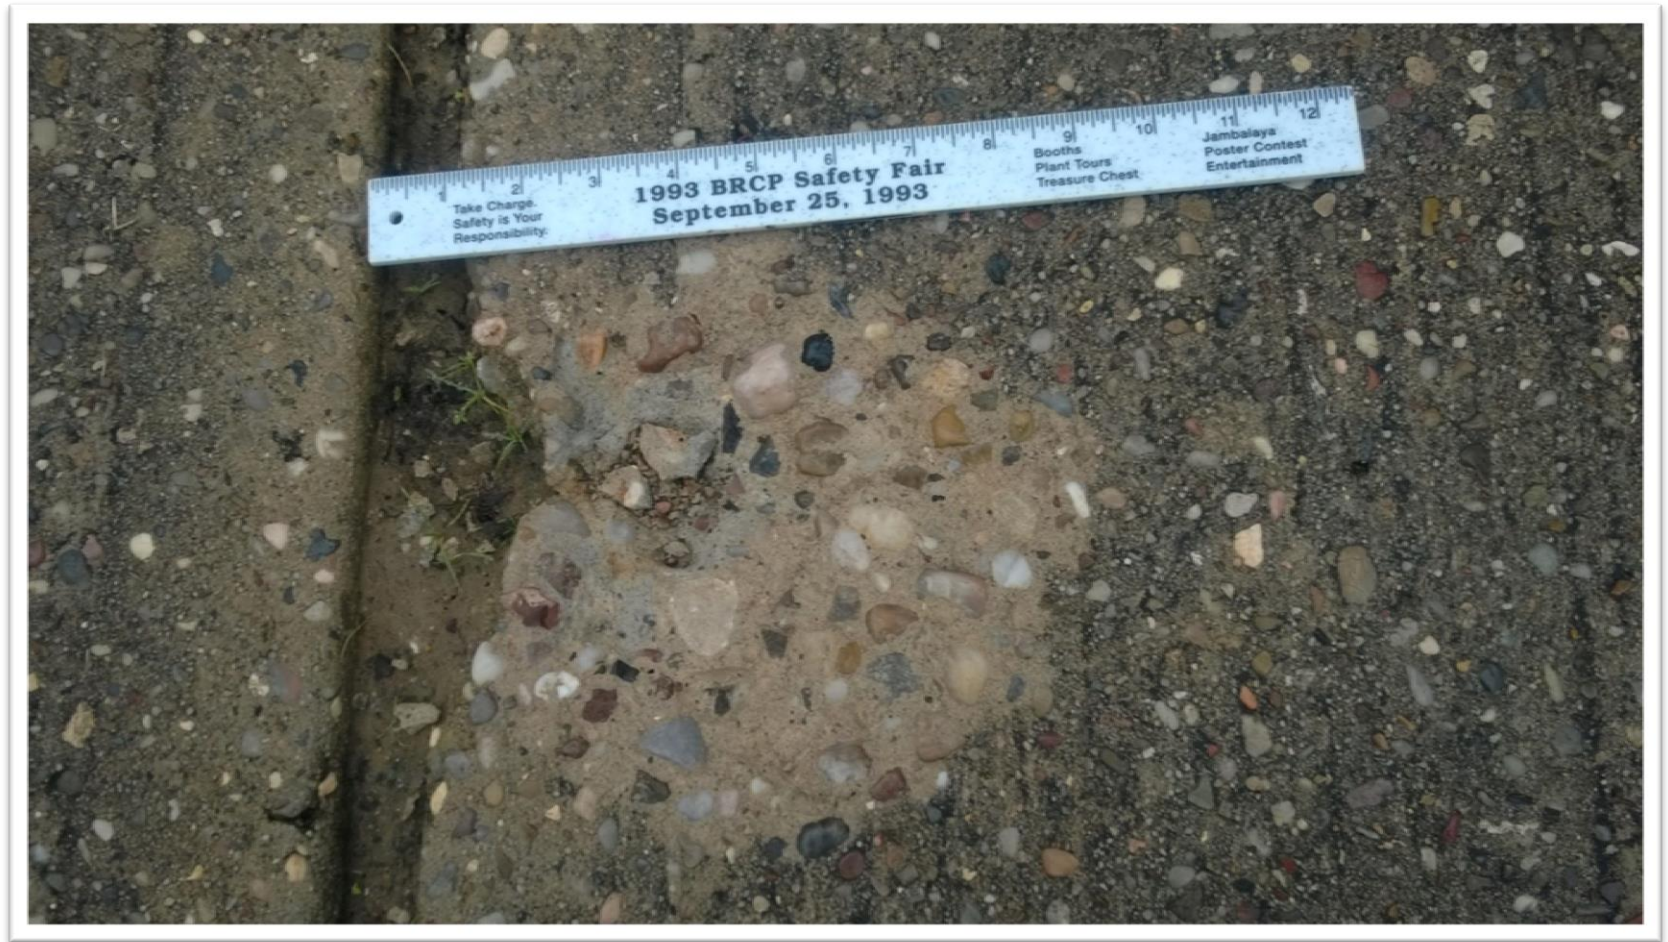
Location Sh-48
Shadowbend
pathway

Hazard Type: Pothole
Severity: 2

Divot - Photo 1

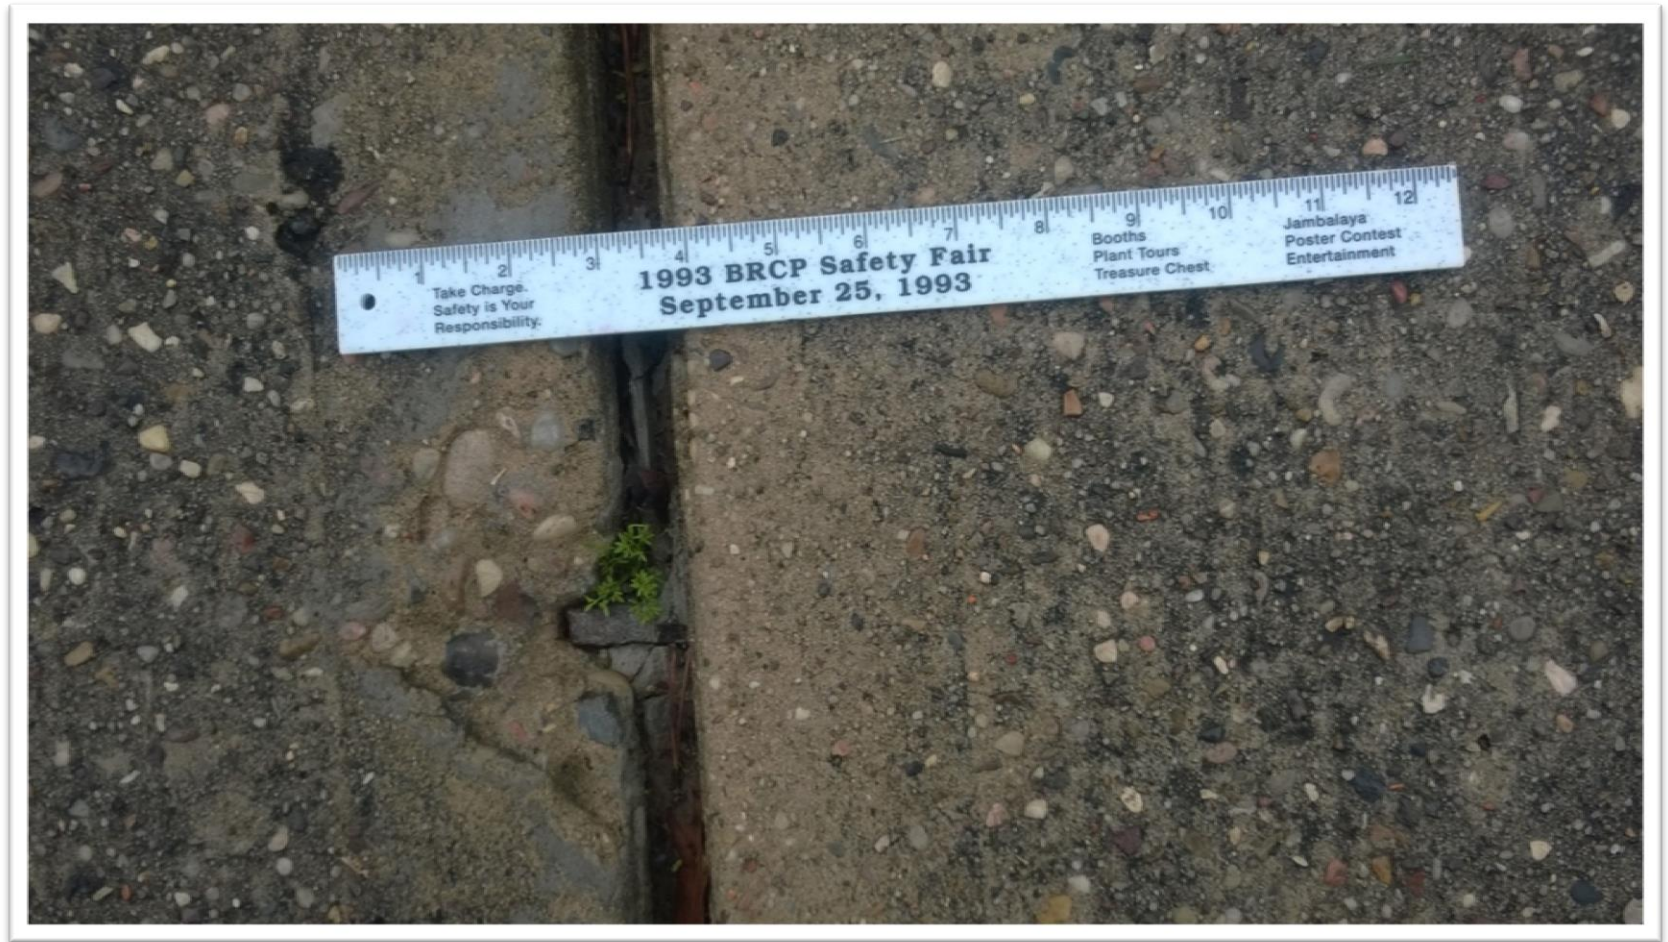
Location Sh-49
Shadowbend
pathway

Hazard Type: Pothole
Severity: 2

Divot - Photo 2

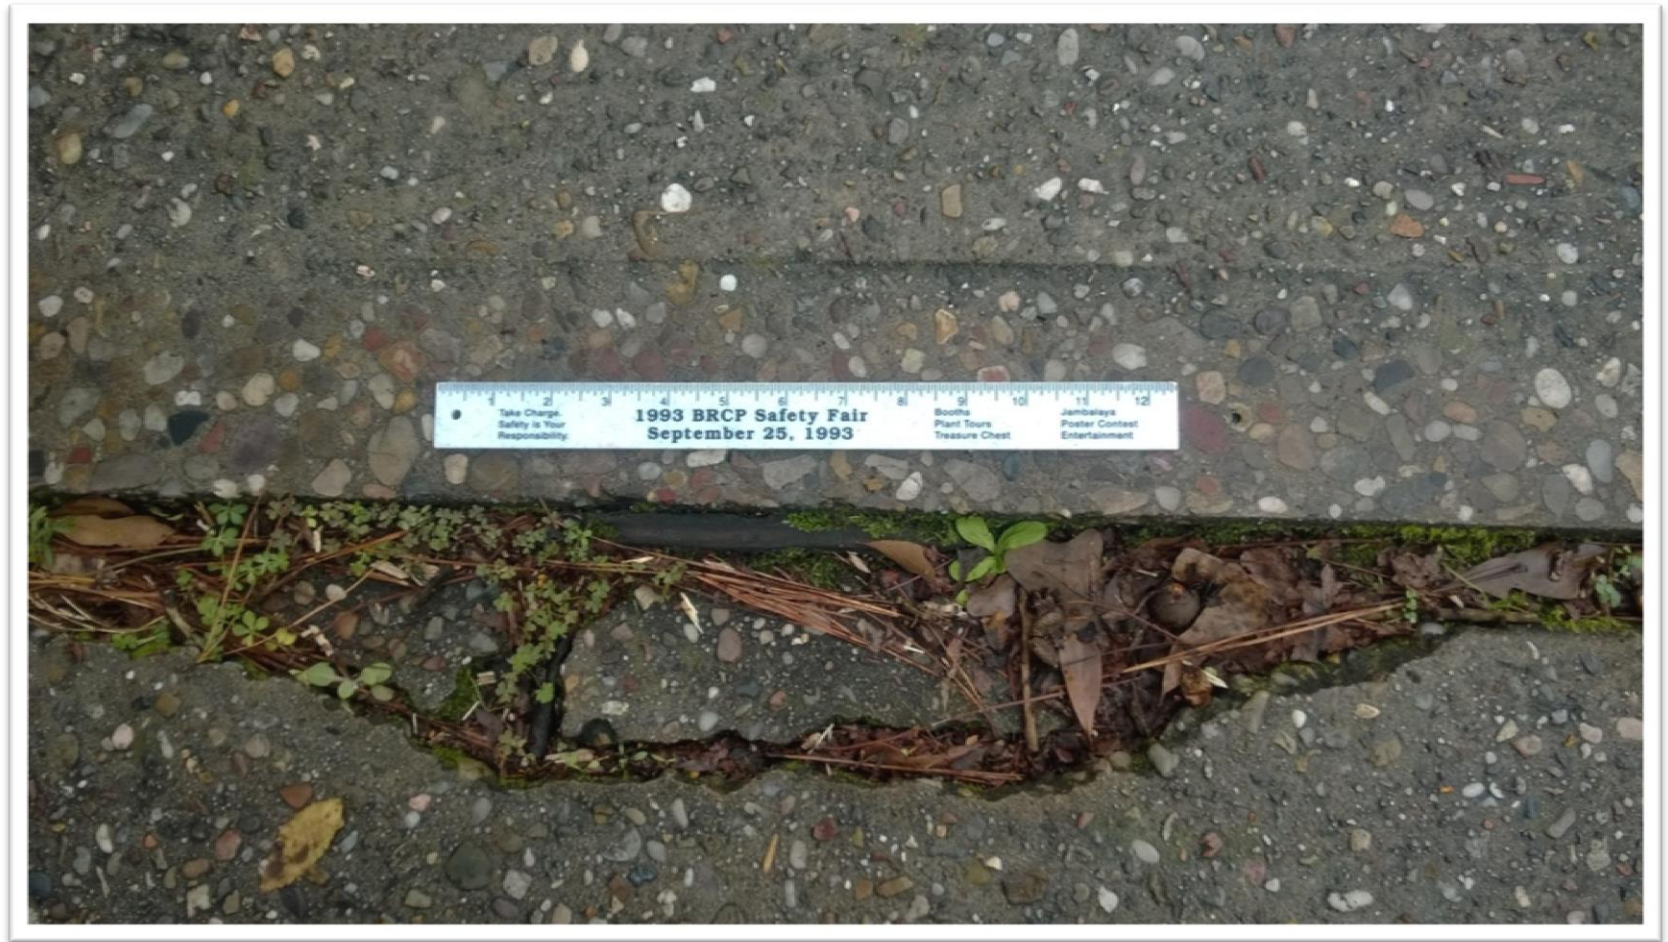
Location Sh-50
Shadowbend
pathway

Hazard Type: Gap
Severity: 2

Open Seam and Cracked Section Corner
Photo 1

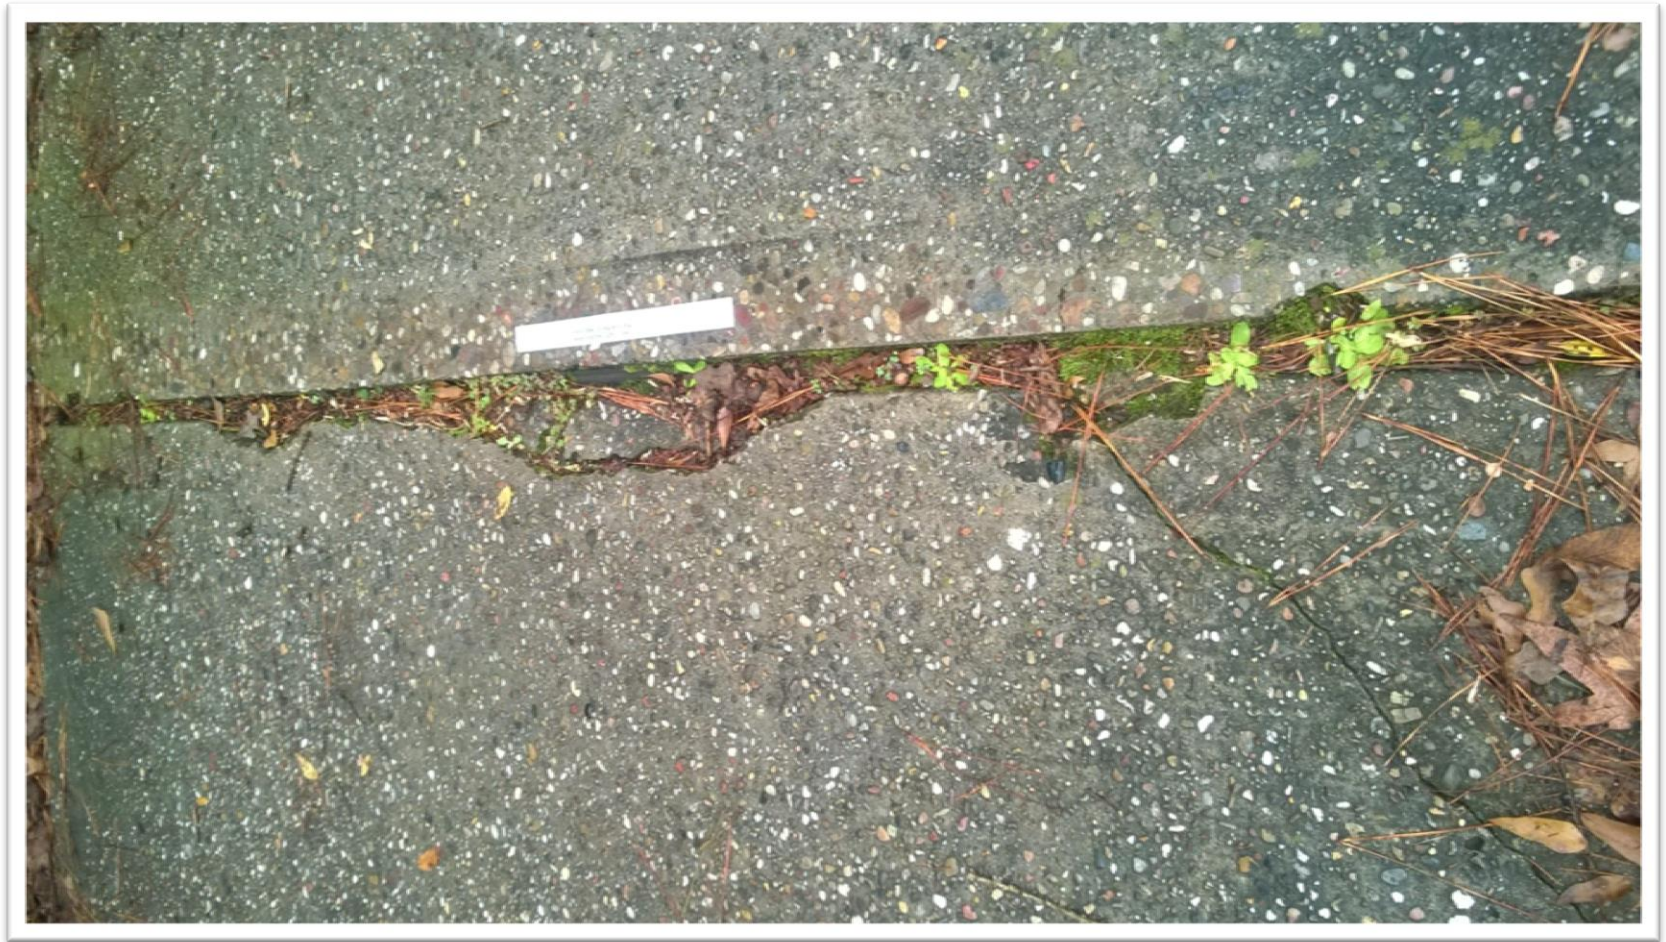
Location Sh-51
Shadowbend
pathway

Hazard Type: Gap
Severity: 2

Open Seam and Cracked Section Corner
Photo 2

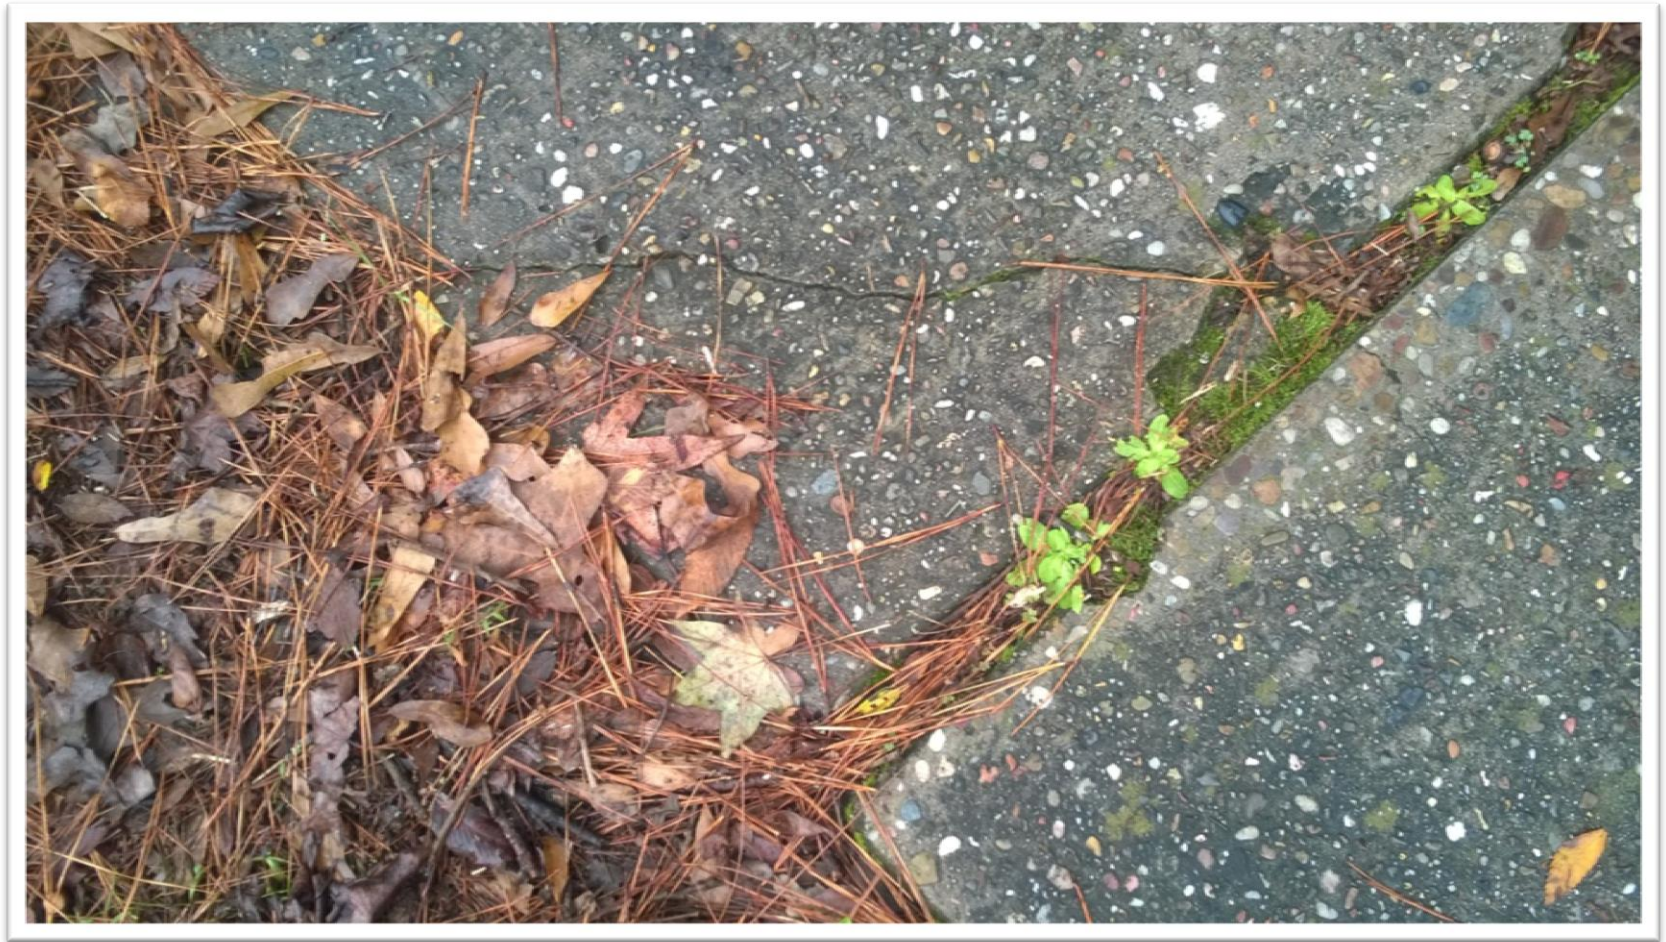
Location Sh-52
Shadowbend
pathway

Hazard Type: Gap
Severity: 2

Open Seam and Cracked Section Corner
Photo 3

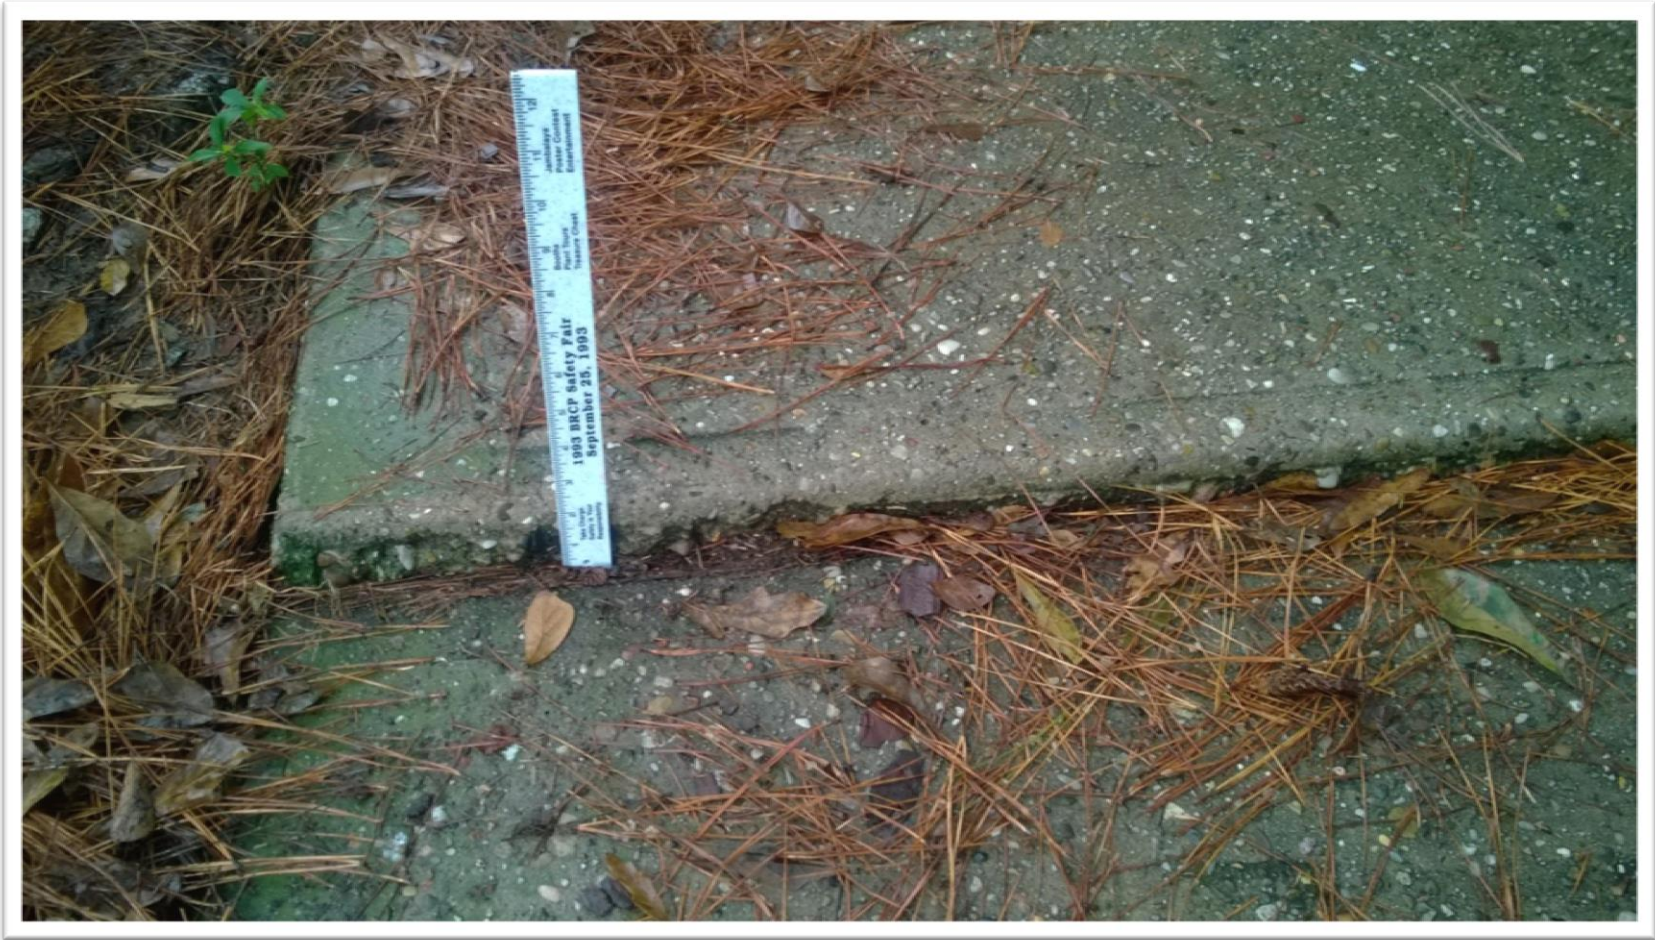
Location Sh-53
Shadowbend
pathway

Hazard Type: Other
Severity: 2

2" Drop Between Sections
