Road Shoulder Hazards along
Shadowbend Place– January 2015

Hazards on road shoulders, that could pose a risk to cyclists, were identified in January 2015 by volunteers from Bike The Woodlands Coalition.

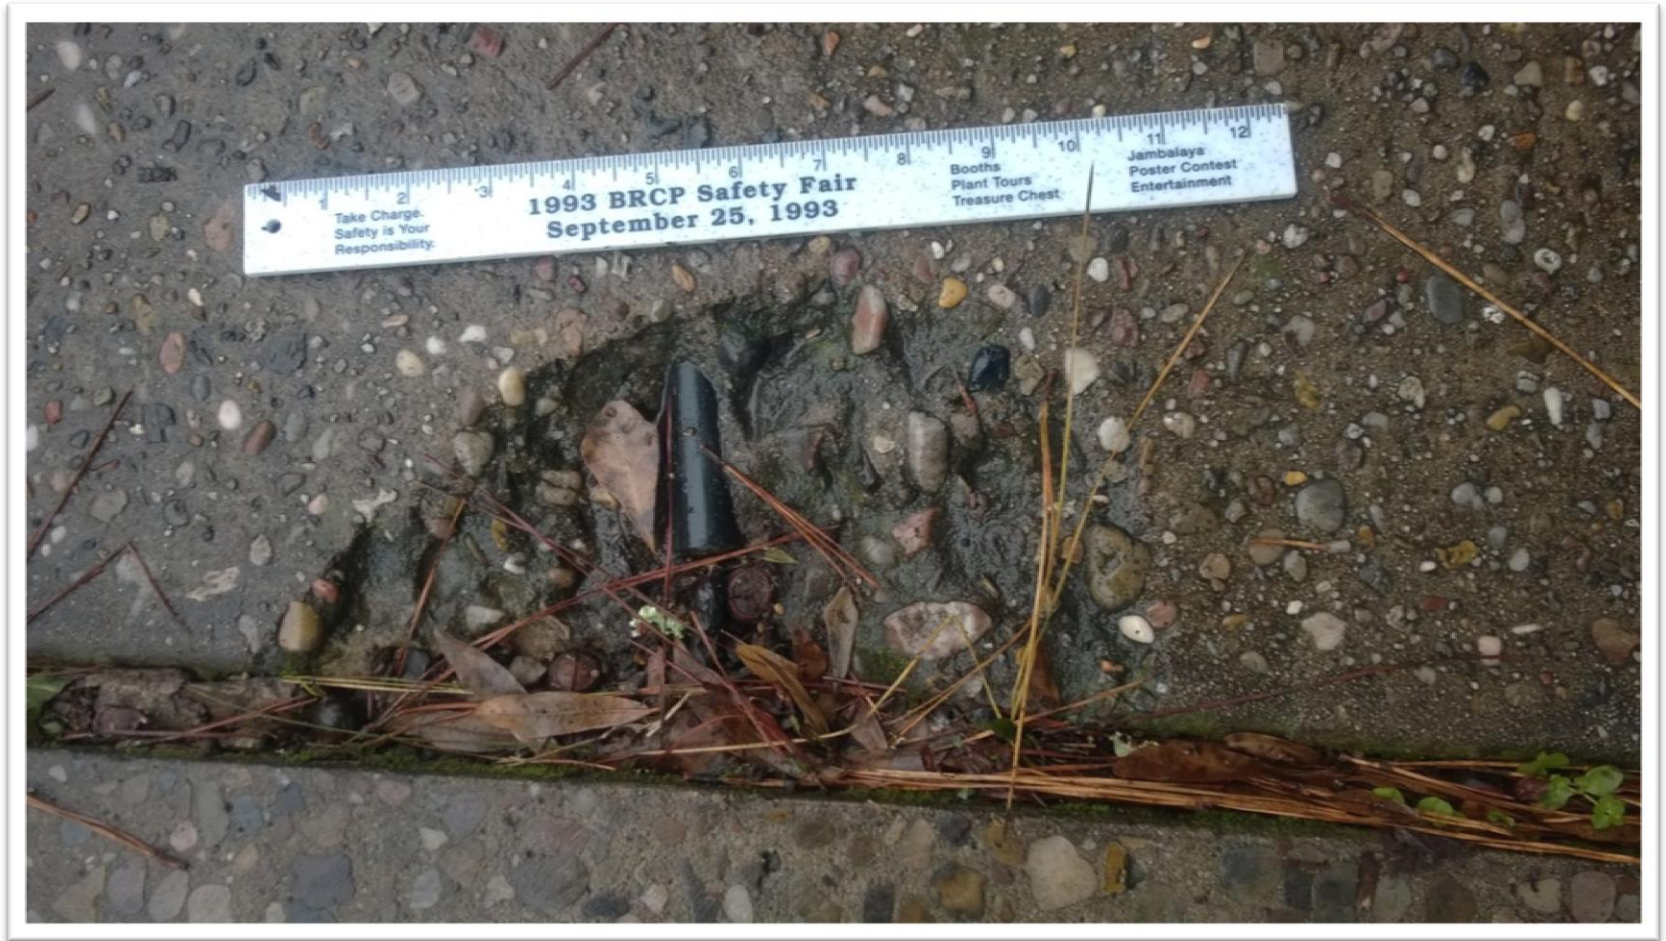
Location Sh-54
Shadowbend
pathway

Hazard Type: Pothole
Severity: 2

Divot with Exposed Metal Rod

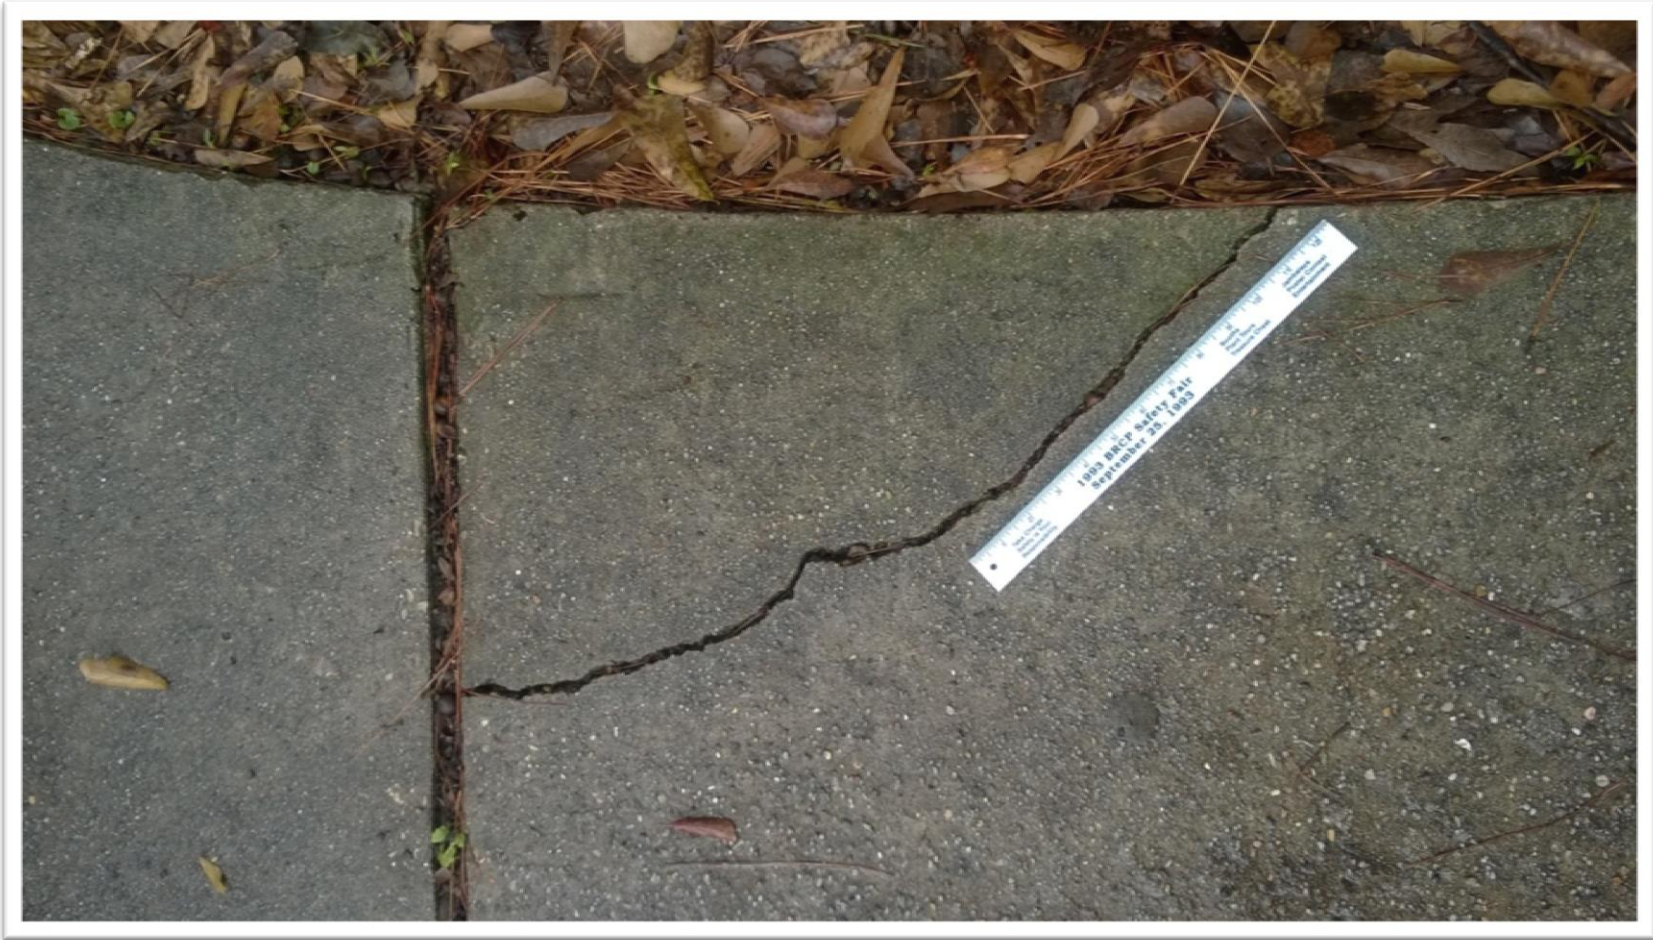
Location Sh-55
Shadowbend
pathway

Hazard Type: Gap
Severity: 2

2' Crack at Section Edge
