Road Shoulder Hazards along
West and North Panther Creek
January 2015

Hazards on road shoulders, that could pose a risk to cyclists, were identified in January 2015 by volunteers from Bike The Woodlands Coalition.

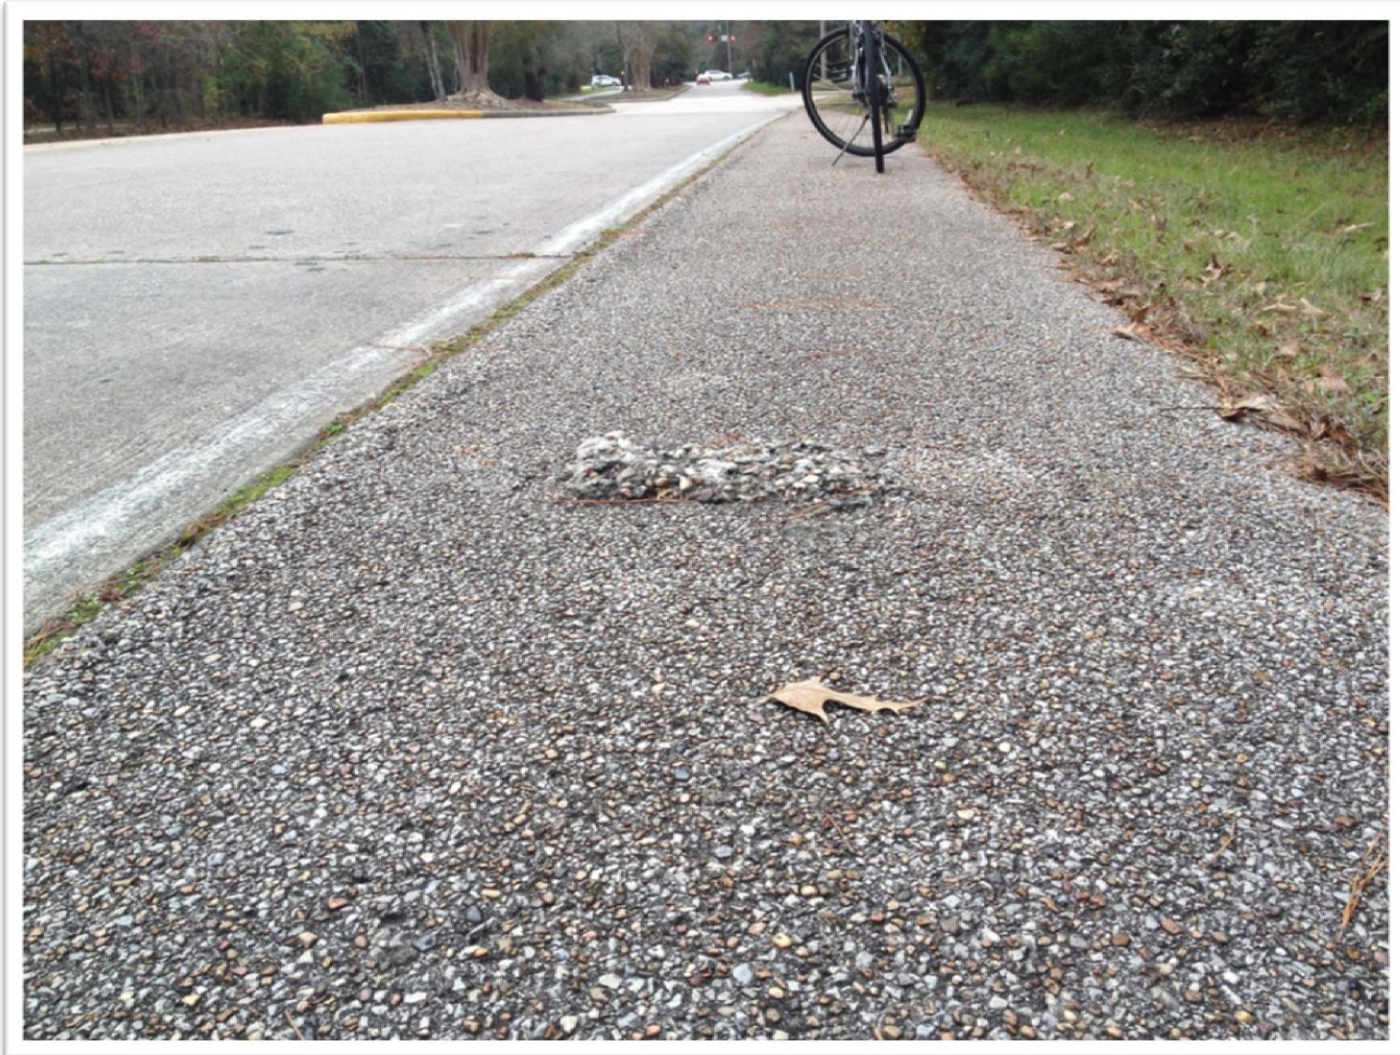
IMG_3626

Location WPC-1
West Panther Creek
Southbound

Hazard Type: Rough area
Severity: 4

Waste concrete (leftovers) dumped by pavers
in center of shoulder creating large uneven
bump

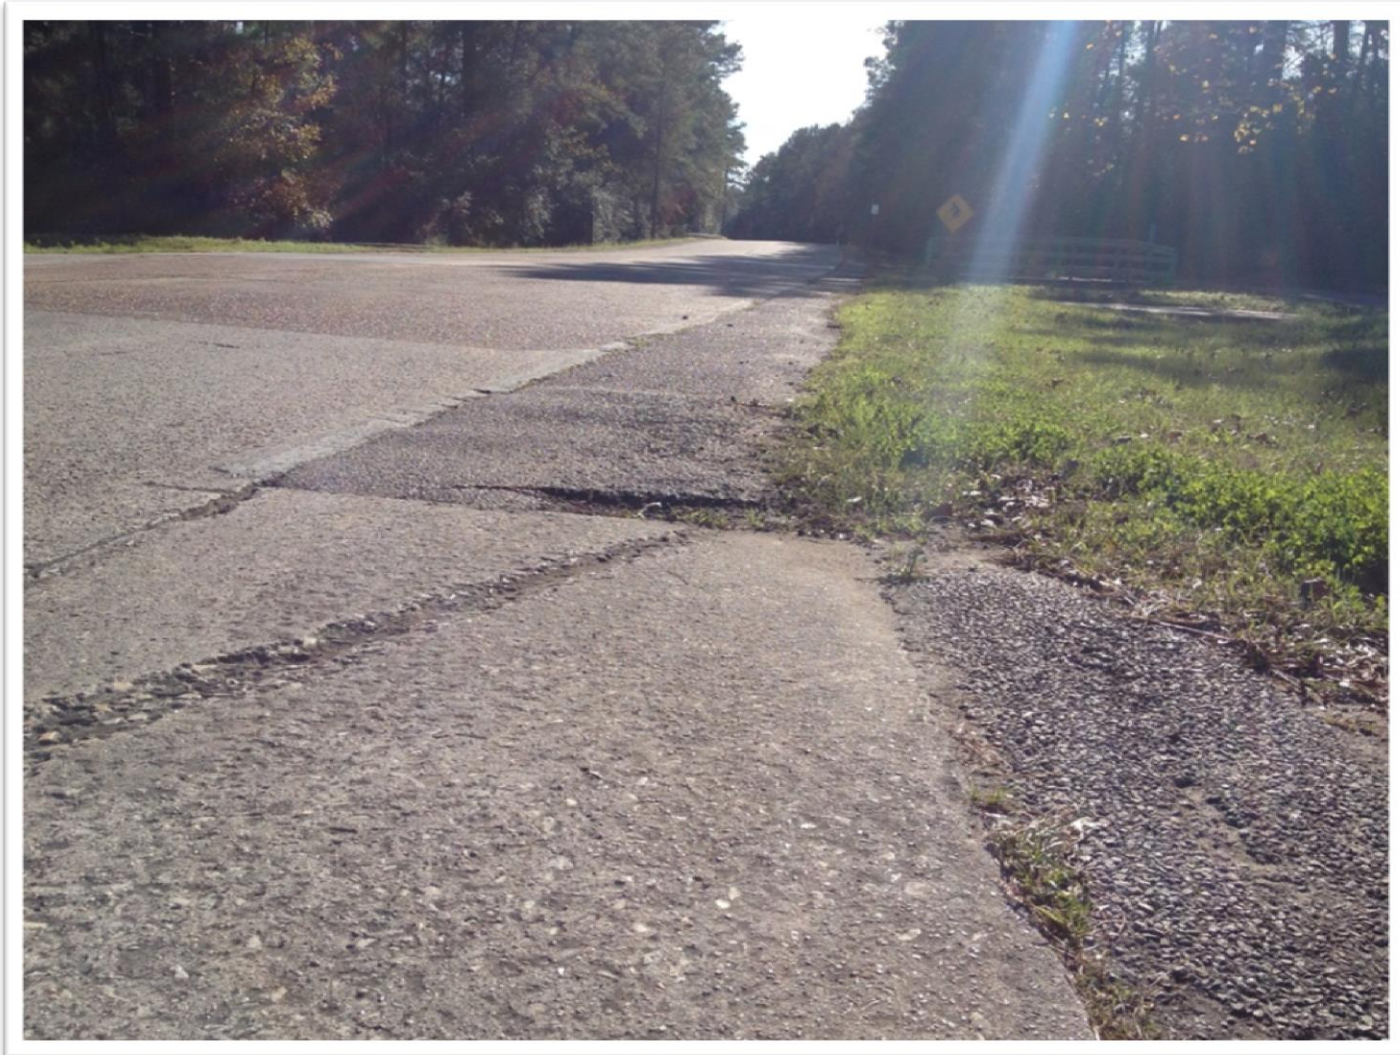
IMG_3647

Location WPC-2
West Panther Creek
Southbound

Hazard Type: Pot hole
Severity: 3

Pot hole and rough shoulder

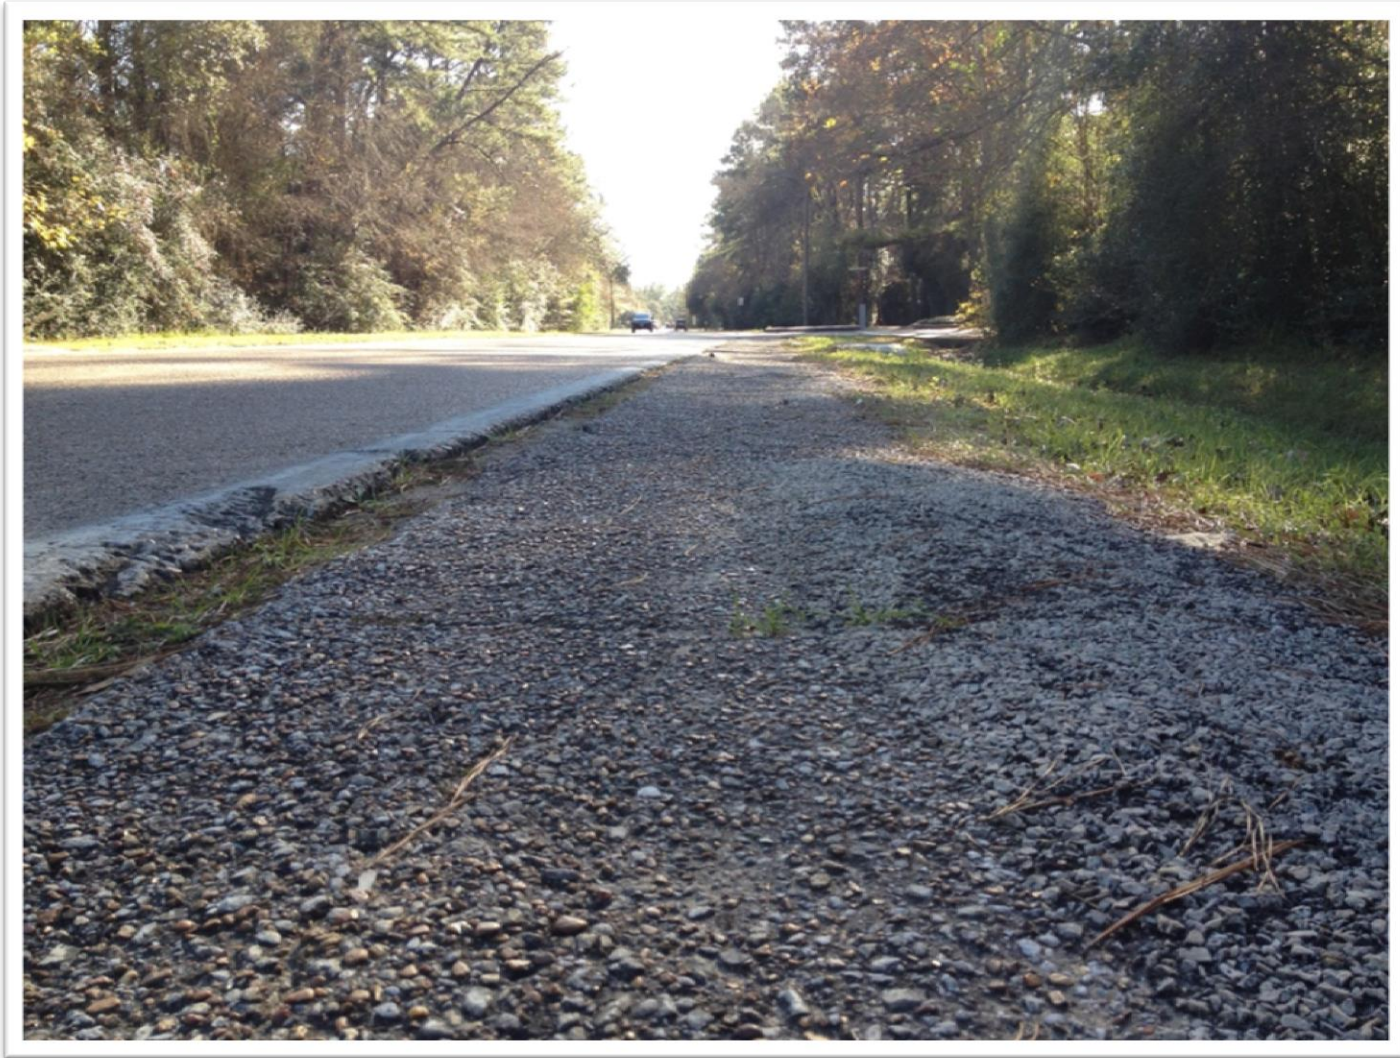
IMG_3651

Location WPC-3
West Panther Creek
Southbound

Hazard Type: Rough area; lip
Severity: 4

Poorly repaired shoulder over more than 50
feet coupled with gap and 2 inch lip

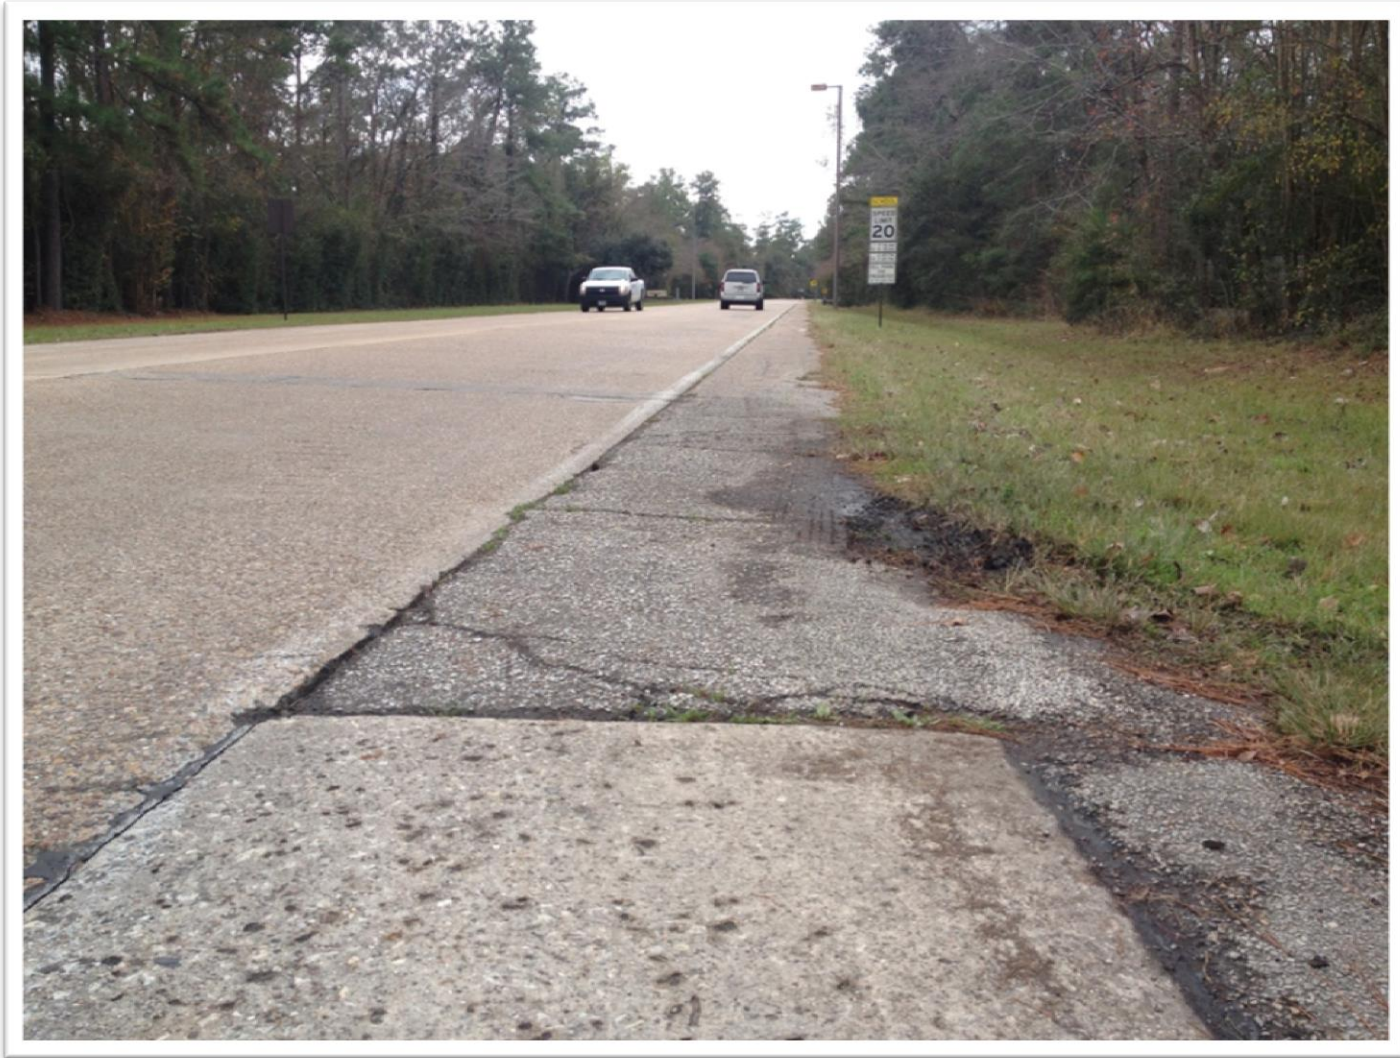
IMG_3587

Location WPC-4
West Panther Creek
Southbound

Hazard Type: Lip; pothole
Severity: 3

Drop from concrete to shoulder paving 1"
with pothole on right edge

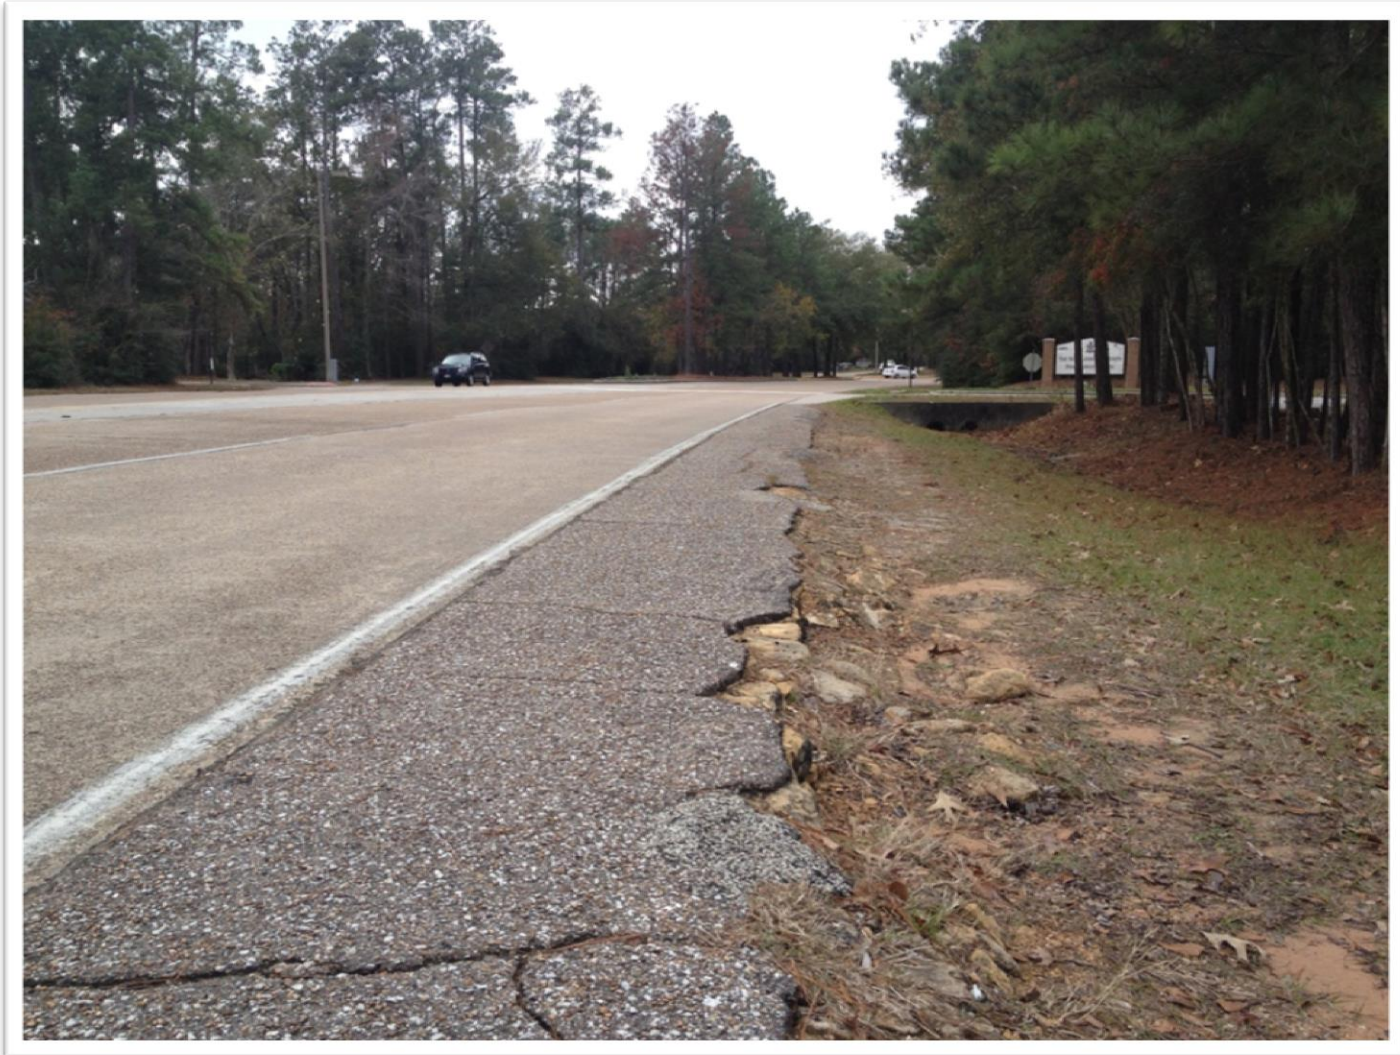
IMG_3588

Location WPC-5
West Panther Creek
Southbound

Hazard Type: Rough area Crumbled shoulder with exposed large rocks
Severity: 3

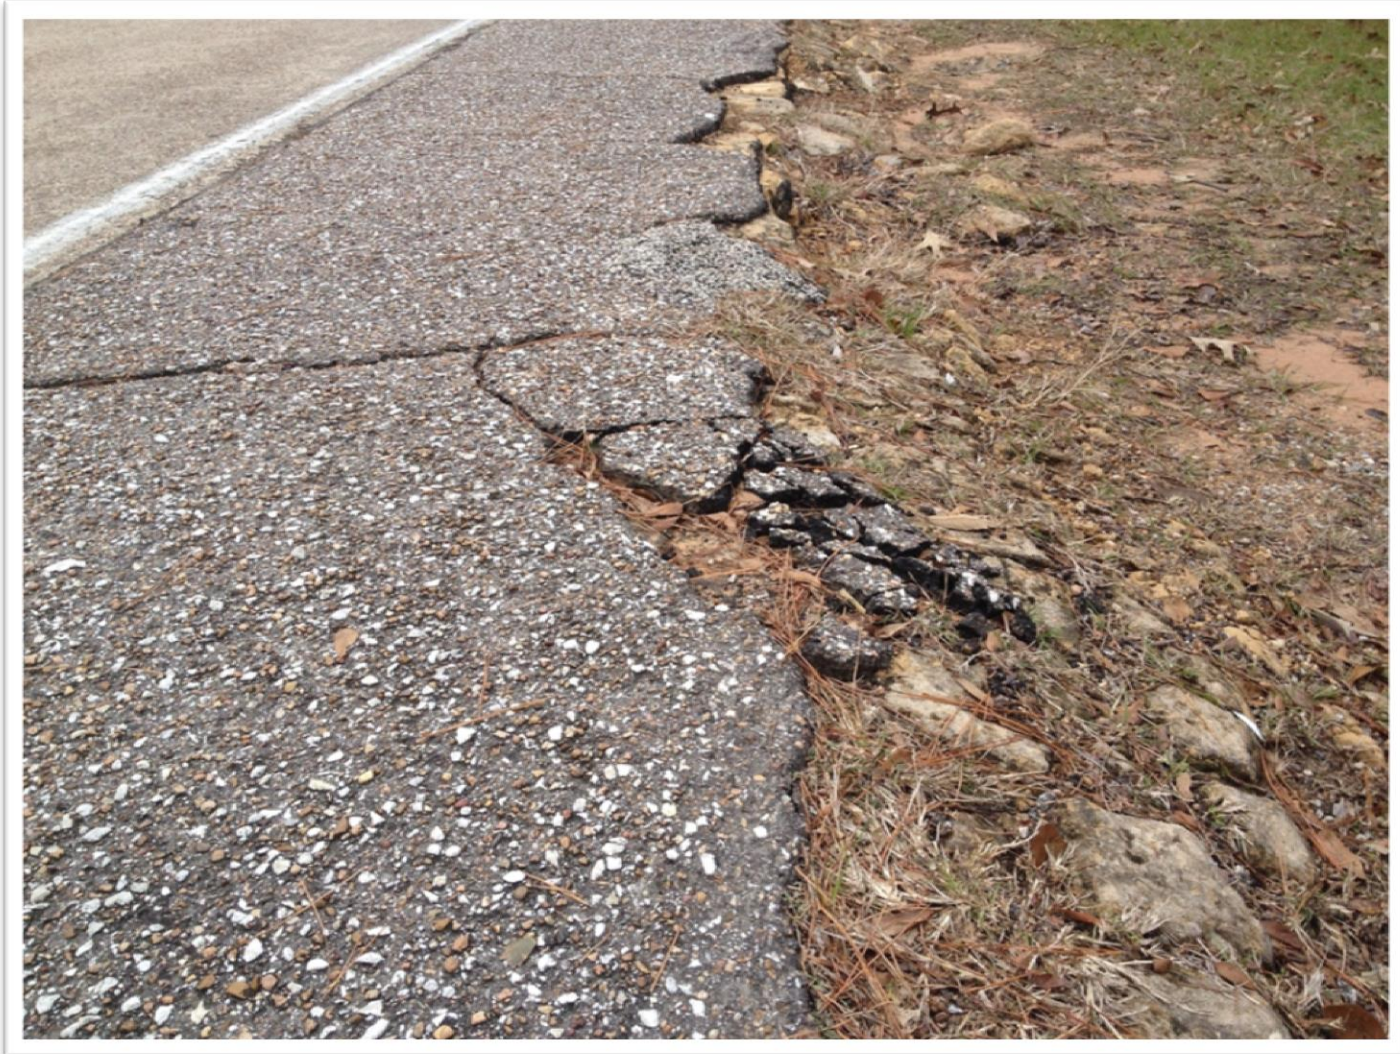
IMG_3589

Location WPC-6
West Panther Creek
Southbound

Hazard Type: Rough area Close up of IMG3588 shoulder area
Severity: 3

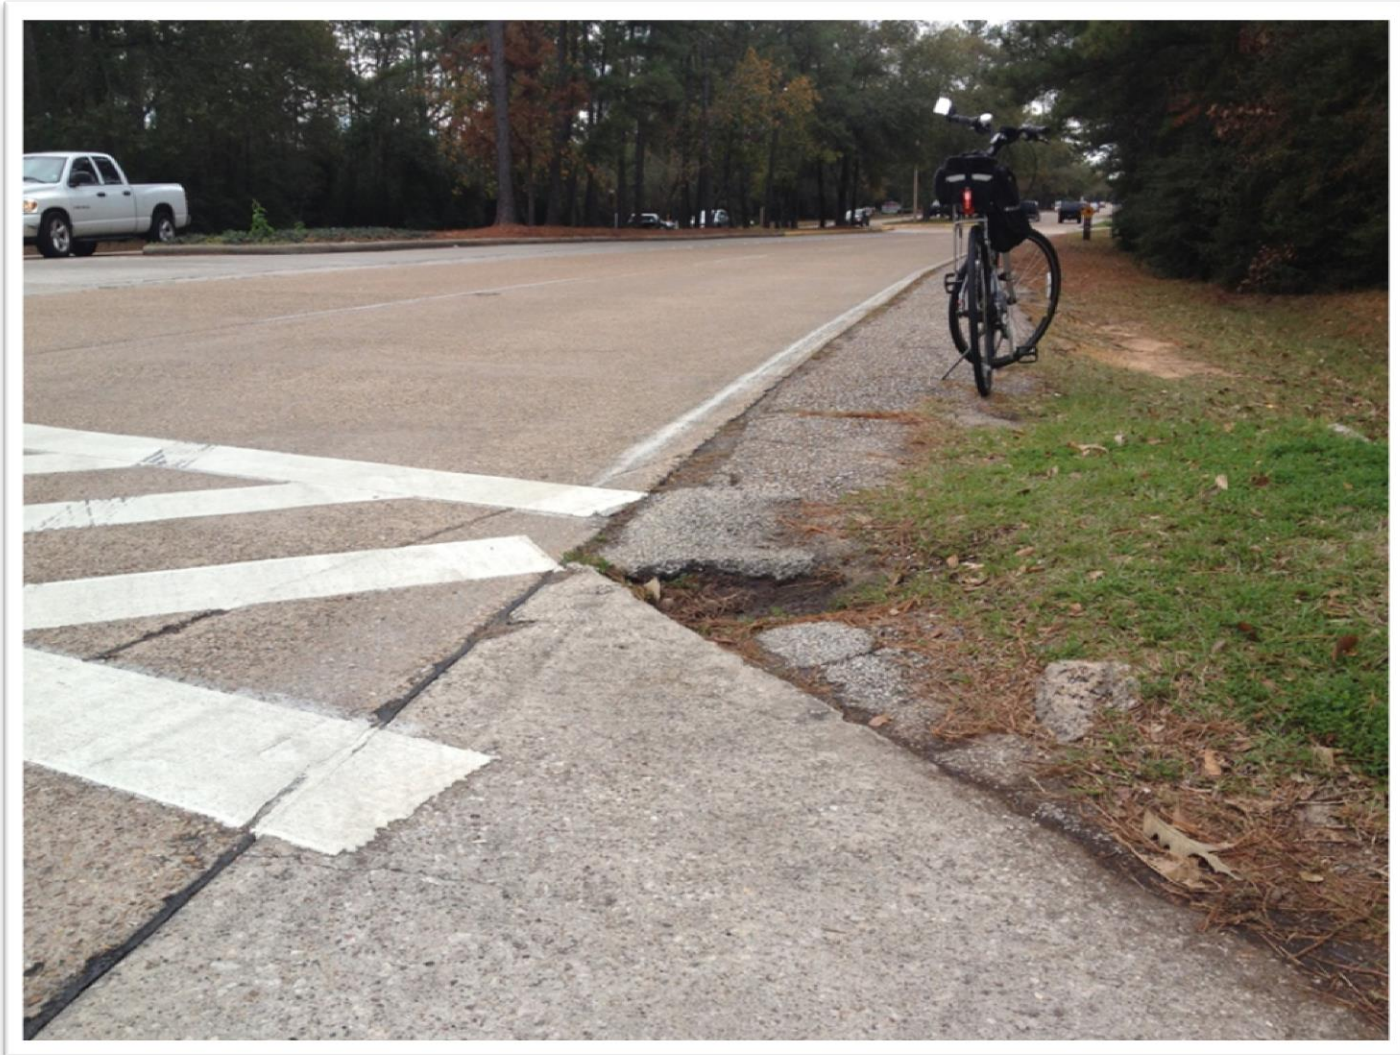
IMG_3590

Location WPC-7
West Panther Creek
Southbound

Hazard Type: Rough area Pothole, poor repairs and crumbling shoulder
Severity: 3

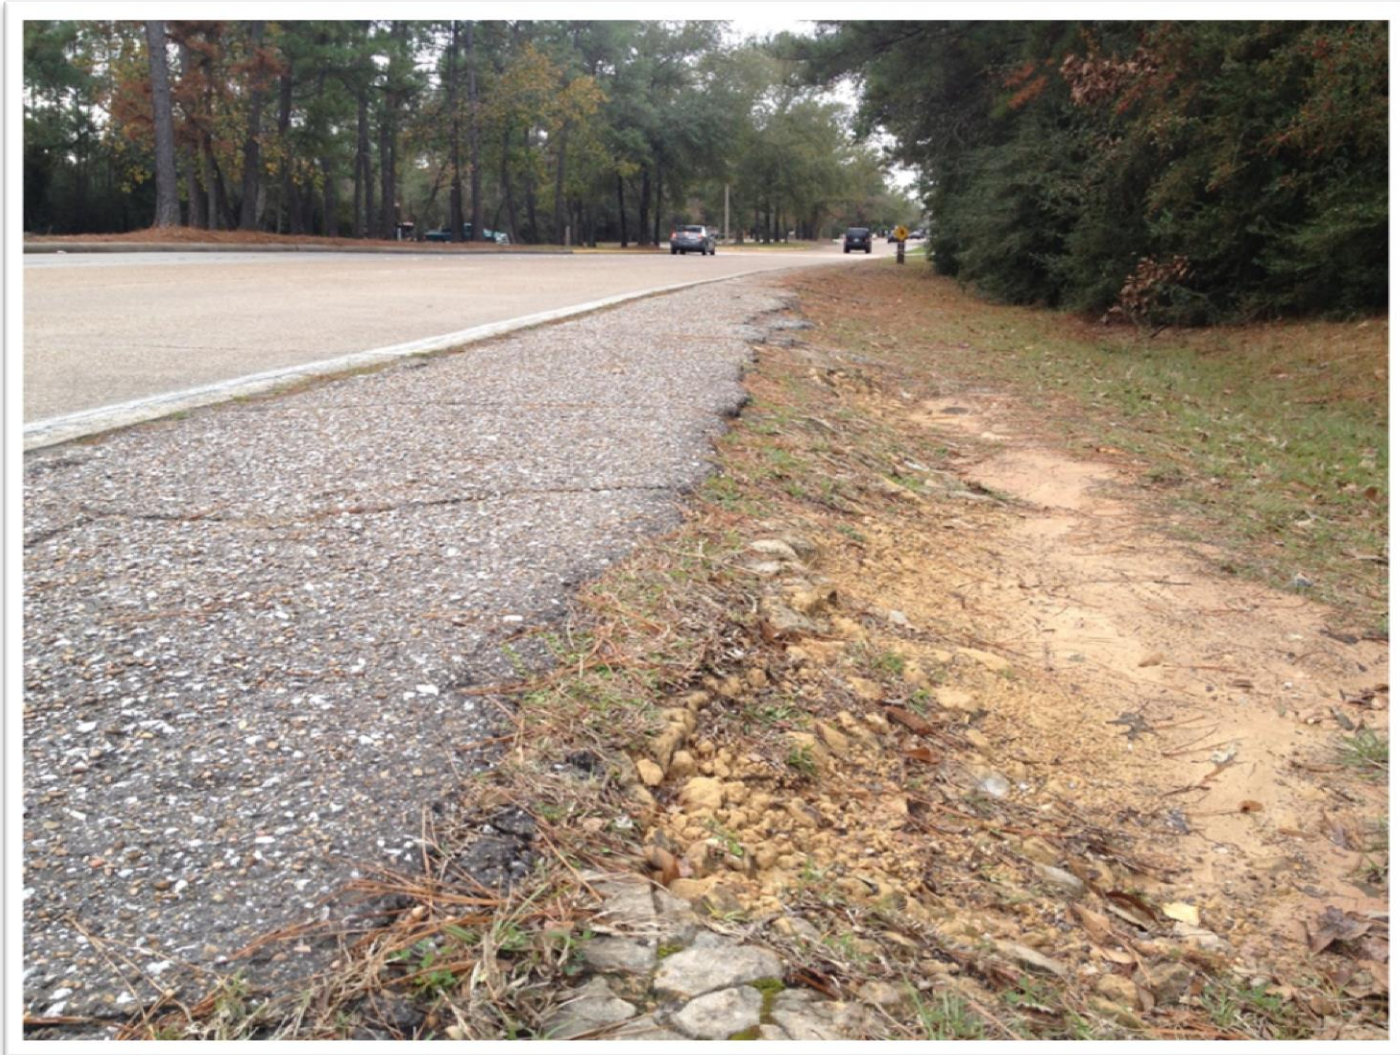
IMG_3591

Location WPC-8
West Panther Creek
Southbound

Hazard Type: Rough area Close up of IMG3590
Severity: 3

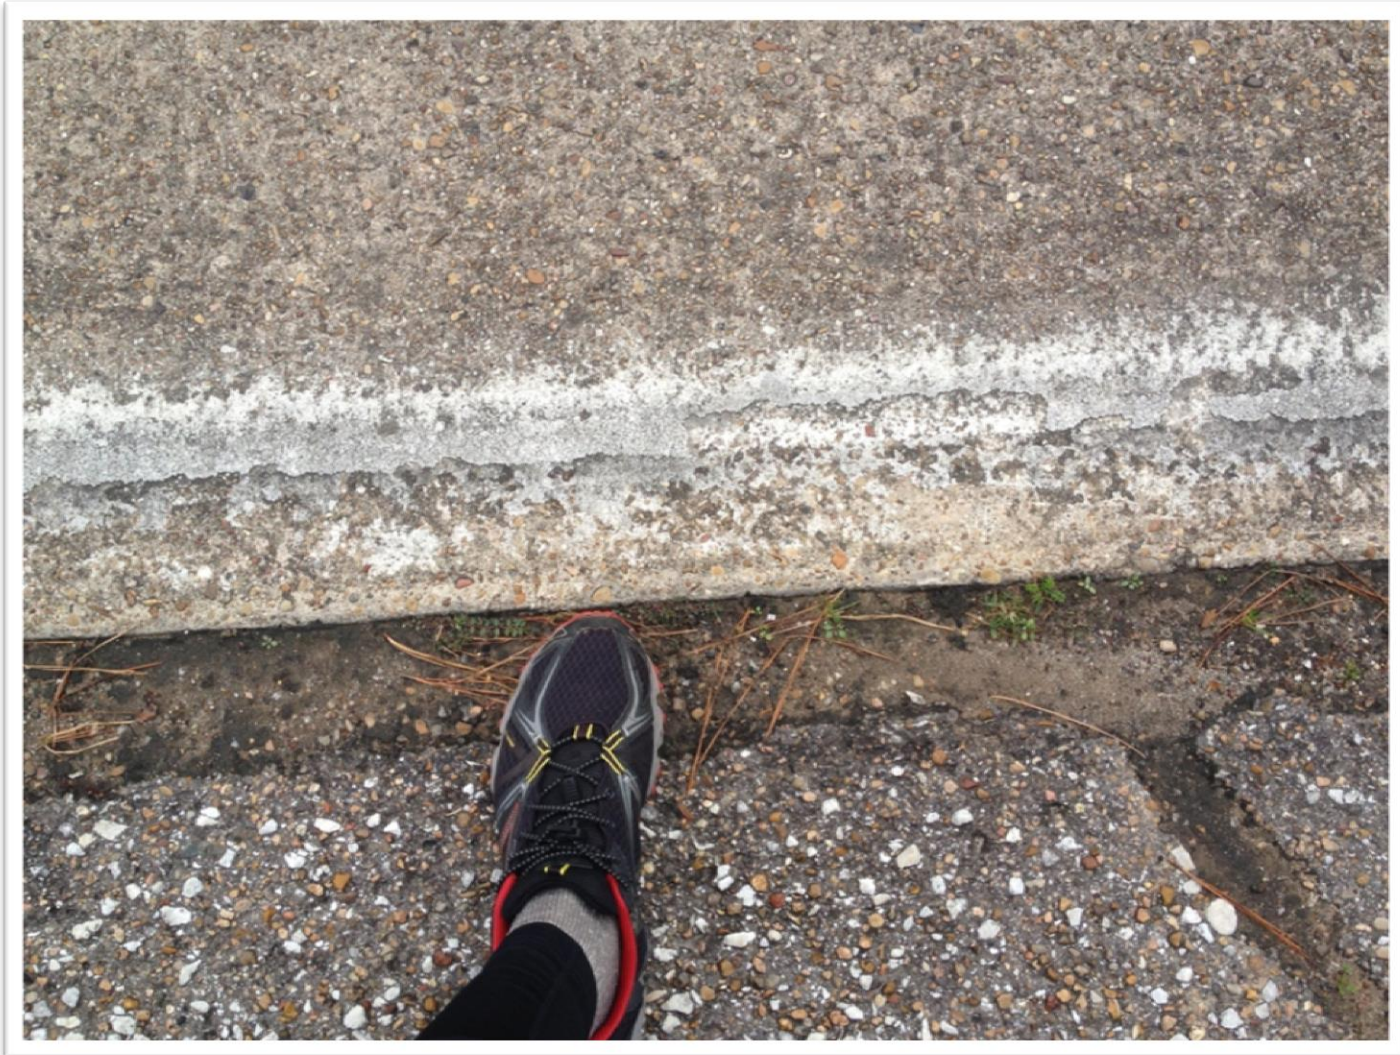
IMG_3592

Location WPC-9
West Panther Creek
Southbound

Hazard Type: Gap
Severity: 3

4" space between shoulder and roadway;
wide gaps are common along W. Panther
Creek from Woodlands Parkway to Lake
Woodlands Drive

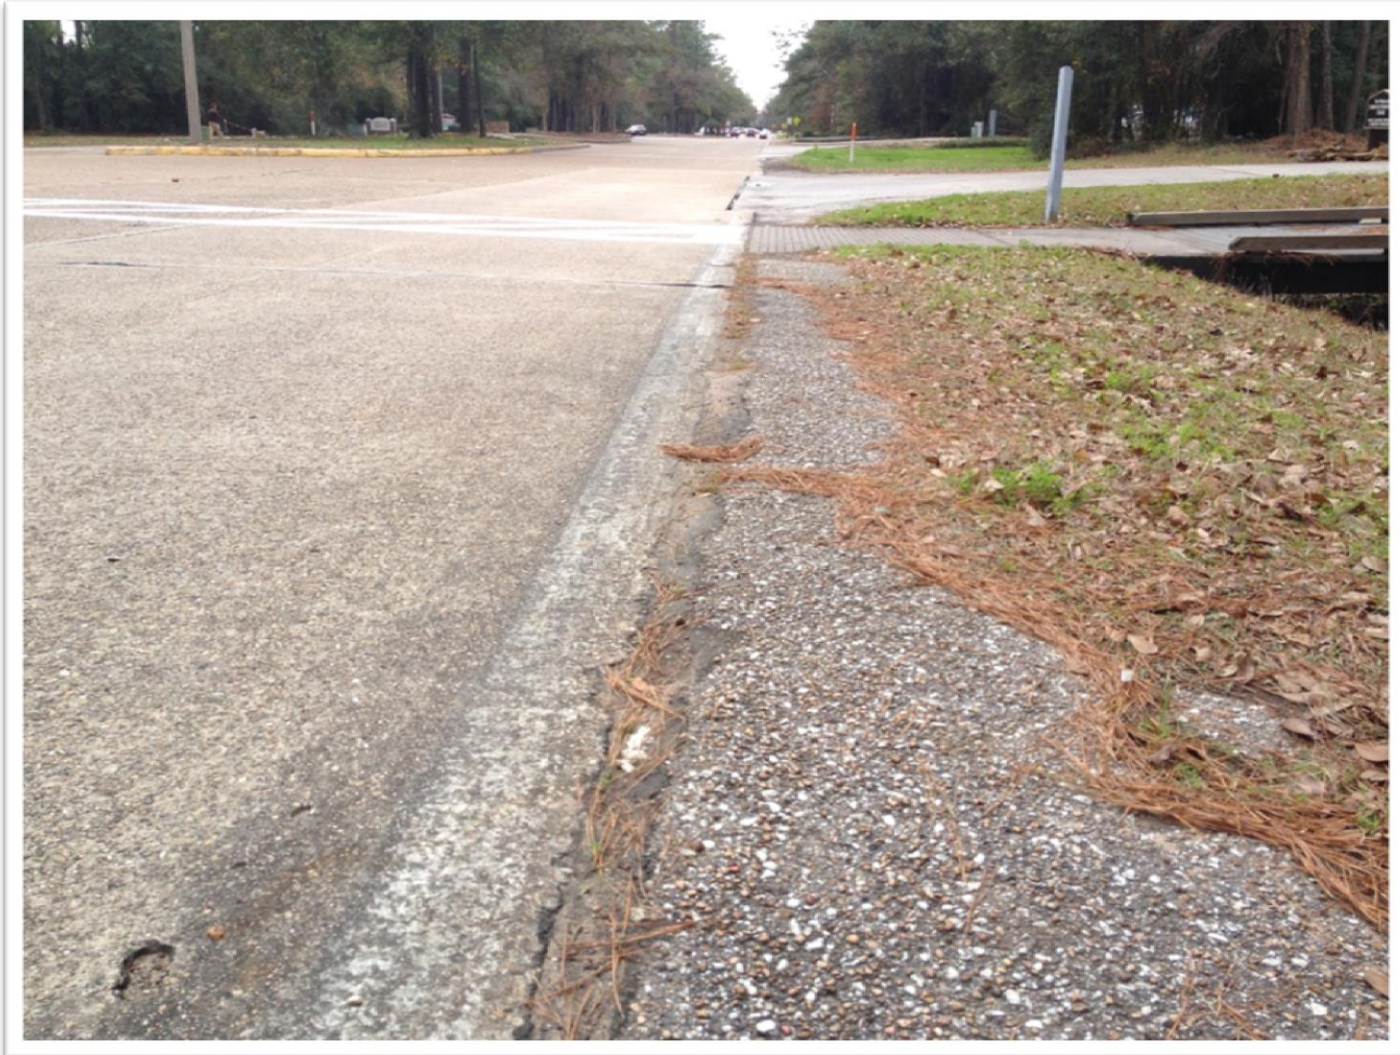
IMG_3593

Location WPC-10
West Panther Creek
Southbound

Hazard Type: Gap
Severity: 4

30 feet long wide and deep gap (2.5 inches)
where entry driveway meets roadway.
entrance to church. IMG3594 and IMG3596
also show the gap across the width of the
entryway

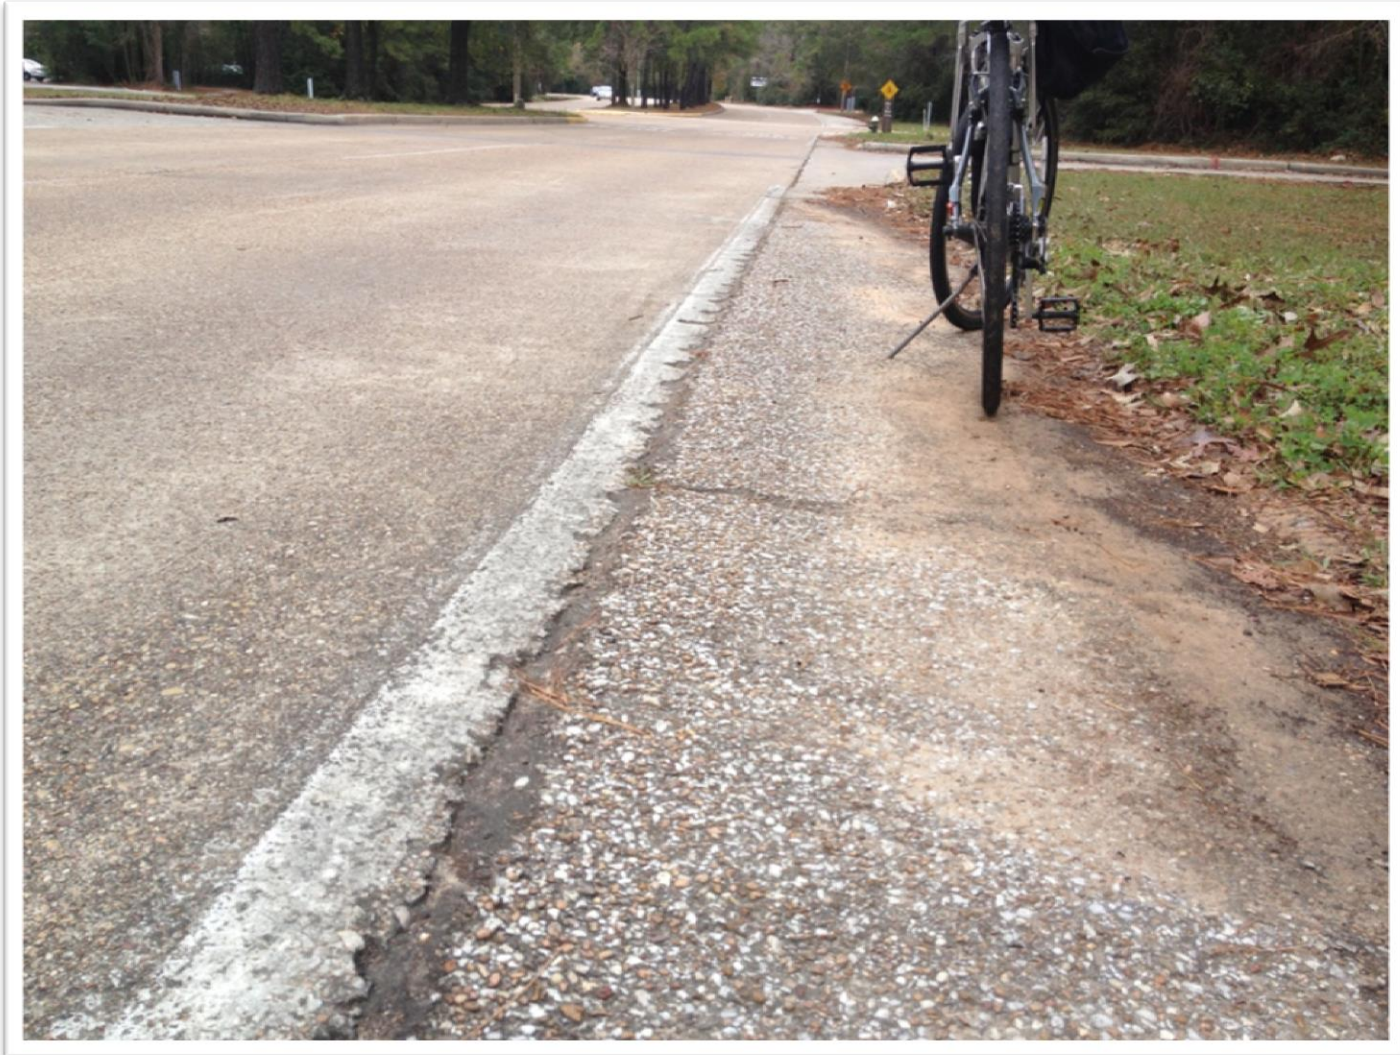
IMG_3601

Location WPC-11
West Panther Creek
Northbound

Hazard Type: Gap
Severity: 3

Looking north toward Ride Elementary,
lengthy rough patch with bumpy, rolling
surface, seam gaps, and 1" lip

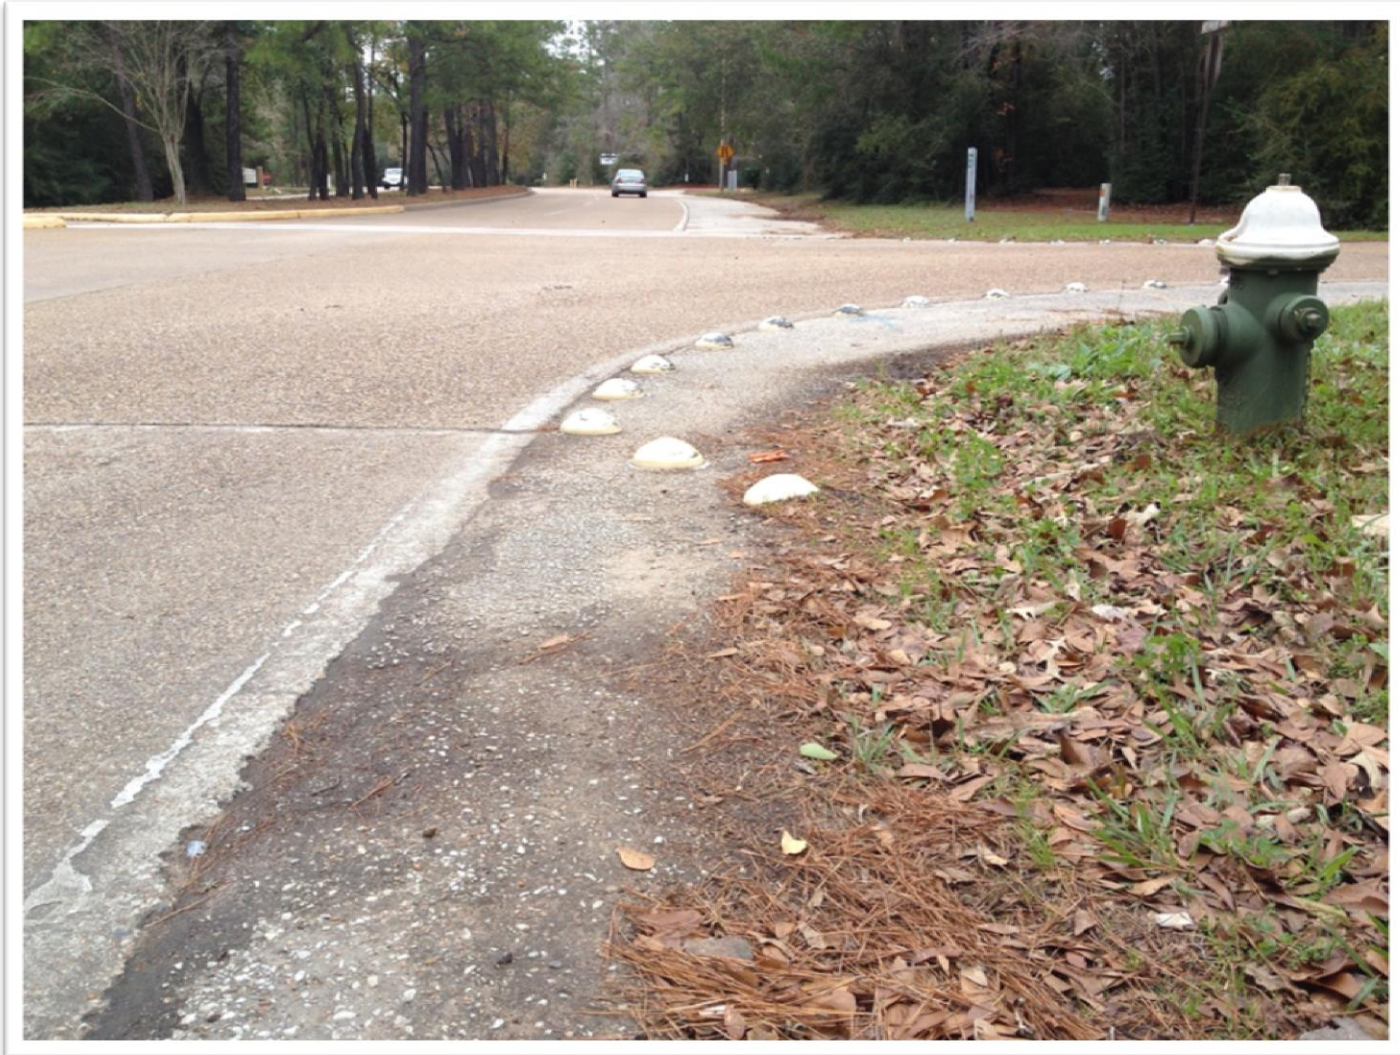
IMG_3602

Location WPC-12
West Panther Creek
Northbound

Hazard Type: Other
Severity: 3

Traffic bumps like these at Interfaith Way are
hazards for cyclists

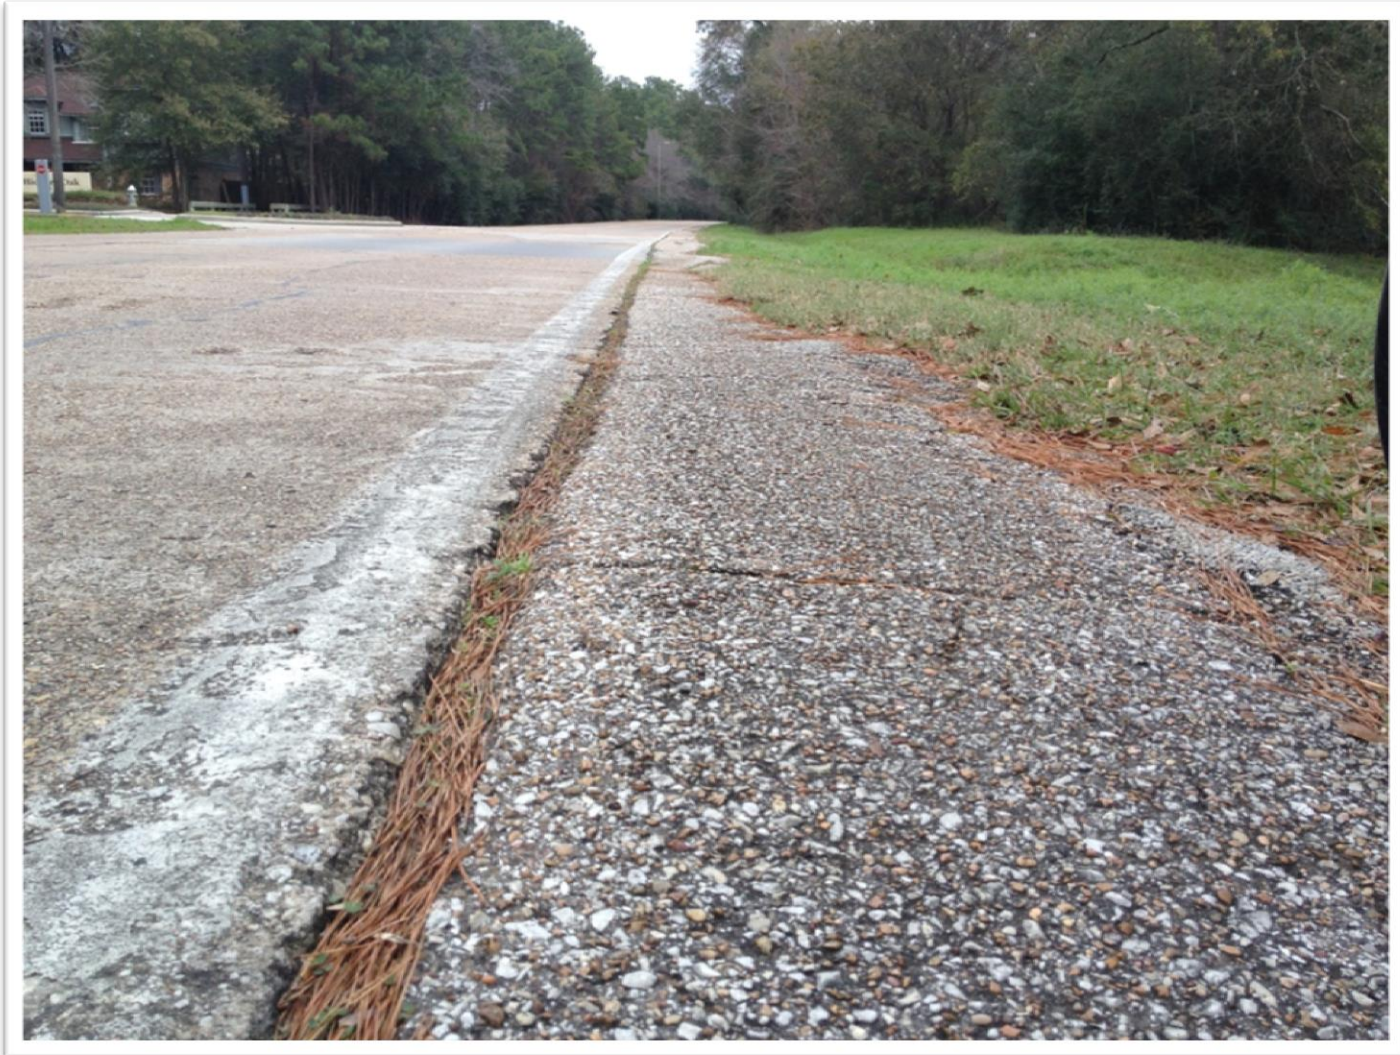
IMG_3603

Location WPC-13
West Panther Creek
Northbound

Hazard Type: Gap; rough area 100+ feet of poor shoulder repairs and 2 to 3"
Severity: 3 gaps

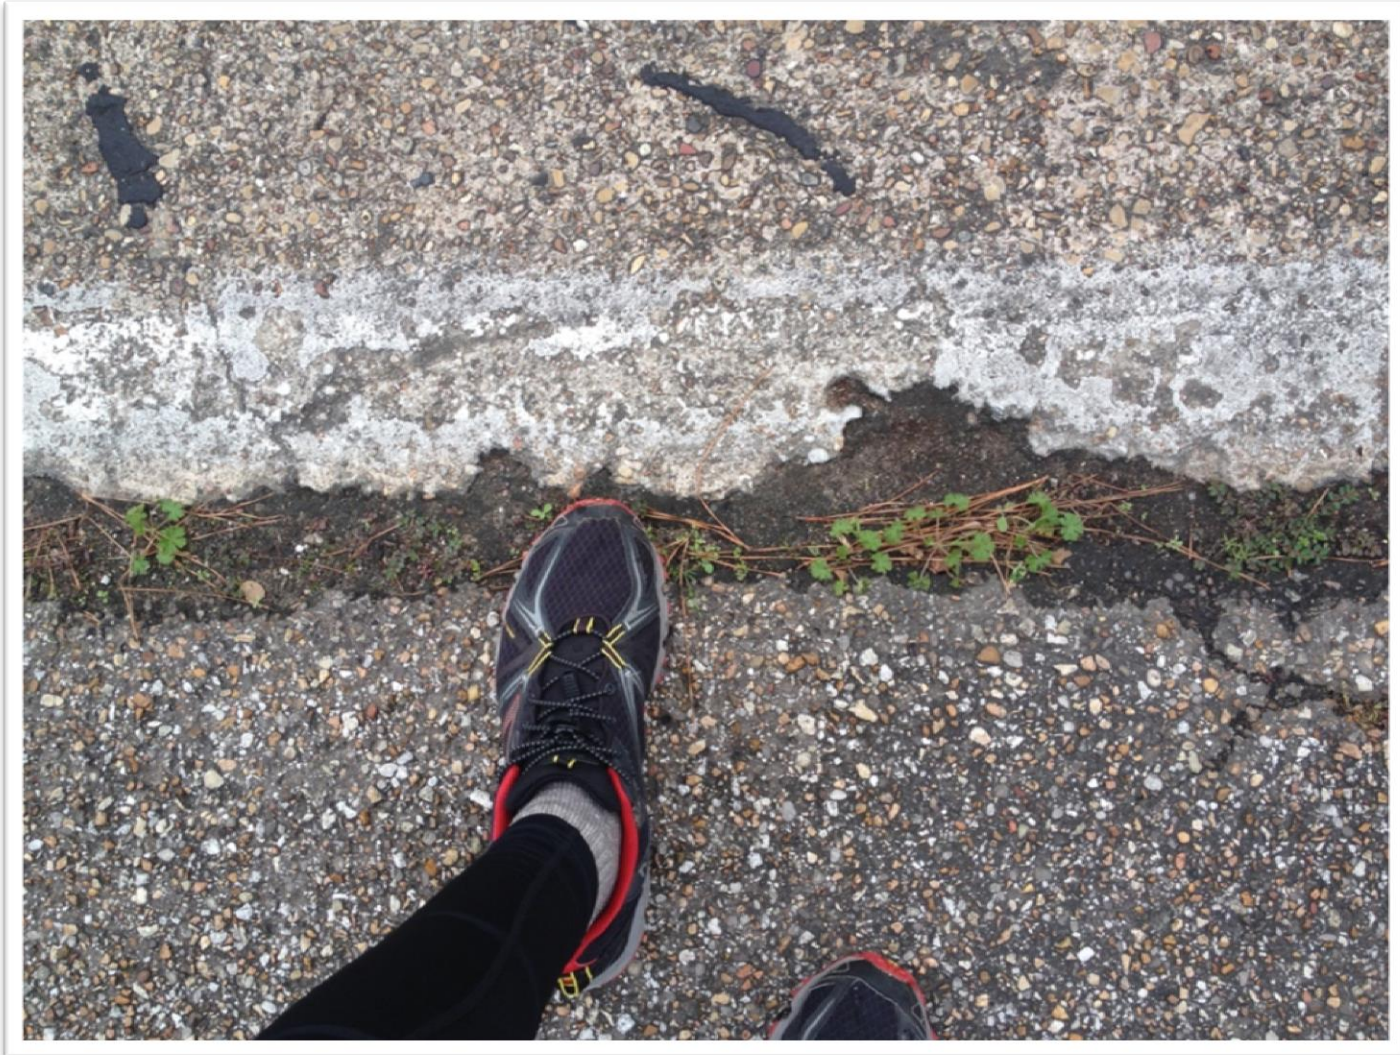
IMG_3607

Location WPC-14
West Panther Creek
Northbound

Hazard Type: Gap
Severity: 3

Close up of gap and poor road condition

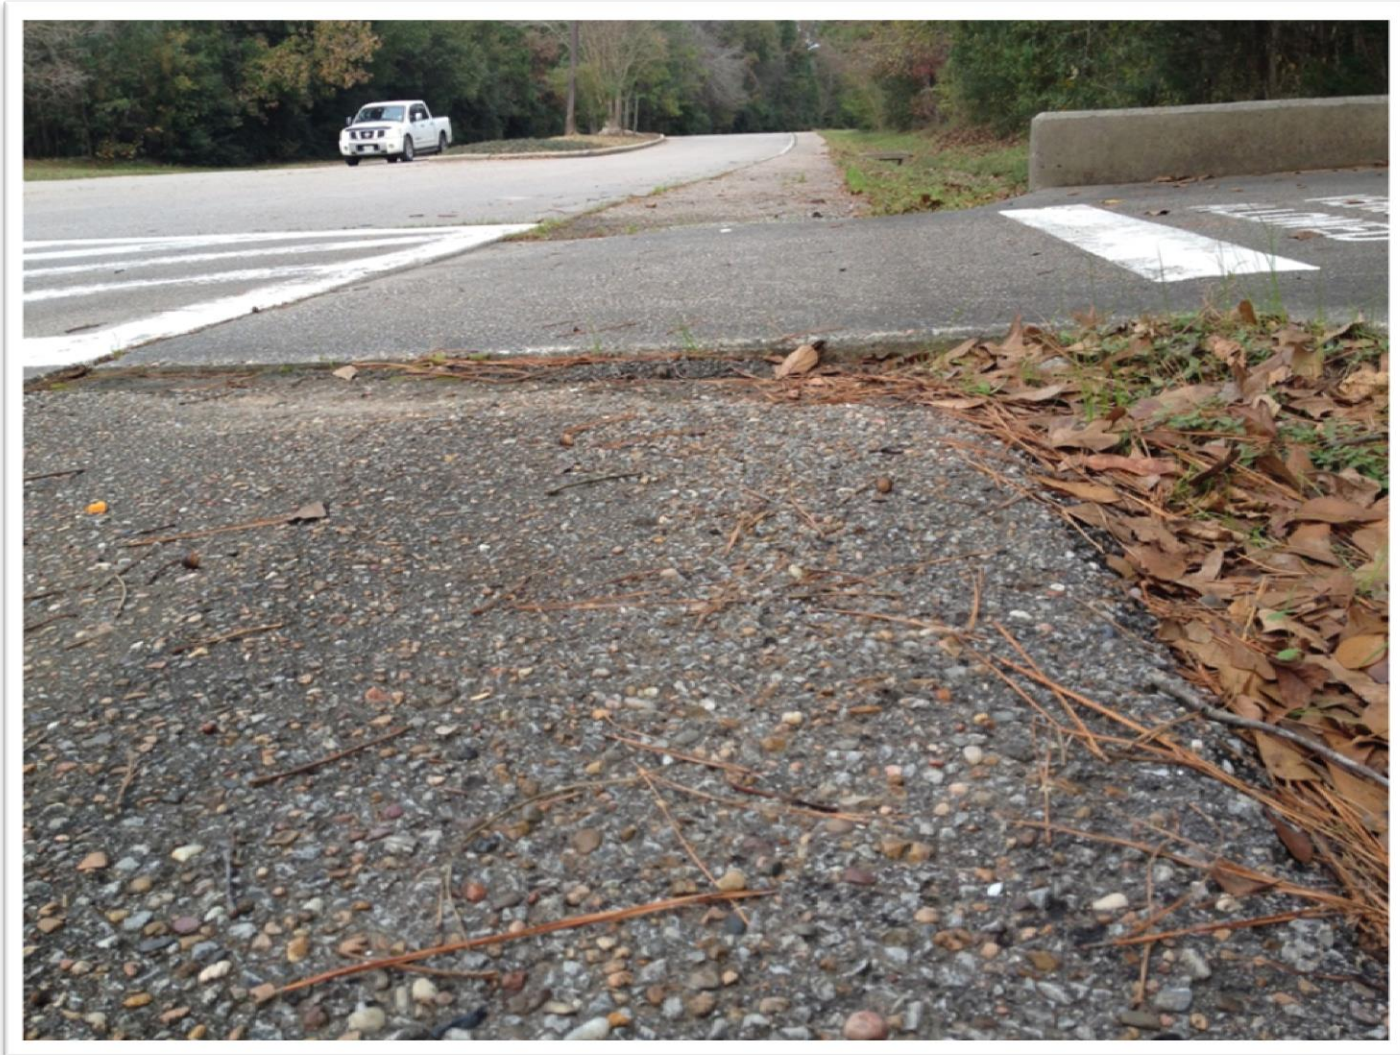
IMG_3608

Location WPC-15
West Panther Creek
Northbound

Hazard Type: Lip
Severity: 3

Lip of pathway crossing roughly 1/2 to 1 inch
high; at S. Mill Trace
