Road Shoulder Hazards along
West and North Panther Creek
January 2015

Hazards on road shoulders, that could pose a risk to cyclists, were identified in January 2015 by volunteers from Bike The Woodlands Coalition.

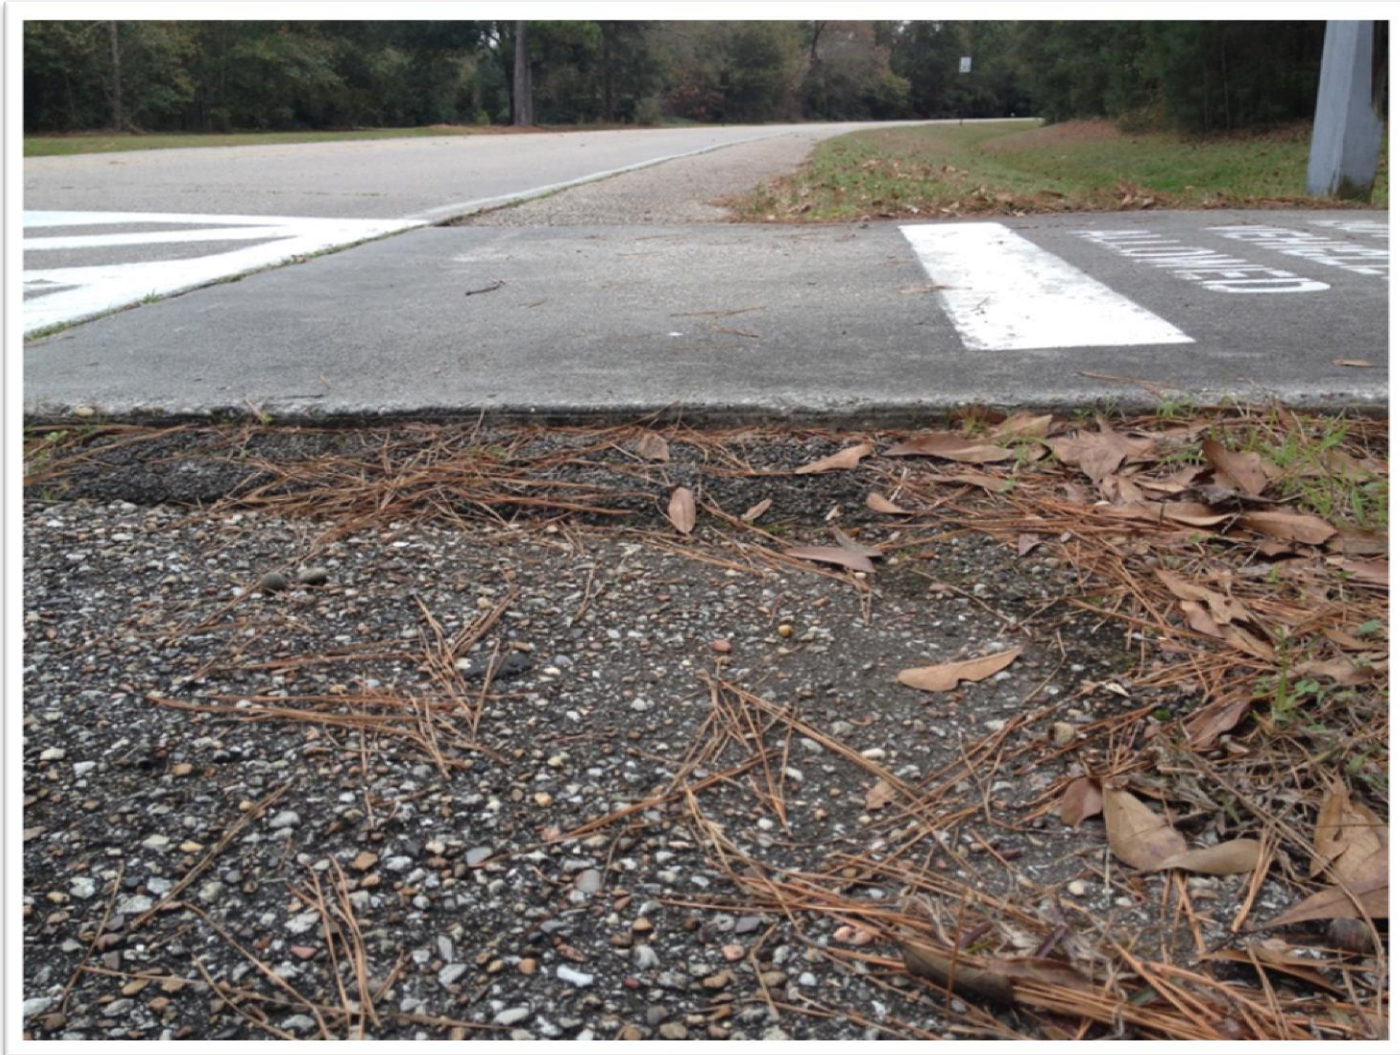
IMG_3610

Location WPC-16
West Panther Creek
Northbound

Hazard Type: Lip
Severity: 3

Lip of pathway crossing roughly 1" or more at
N. Mill Trace

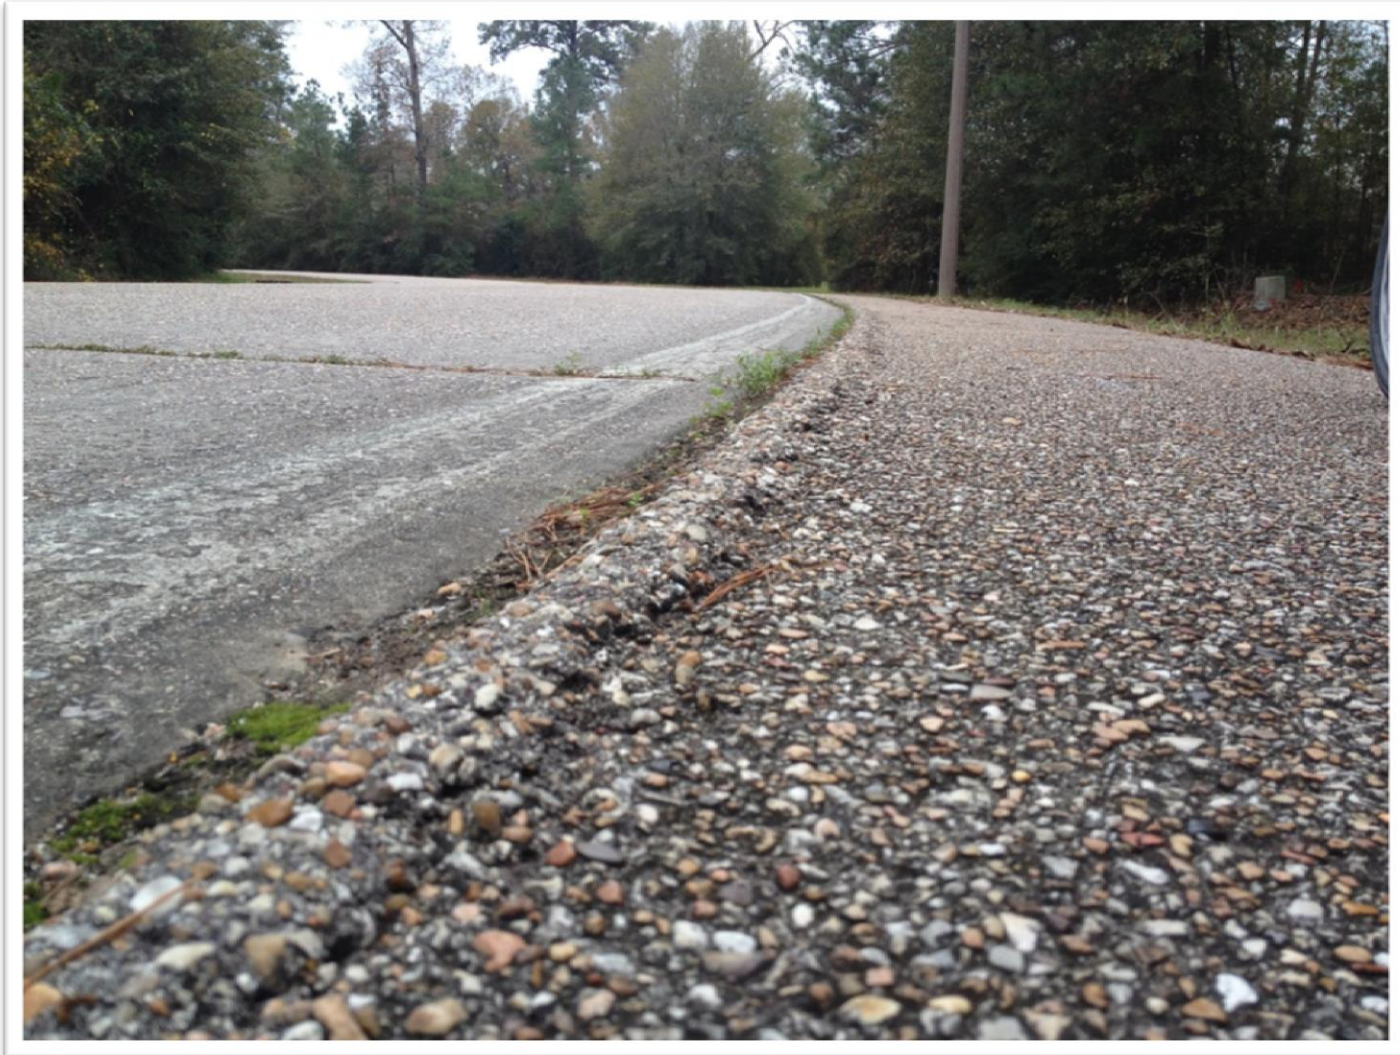
IMG_3612

Location NPC-1
North Panther Creek
Southbound

Hazard Type: Lip; rough area
Severity: 4
1 inch ridge on shoulder adjacent to wide gap
- a condition that exists on many locations on
WPC, NPC, and EPC.

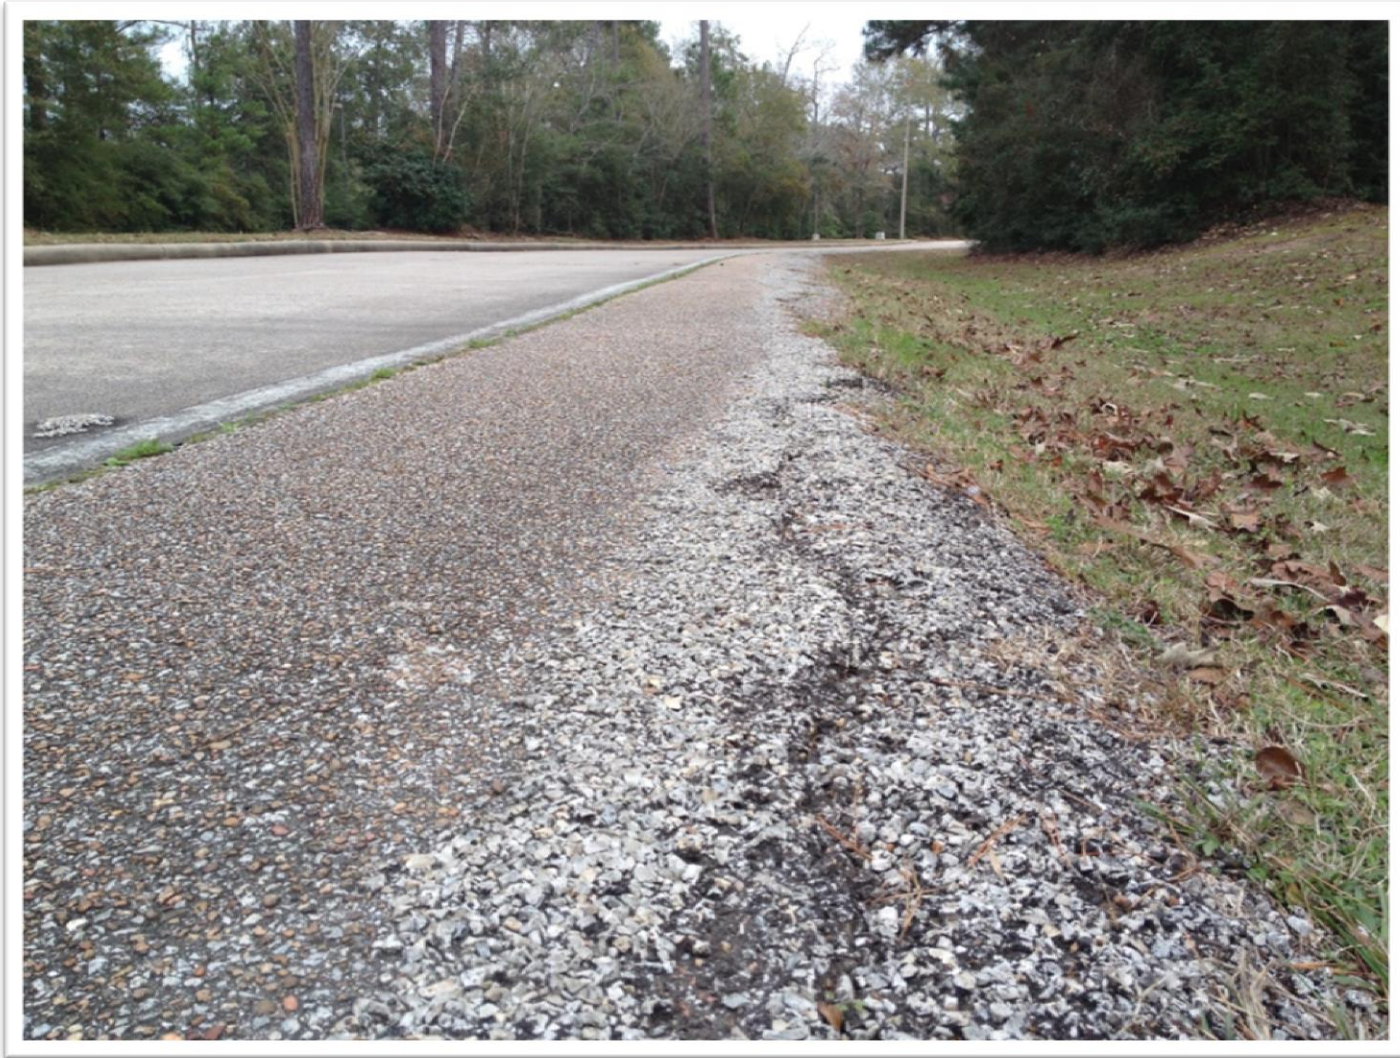
IMG_3615

Location NPC-2
North Panther Creek
Southbound

Hazard Type: Rough area
Severity: 2

Long strip of bad shoulder repairs; right side
collapsing into ditch

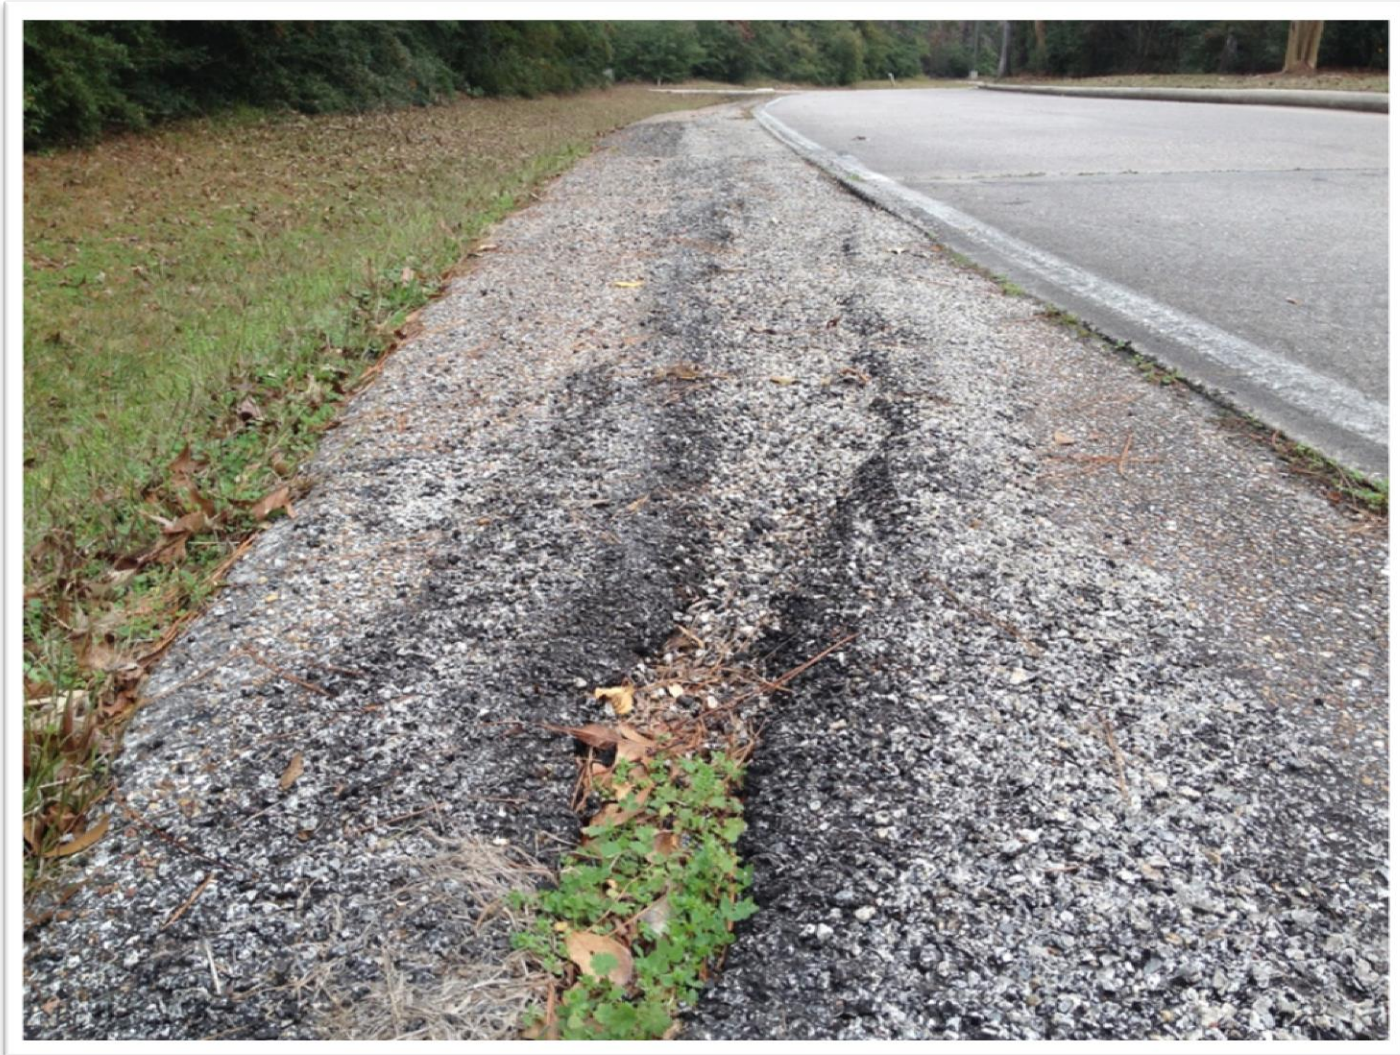
IMG_3621

Location NPC-4
Northbound

Hazard Type: Rough area
Severity: 3

Long stretch of rough, poorly repaired
shoulder with linear cracks

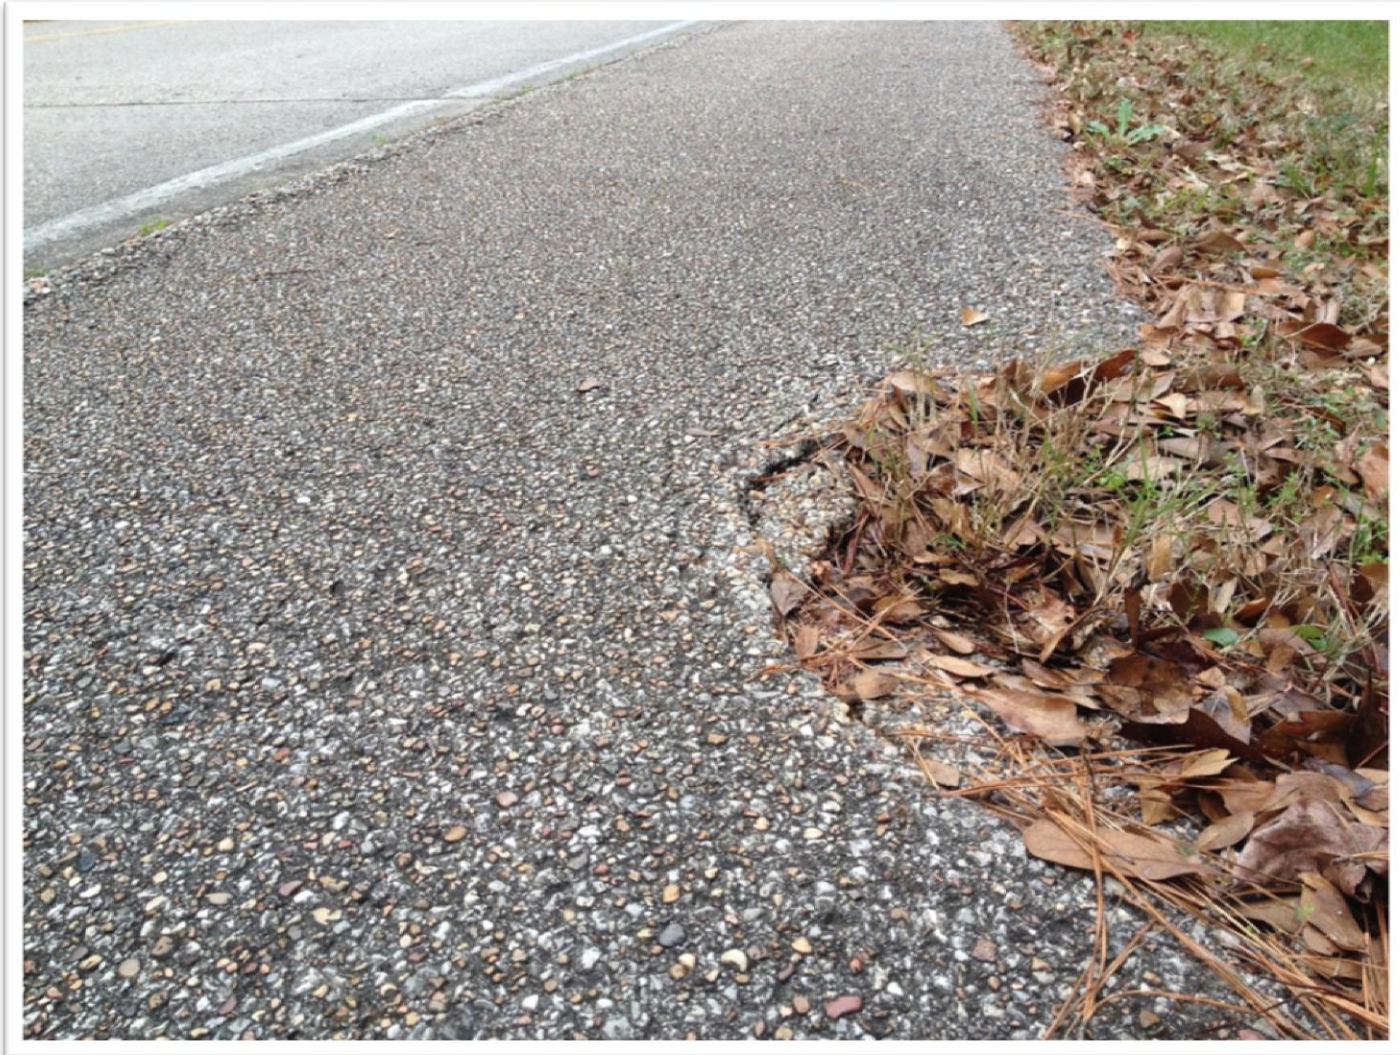
IMG_3624

Location NPC-5
North Panther Creek
Northbound

Hazard Type: Pothole
Severity: 3

Several of these spots of broken pavement
edge in this area
