bikethewoodlands.org

Road Shoulder Hazards in The Woodlands – January 2015

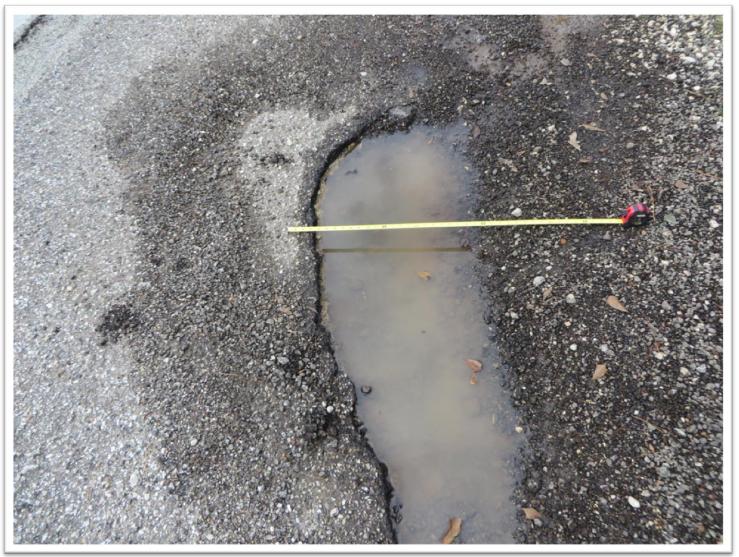
IMG_0772

LW-7 Lake Woodlands Westbound Hazard type: Pothole Severity: 4 Serious pothole

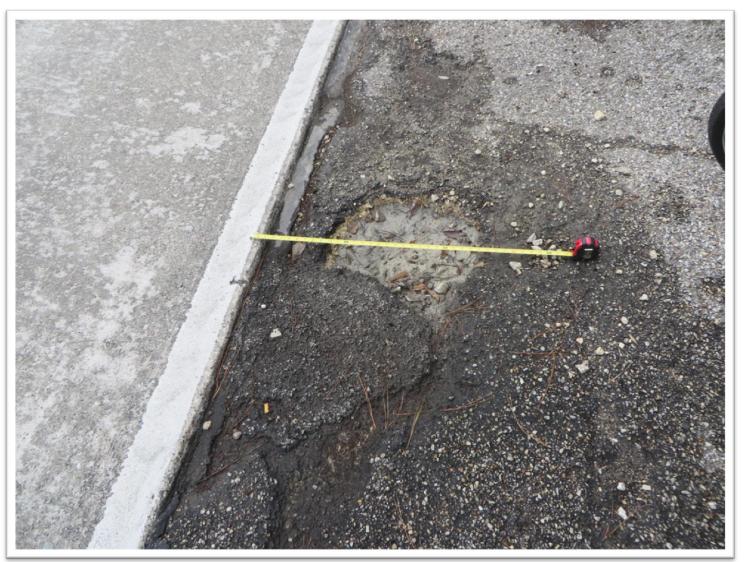
LW-15 Lake Woodlands Westbound Hazard type: Rough area and Pothole Severity: 3

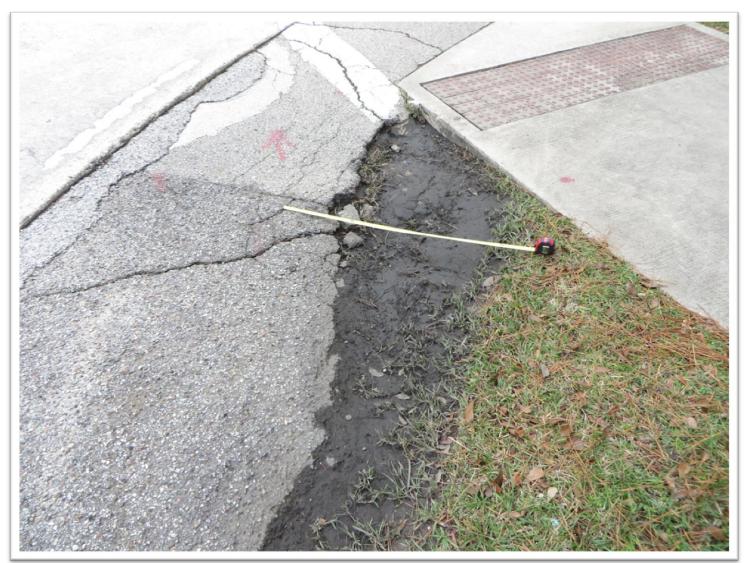
LW-20 Lake Woodlands Eastbound

Hazard type: Rough area Severity: 3 Shoulder deterioration leading to narrower-thanexpected shoulder.

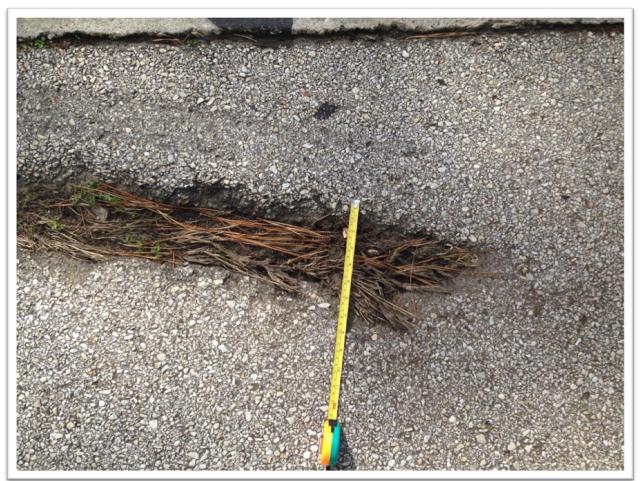
Location WP 6 Woodlands Pkwy Eastbound Hazard Type: Pothole Severity: 2 6" wide gouge in the shoulder over 4 feet long which cyclists tire could get stuck in and cause bike to fall. Unlike Flintridge, Shoulder is wider on this stretch of and cyclists are able to ride to the right of the damaged shoulder comfortably if they see the pot hole in time.

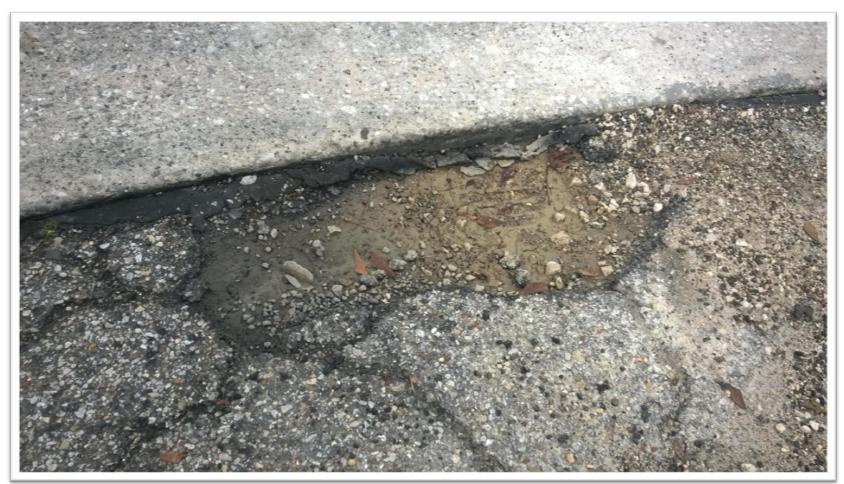
WP_20141230_012

Location Sh-13 Shadowbend Northbound

Hazard Type: Pothole Severity: 4 3.5" drop from road surface to shoulder at intersection with LW Photo 1

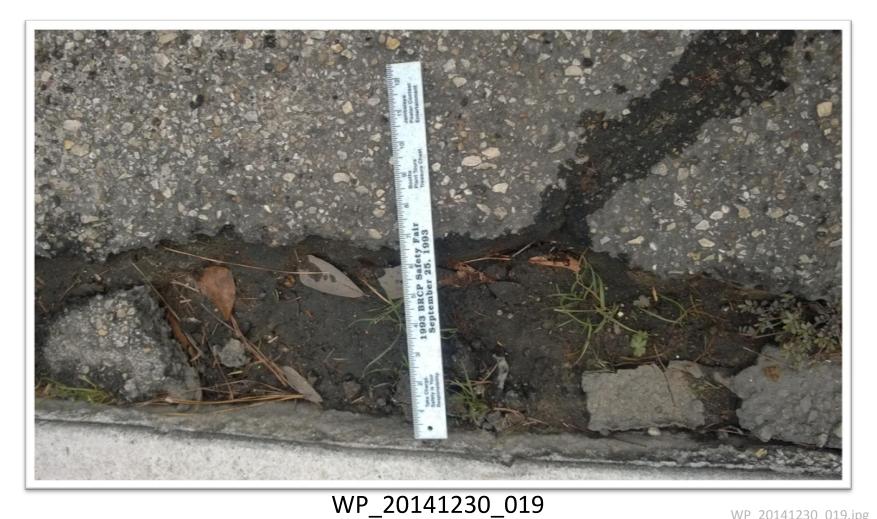
Location Sh-20 Shadowbend Northbound

Hazard Type: Lip Severity: 3

Eroded Section from Roadway 1.5" deep-Photo 1

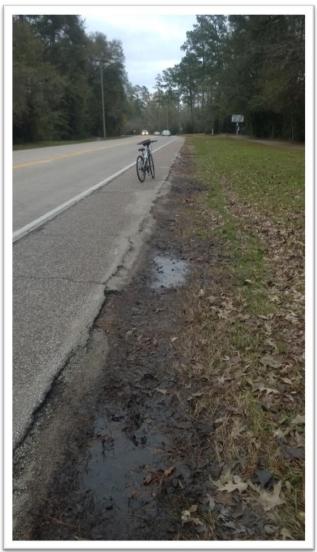
WP_20141230_022

Location Sh-22 Shadowbend Northbound Hazard Type: Maint. Severity: 2 Degraded shoulder edge due to car parking near Collins Intermediate School

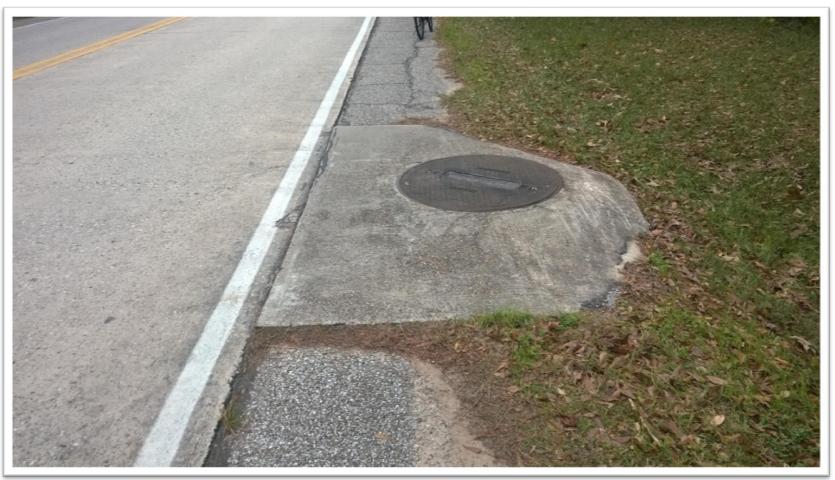
WP_20141230_027

Location Sh-27 Shadowbend Southbound Hazard Type: Other Severity: 2 Sewer Structure 1" above shoulder

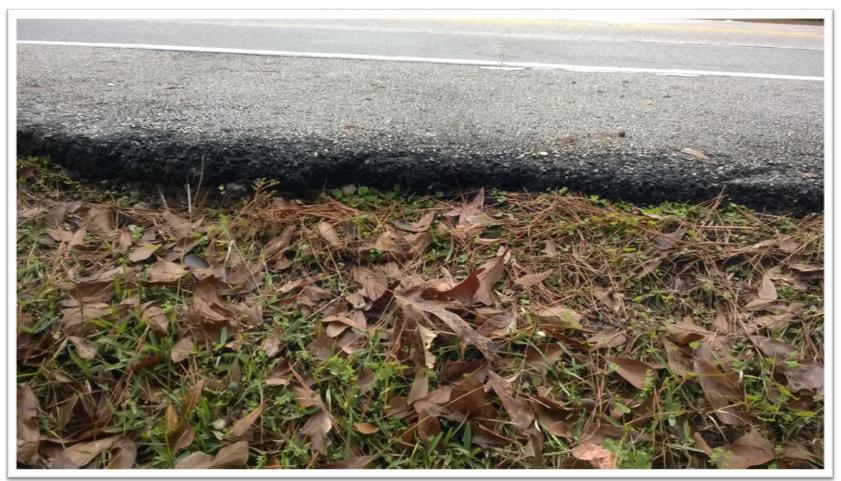
WP_20141230_001

Location Sh-31a Shadowbend Southbound Hazard Type: Other Severity: 2 Degraded Edge near Intersection with LW

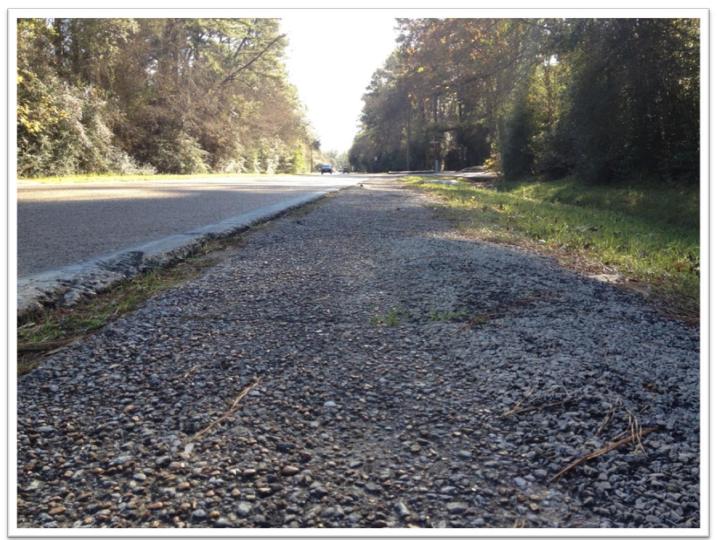
IMG_3651

Location WPC-3 West Panther Creek Southbound Hazard Type: Rough area; lip Severity: 4 Poorly repaired shoulder over more than 50 feet coupled with gap and 2 inch lip

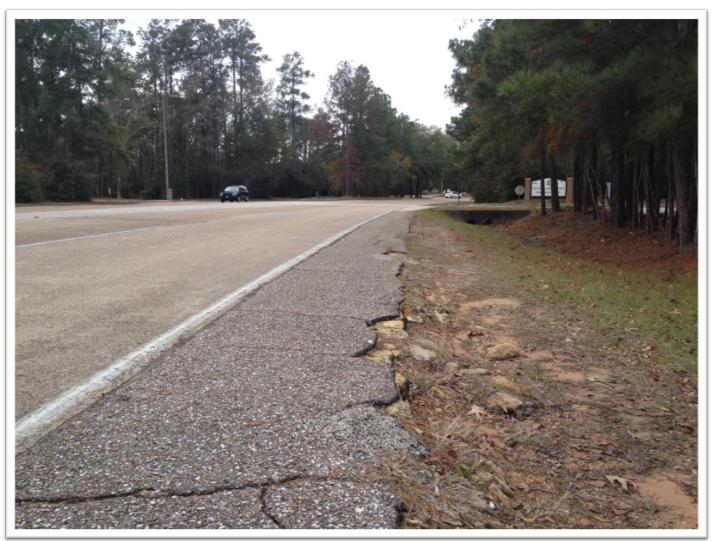
Location WPC-5 West Panther Creek Southbound Hazard Type: Rough area Crumbled shoulder with exposed large rocks Severity: 3

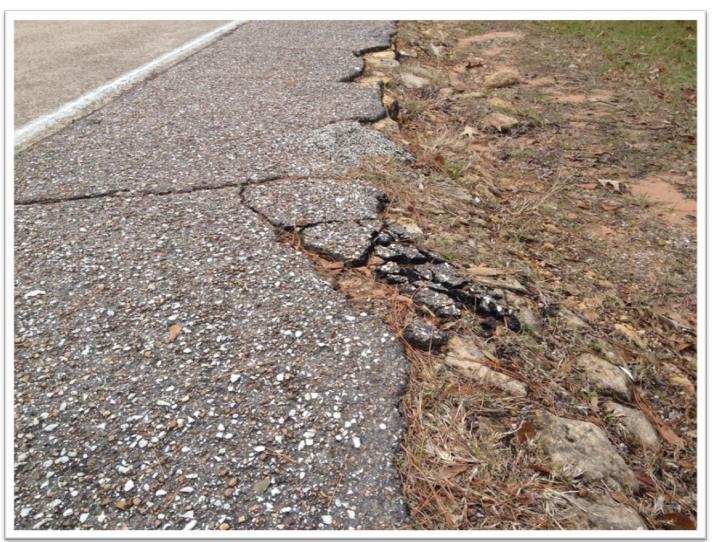
Location WPC-6 West Panther Creek Southbound Hazard Type: Rough area Close up of IMG3588 shoulder area Severity: 3

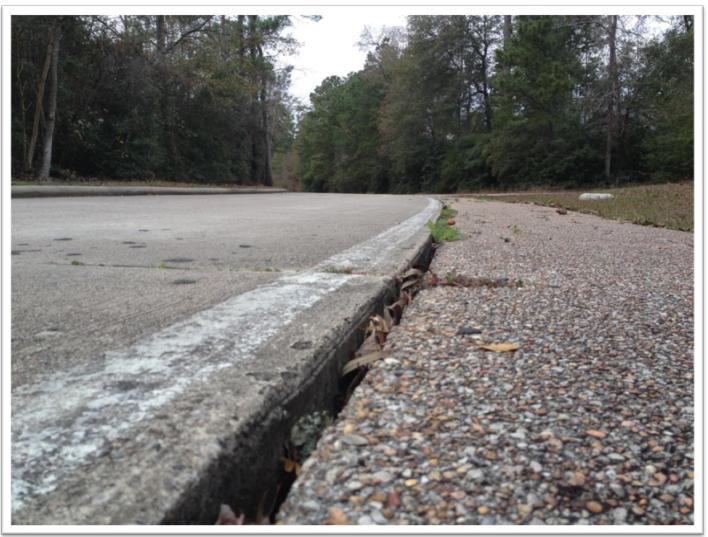
Location NPC-3 North Panther Creek Northbound Hazard Type: Gap; Lip Severity: 4 Large, deep gap 15 to 20 feet in legnth
