Road Shoulder Hazards along  
Flintridge– January 2015

Hazards on road shoulders, that could pose a risk to cyclists, were identified in January 2015 by volunteers from Bike The Woodlands Coalition.

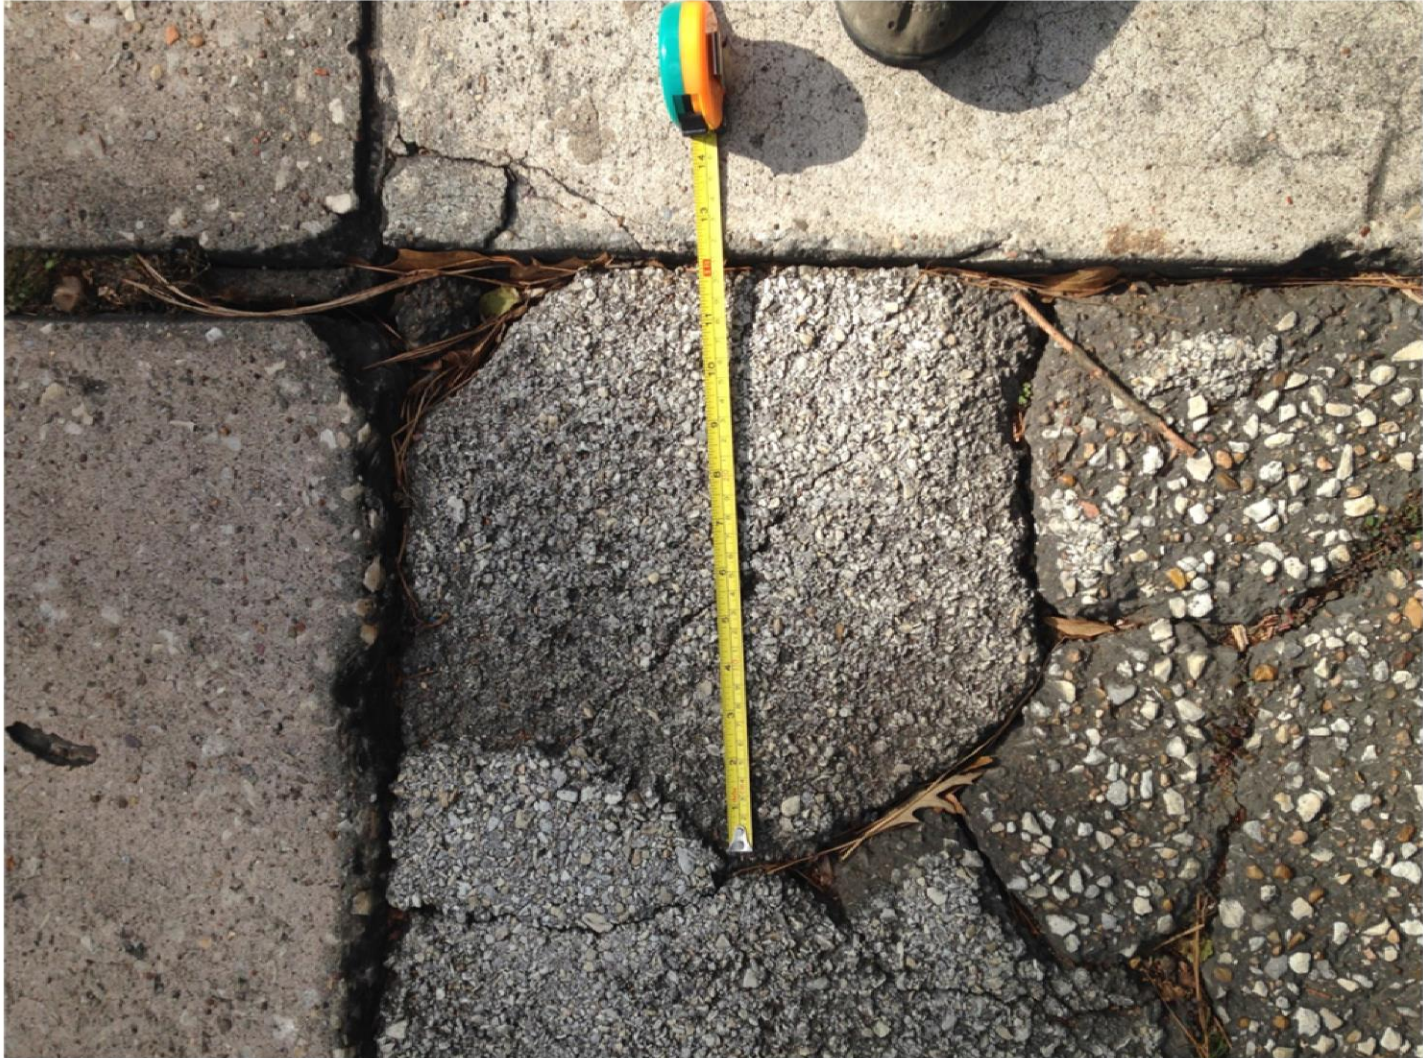
Location FR 1  
Flintridge  
Eastbound

Hazard Type: Rough area    12" cracked and uneven shoulder section  
Severity: 3

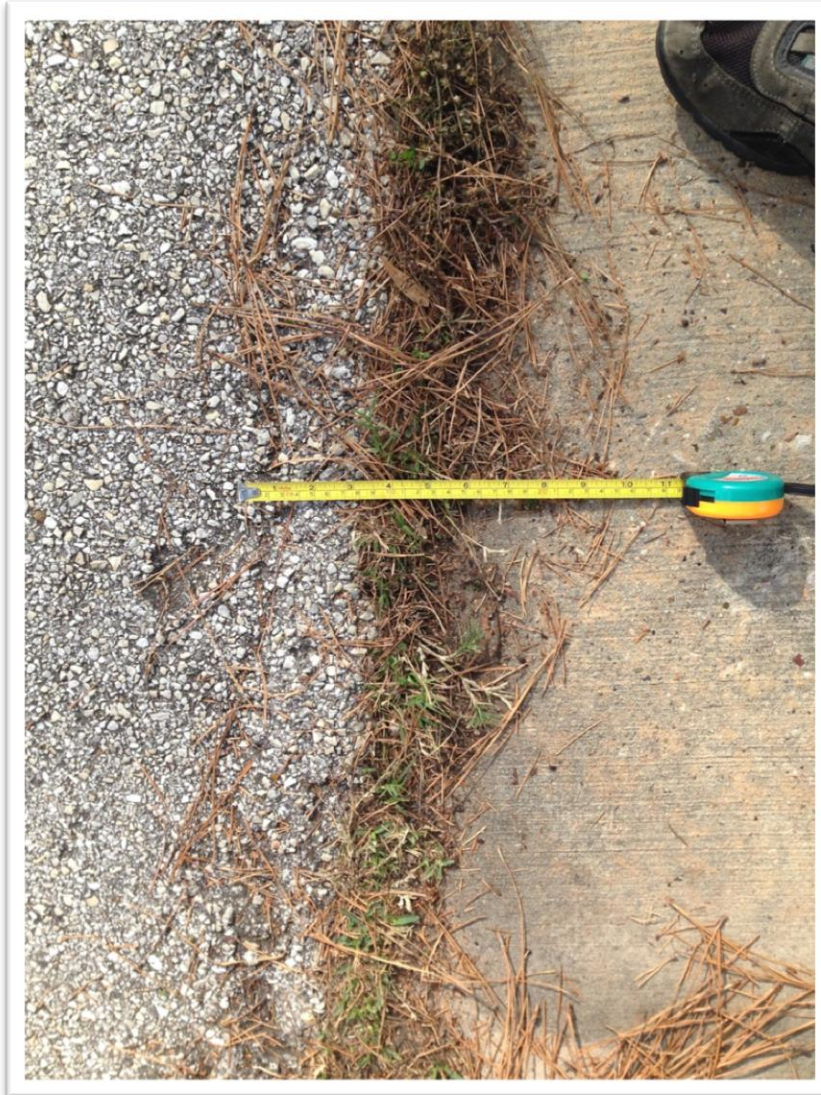
Location FR 2  
Flintridge  
Eastbound and Westbound

Hazard Type: Lip and Crack  
Severity: 4

east and west bound from Gosling to Lake Woodlands. The shoulder has dropped below the height of the road by 1-2" and has also separated causing cracks to open up of over 2". The danger comes with the shoulder on being narrower (4') which causes cyclists to ride closer to the road side of the shoulder which increases the risk of the tire either wing caught in the crack or hitting the lip and causing the cyclist to fall. When the shoulders are wider (8'), the cyclists is more prone to ride in the middle of the shoulder and less likely to hit the cracks or road lips. The photos attached are examples of the cracks and lips along Flintridge. These cracks and lips are especially dangerous to the cyclist when the need arises to avoid a curb jut out and move to the road.

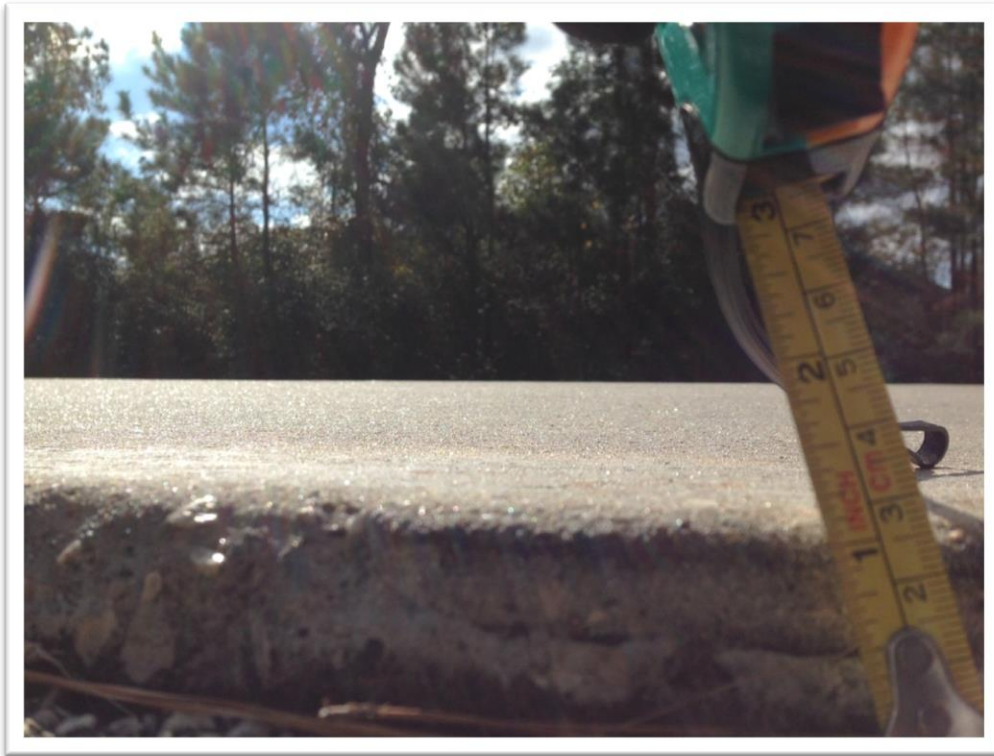
Location FR 7  
Flintridge  
Eastbound and Westbound

Hazard Type: Lip and Crack  
Severity: 4

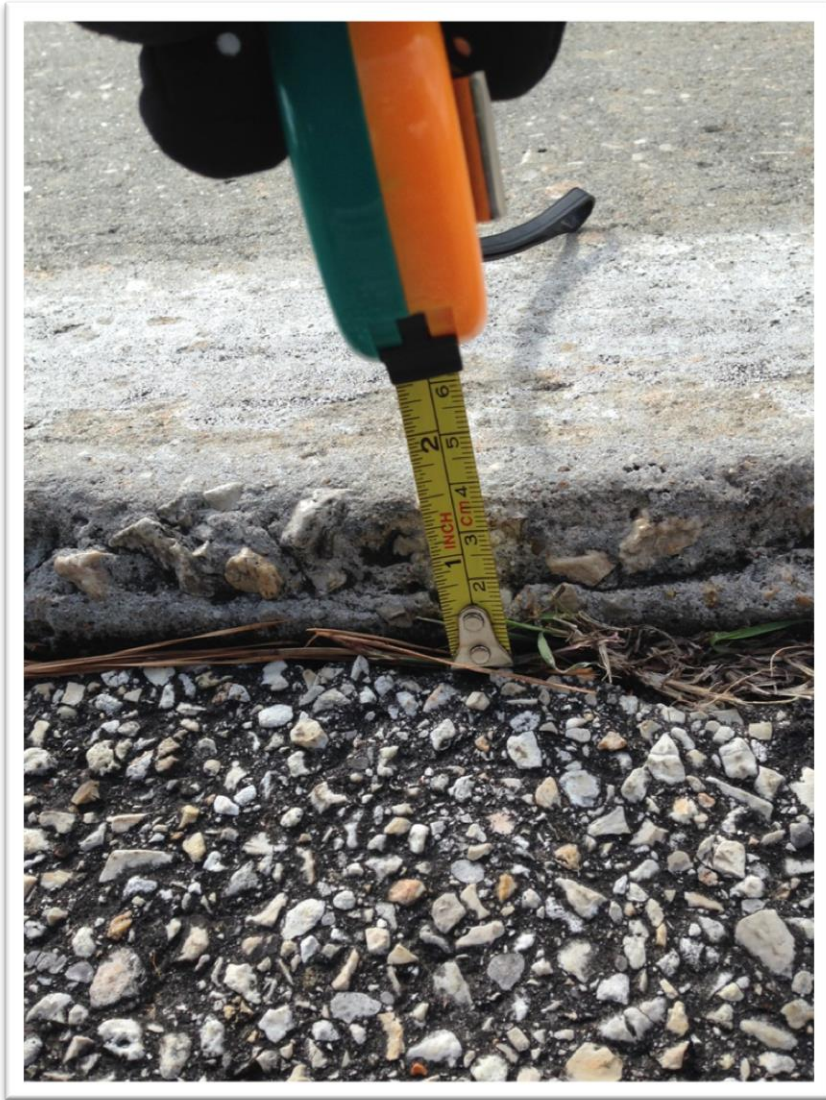
Location FR 8  
Flintridge  
Eastbound and Westbound

Hazard Type: Lip and Crack  
Severity: 4

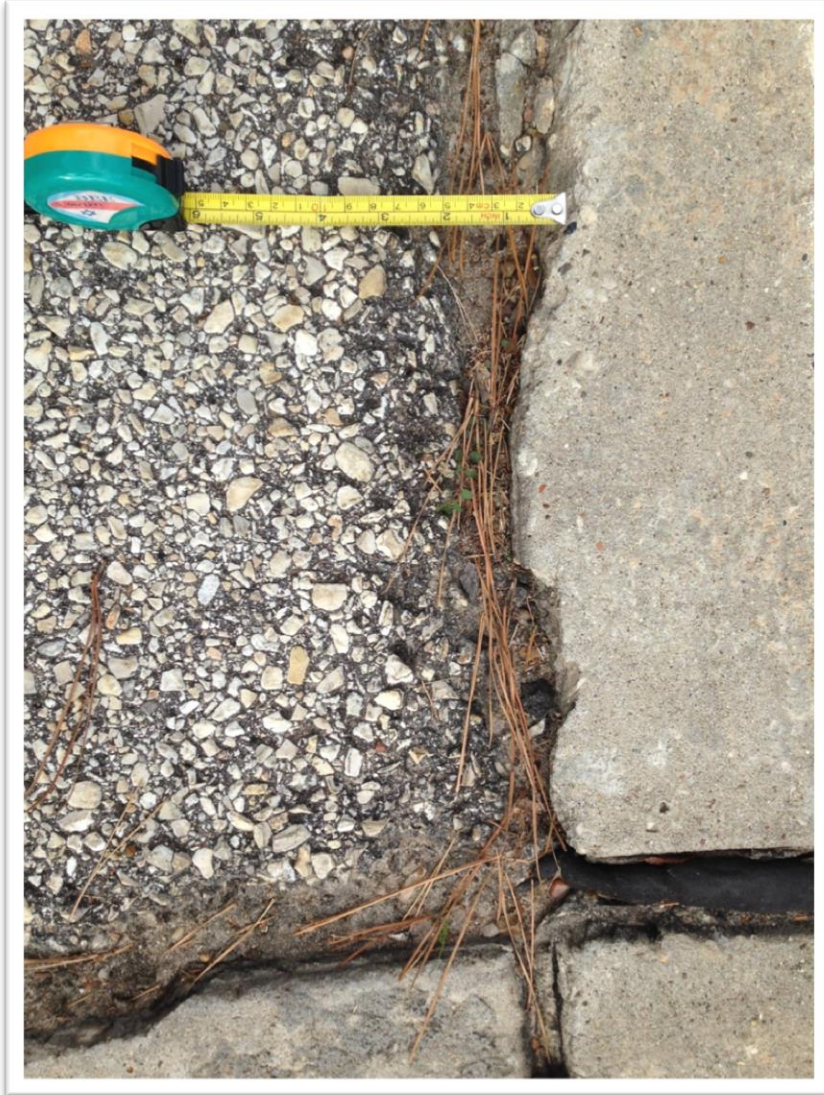
Location FR 9  
Flintridge  
Eastbound and Westbound

Hazard Type: Lip and Crack  
Severity: 4

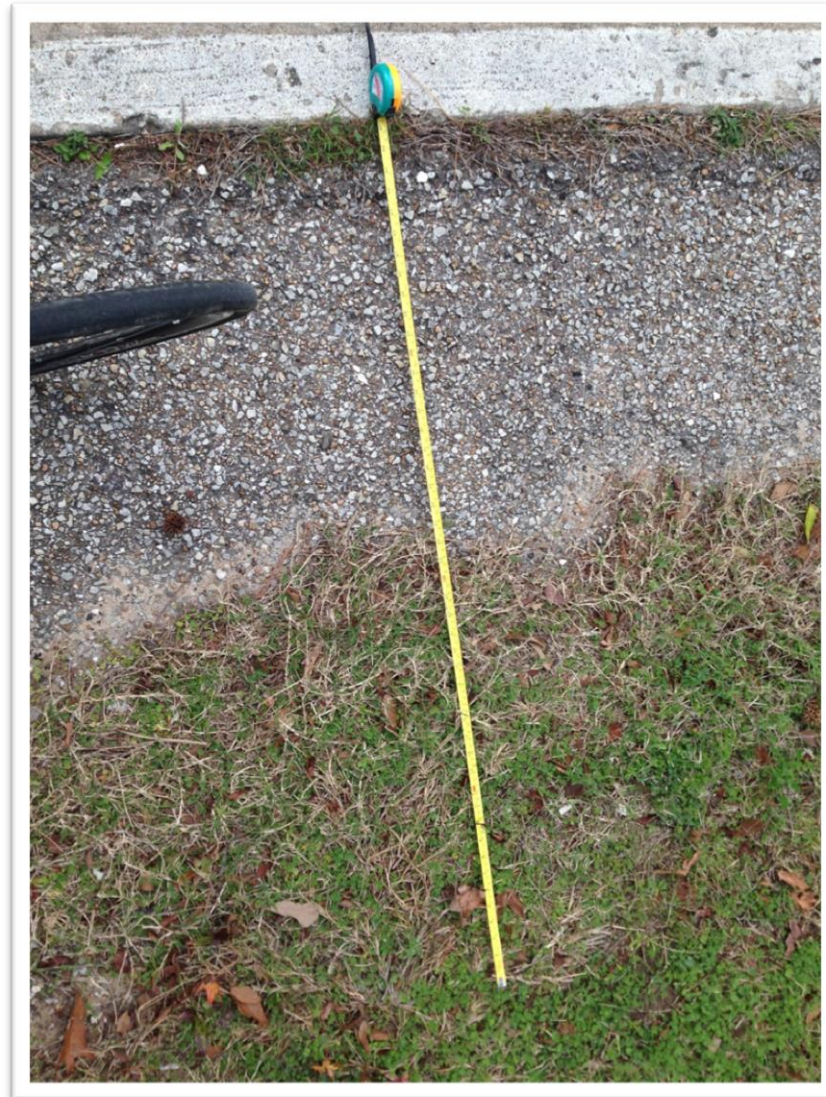
Location FR 3  
Flintridge  
Eastbound

Hazard Type: Other  
Severity: 4

what is normally a 4 foot shoulder has been  
cut in half by over 2 feet of overgrown  
weeds/grass/sand

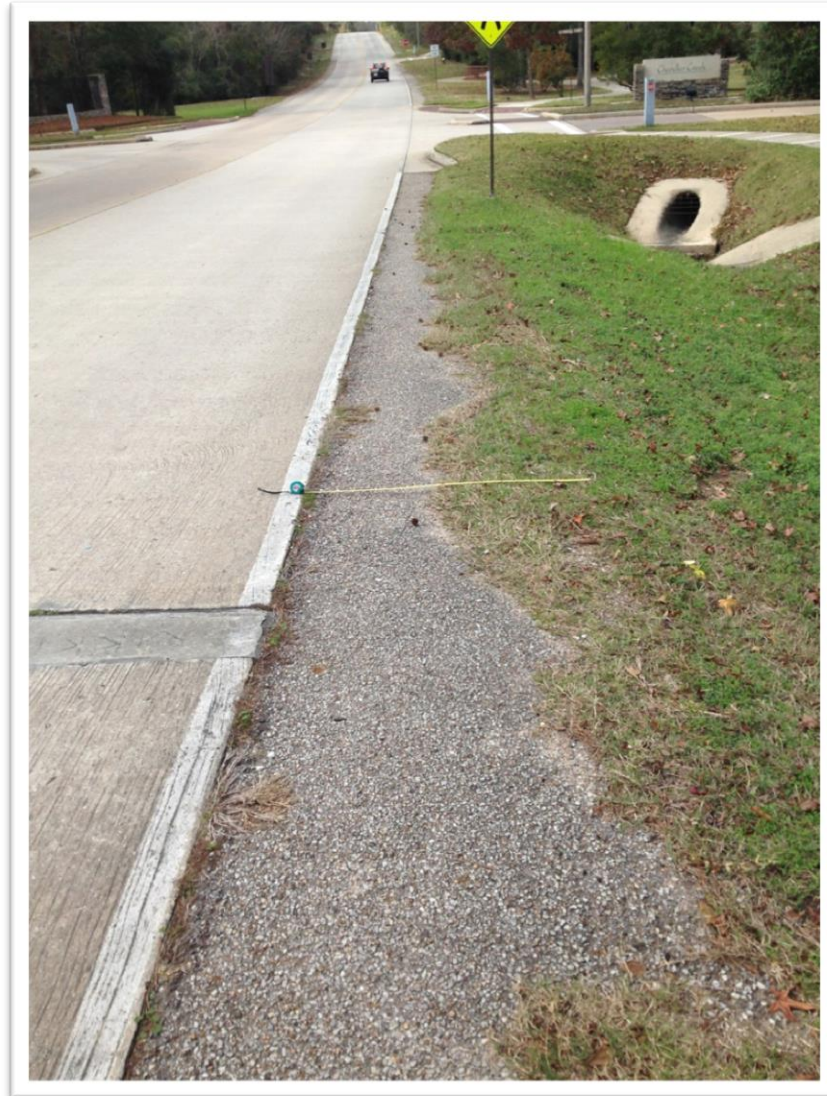
Location FR 4  
Flintridge  
Eastbound

Hazard Type: Other  
Severity: 4

what is normally a 4 foot shoulder has been  
cut in half by over 2 feet of overgrown  
weeds/grass/sand

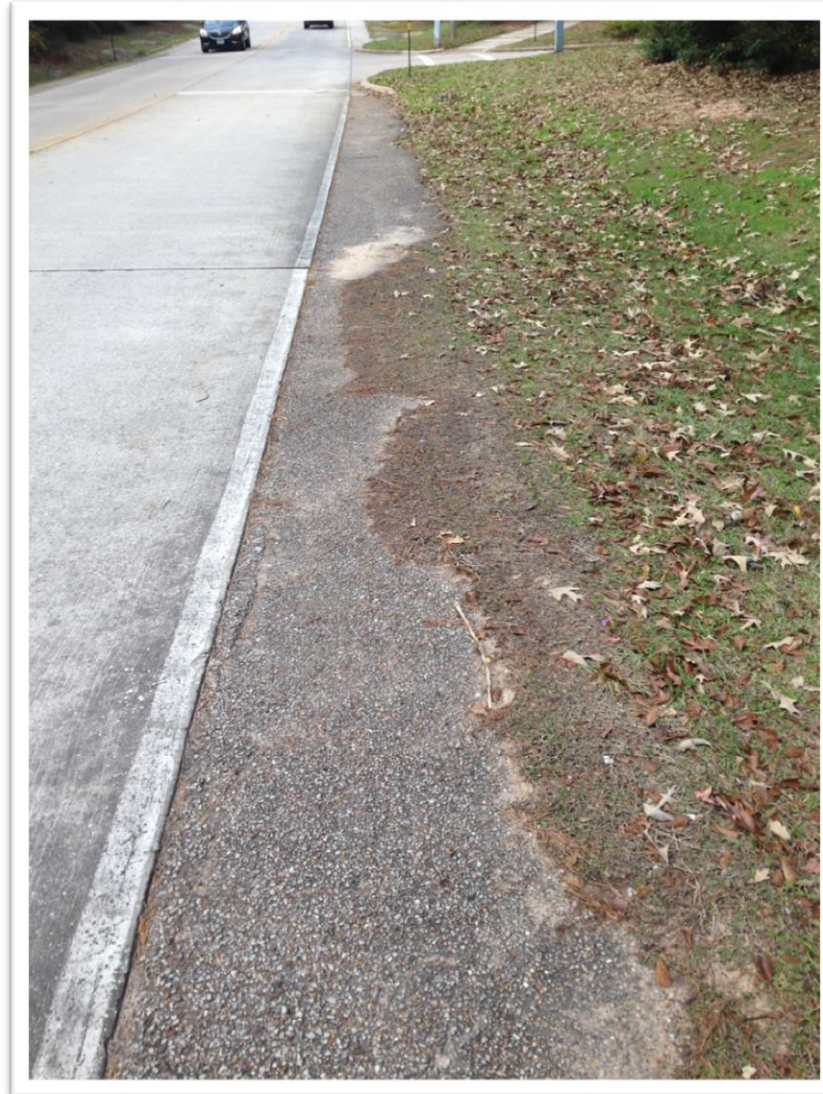
Location FR 5  
Flintridge  
Eastbound

Hazard Type: Other  
Severity: 4

what is normally a 4 foot shoulder has been  
cut in half by over 2 feet of overgrown  
weeds/grass/sand

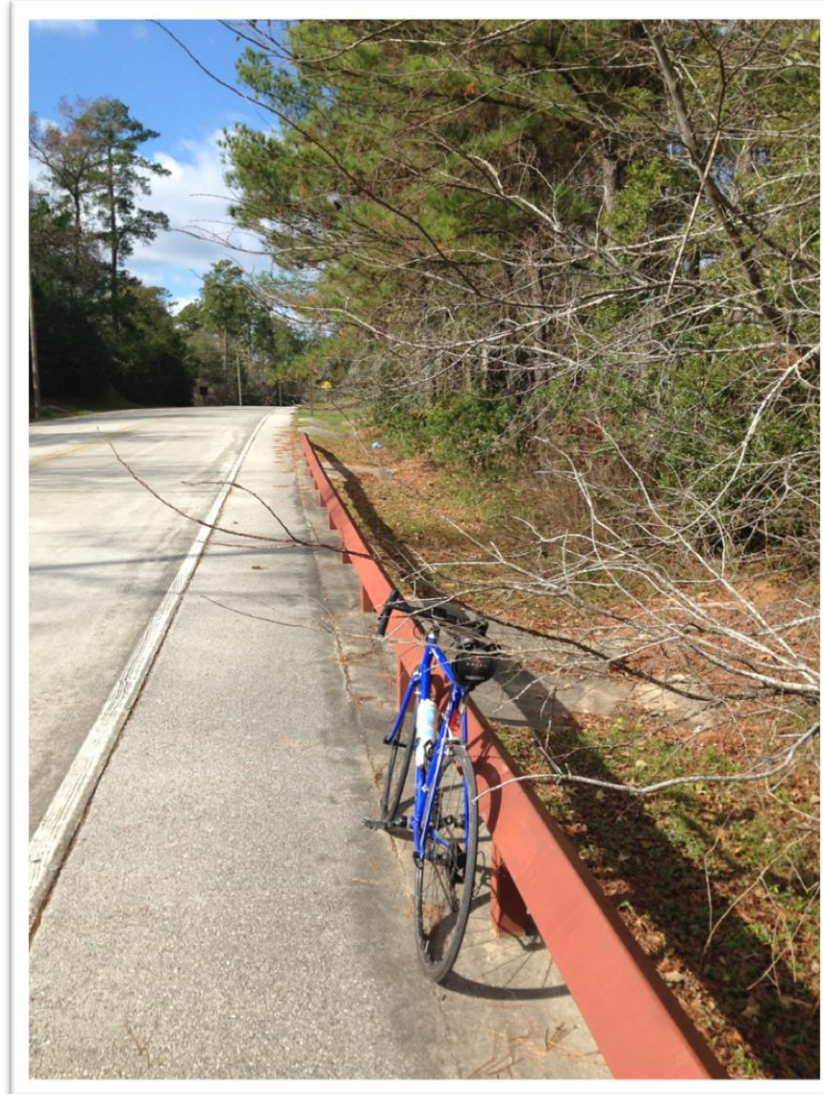
Location FR 6  
Flintridge  
Eastbound

Hazard Type: Other  
Severity: 2

East - several tree branches protrude into shoulder which can hit a cyclist while riding on the shoulder causing the cyclist to fall or get scratched/poked by branches.

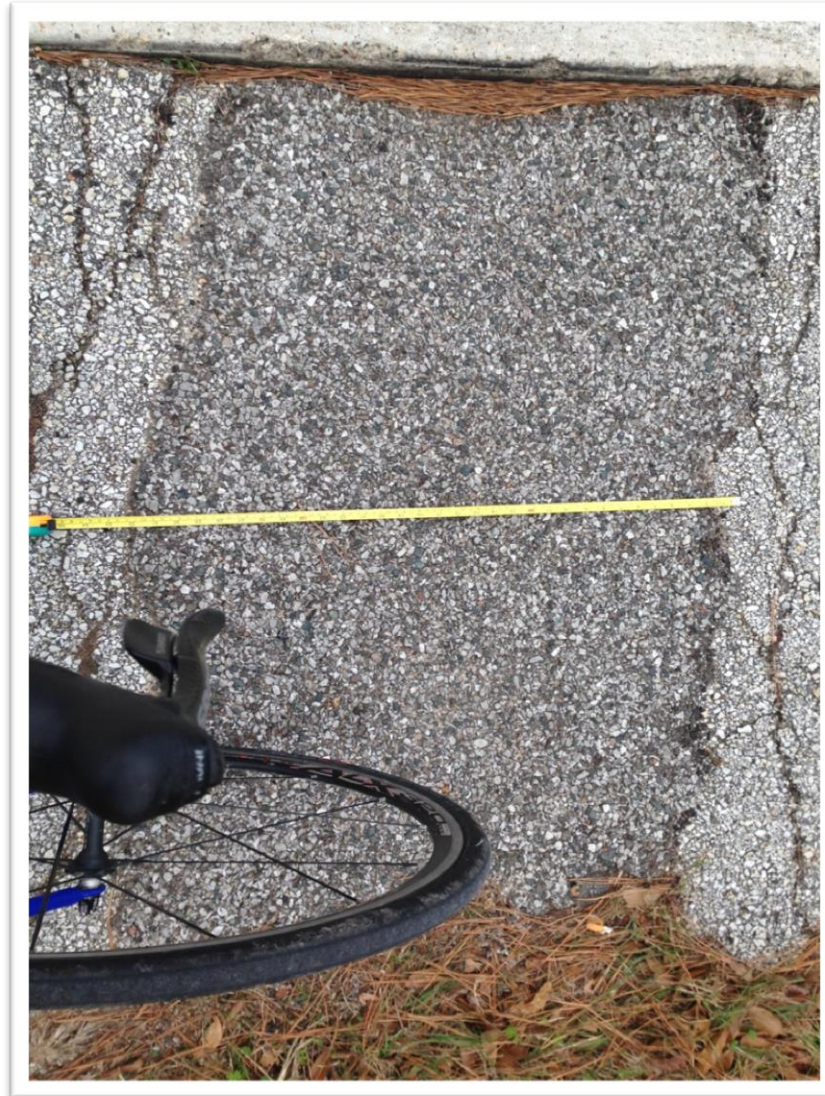
Location FR 10  
Flintridge  
Westbound

Hazard Type: Rough area  
Severity: 3

rough shoulder and big dip in road. Also notice the large lip between the shoulder and road.

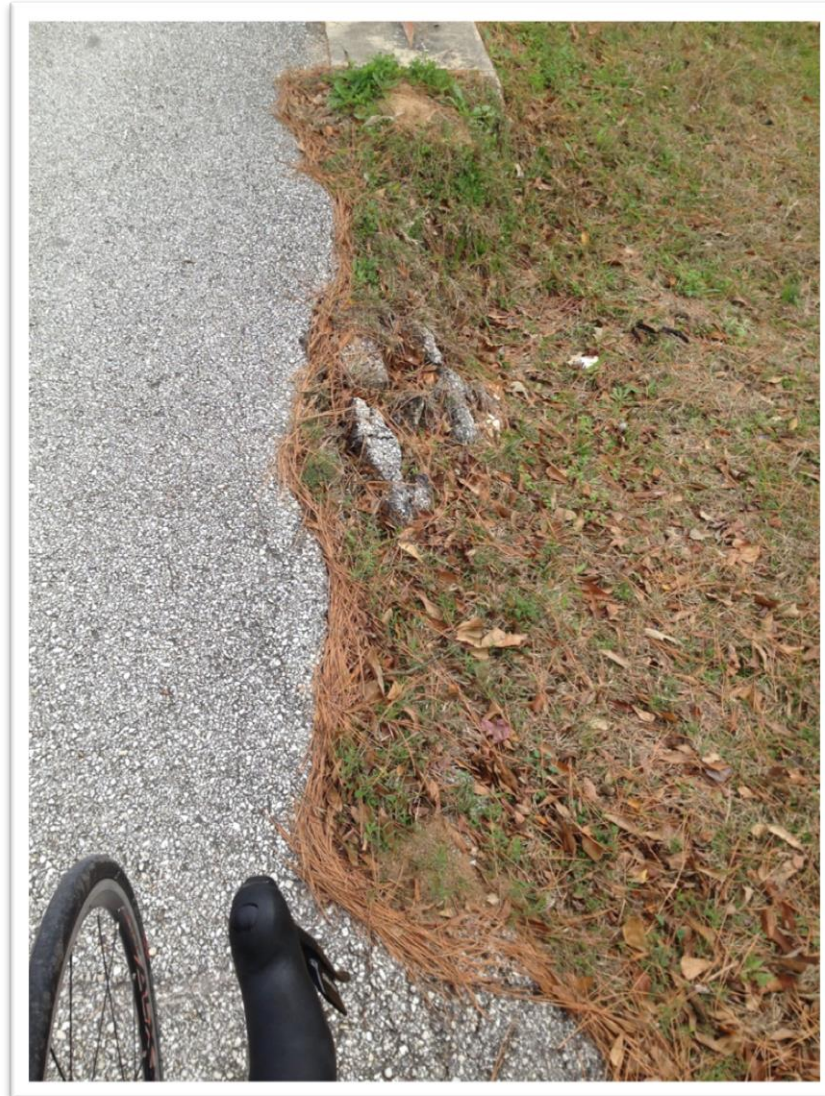
Location FR 11  
Flintridge  
Westbound

Hazard Type: Pothole  
Severity: 3

2 feet of shoulder has eroded into the side of  
the raven, reducing the overall width of the  
shoulder in half.

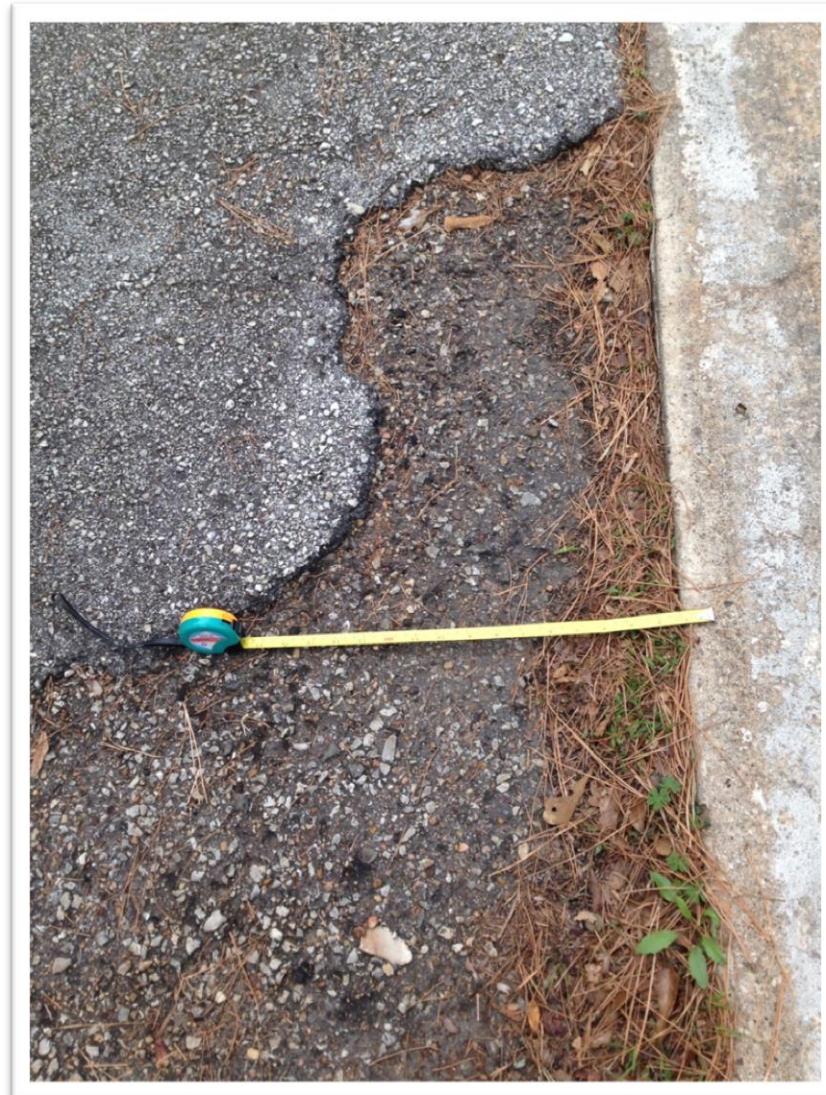
Location FR 12  
Flintridge  
Westbound

Hazard Type: Rough area  
Severity: 2

cracked rough shoulder 2 feet across (half of  
shoulder damaged)

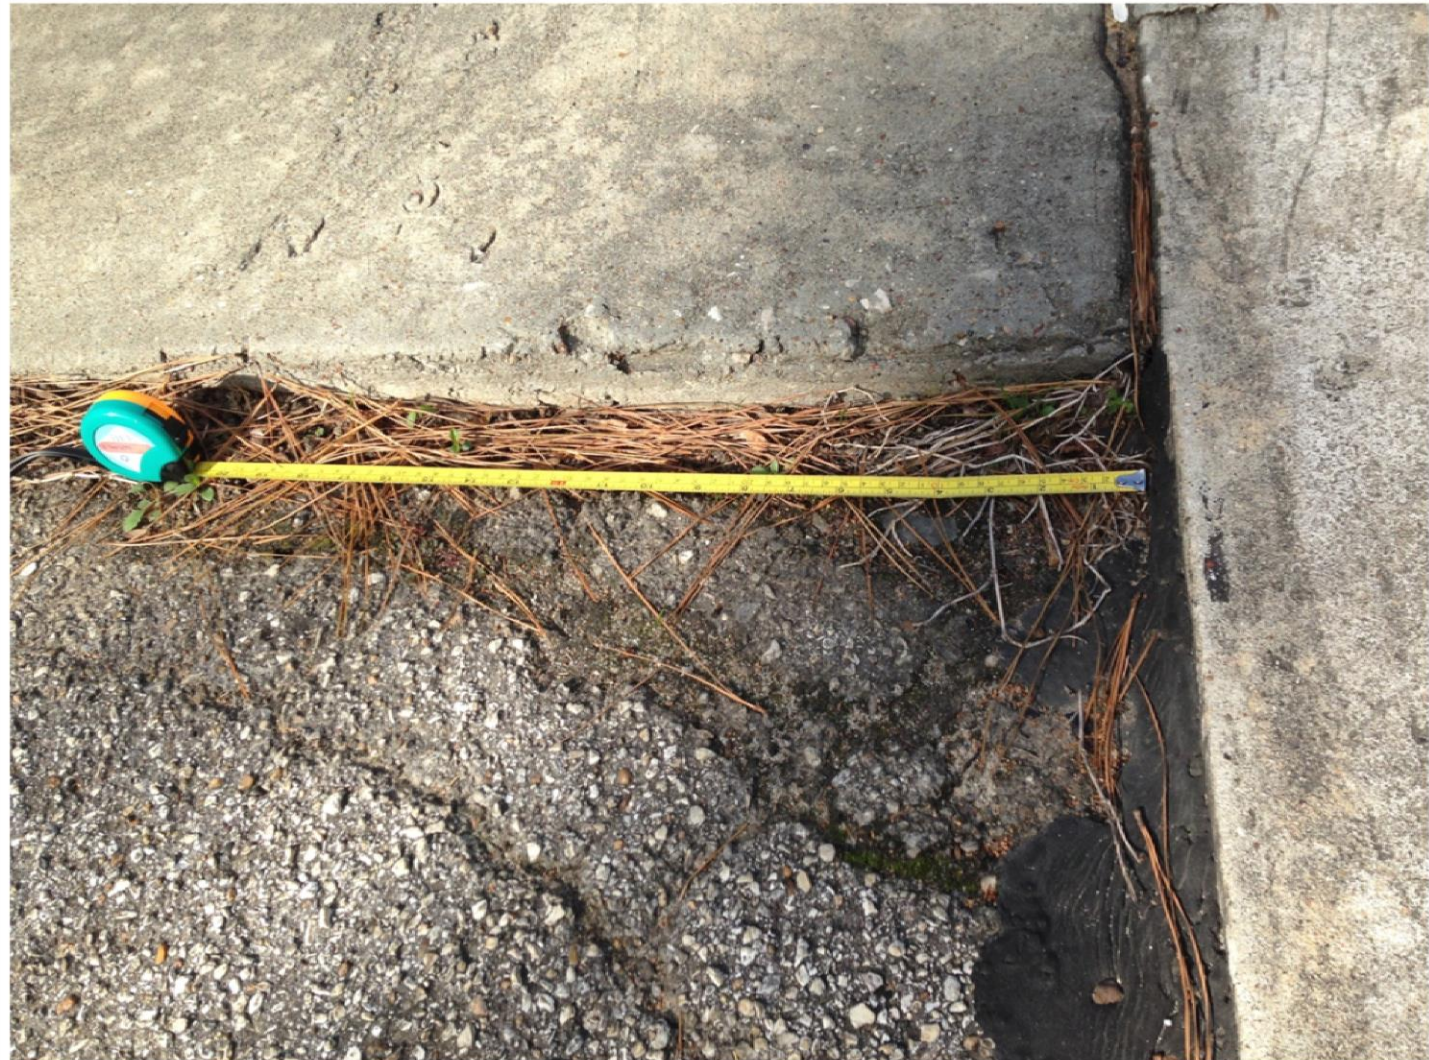
Location FR 13  
Flintridge  
Westbound

Hazard Type: Lip and Crack 2 feet of shoulder hits 2" lip with front tire  
Severity: 3 going west bound

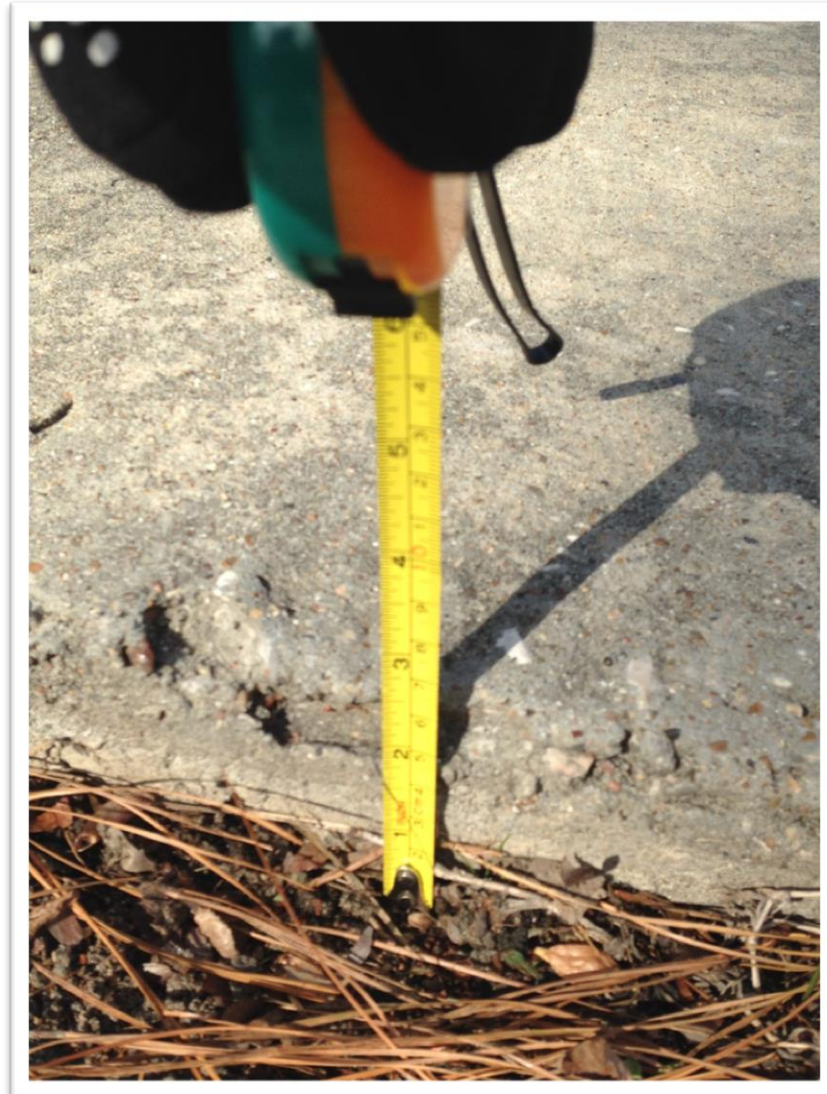
Location FR 14  
Flintridge  
Westbound

Hazard Type: Lip and Crack 2 feet of shoulder hits 2" lip with front tire  
Severity: 3 going west bound

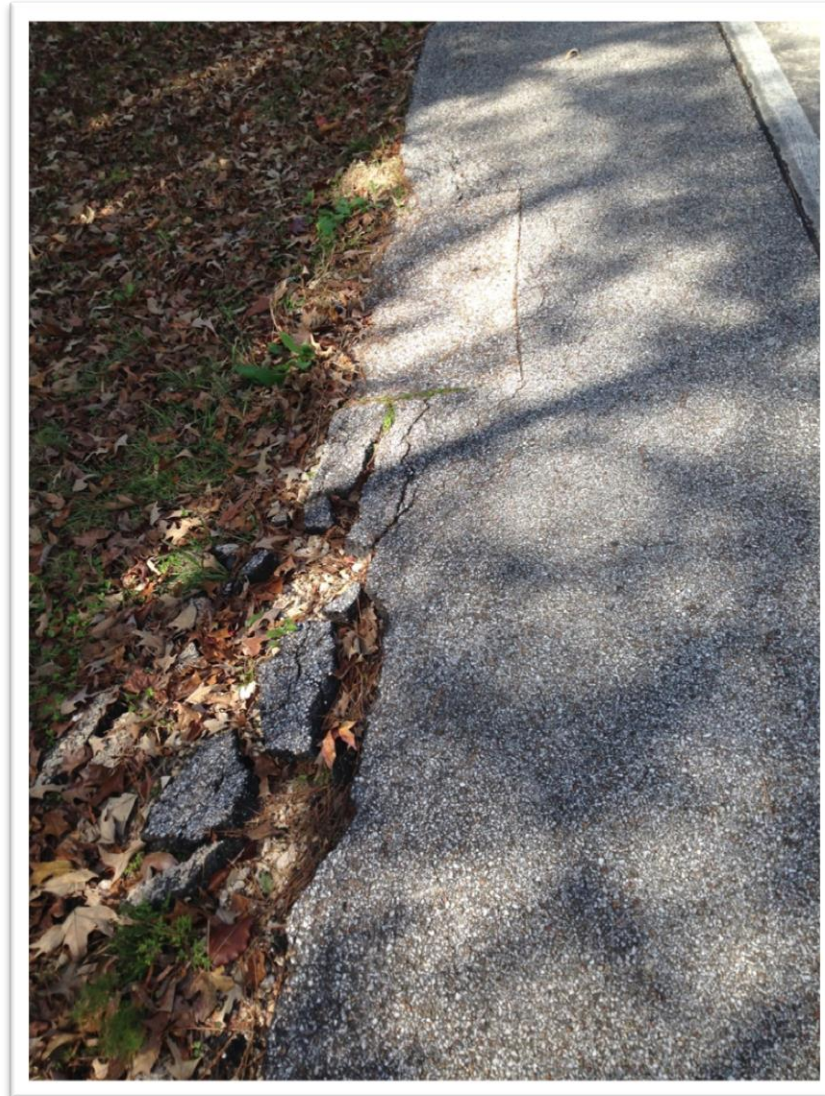
Location FR 15  
Flintridge  
Westbound

Hazard Type: Crack and Rough area  
Severity: 2

Right side of shoulder is eroding into the  
raven and crumbling apart

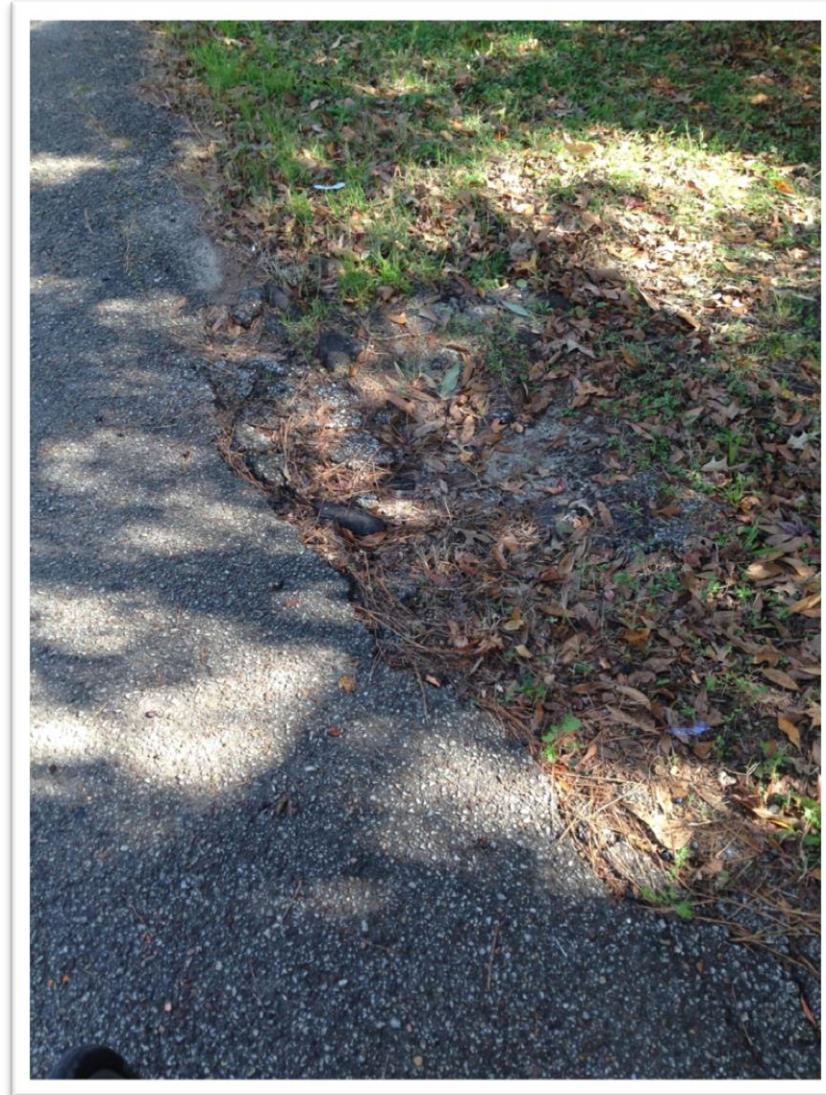
Location FR 16  
Flintridge  
Westbound

Hazard Type: Rough area    Rough pavement  
Severity: 2

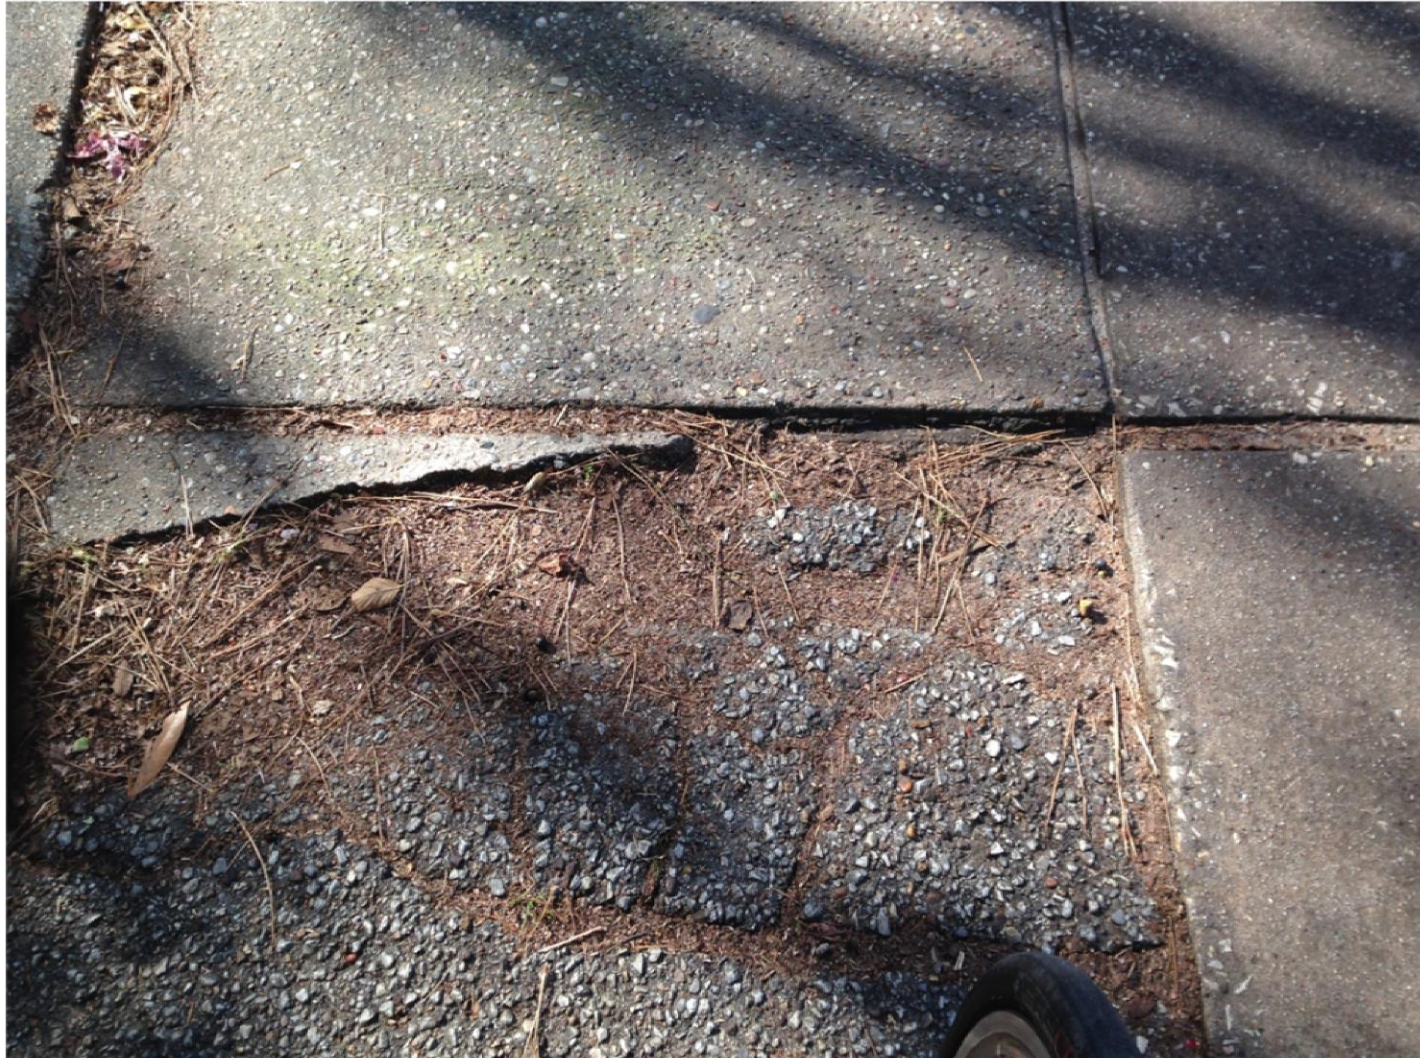
Location FR 17  
Flintridge  
Westbound

Hazard Type: Rough area    rough pavement  
Severity: 2
