Road Shoulder Hazards along  
Sterling Ridge – January 2015

Hazards on road shoulders, that could pose a risk to cyclists, were identified in January 2015 by volunteers from Bike The Woodlands Coalition.

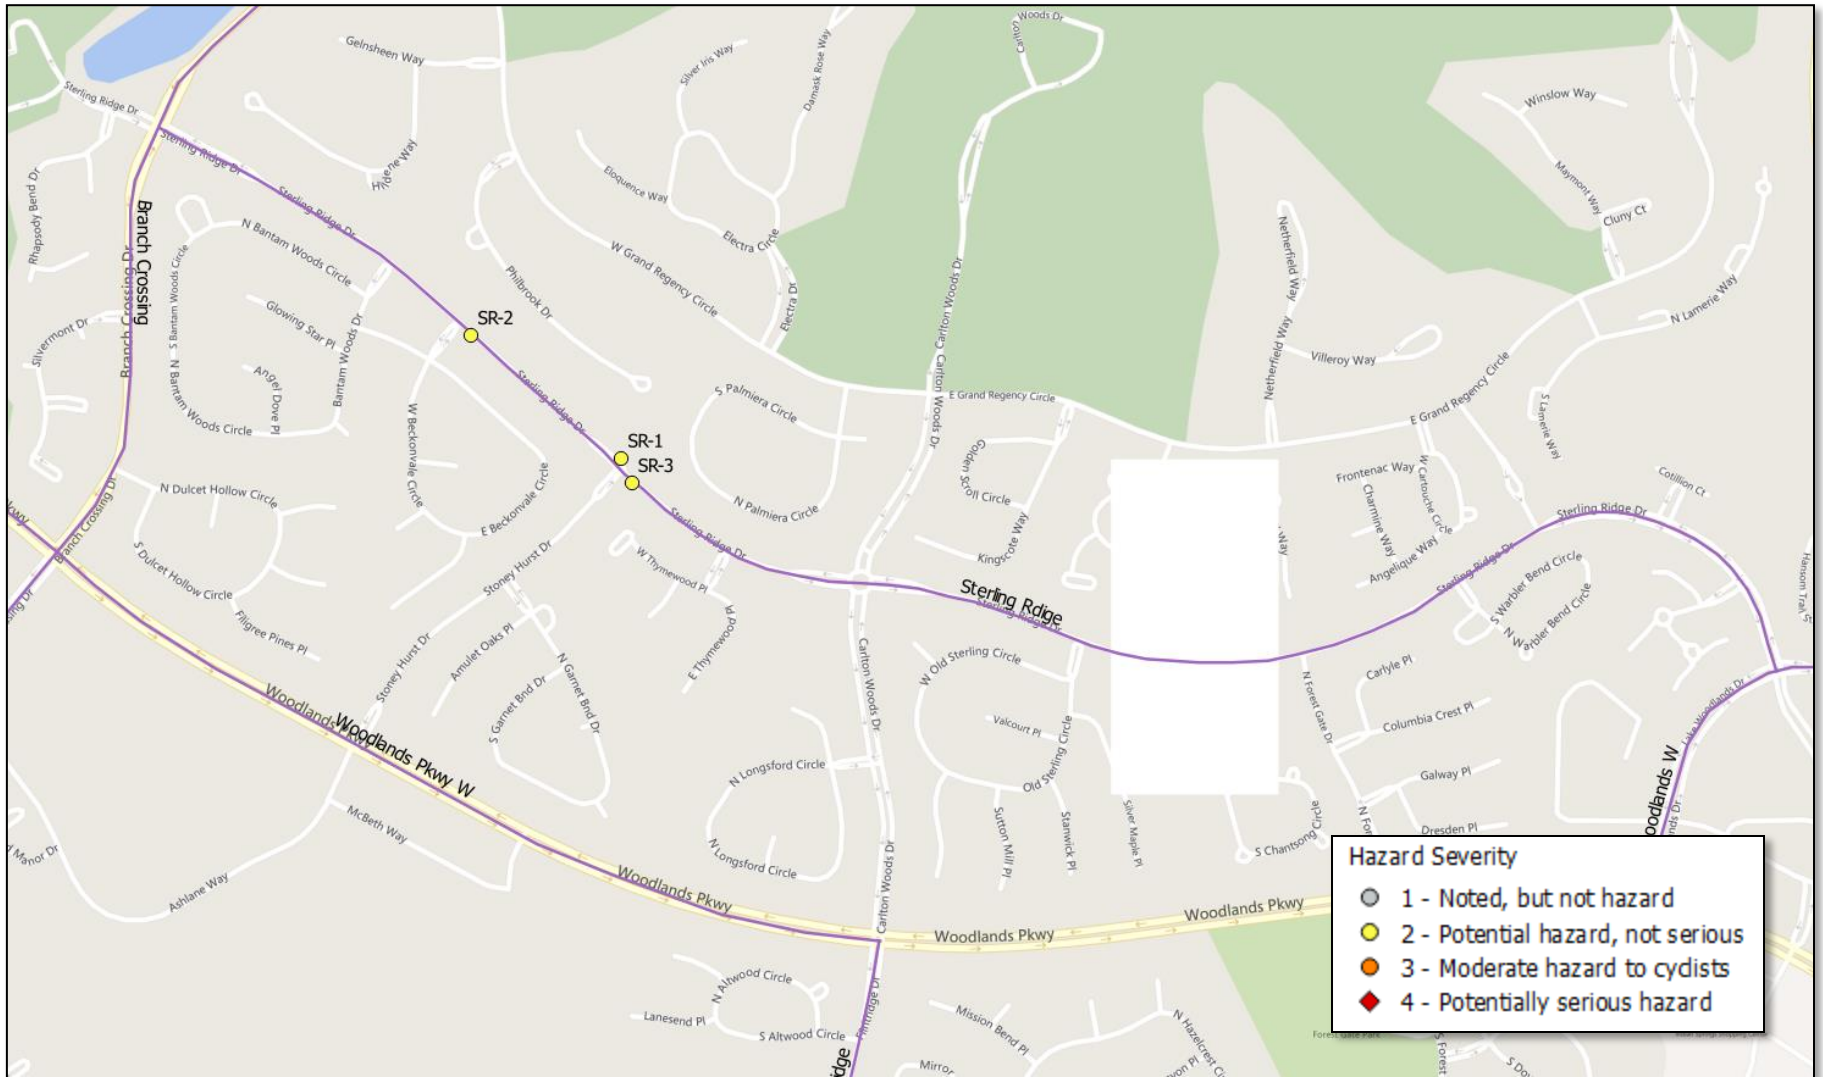
Location SR-1  
Sterling Ridge  
Westbound

Hazard Type: Rough Area  
Severity: 2

Rough area causing cyclists to move on to  
road if possible.

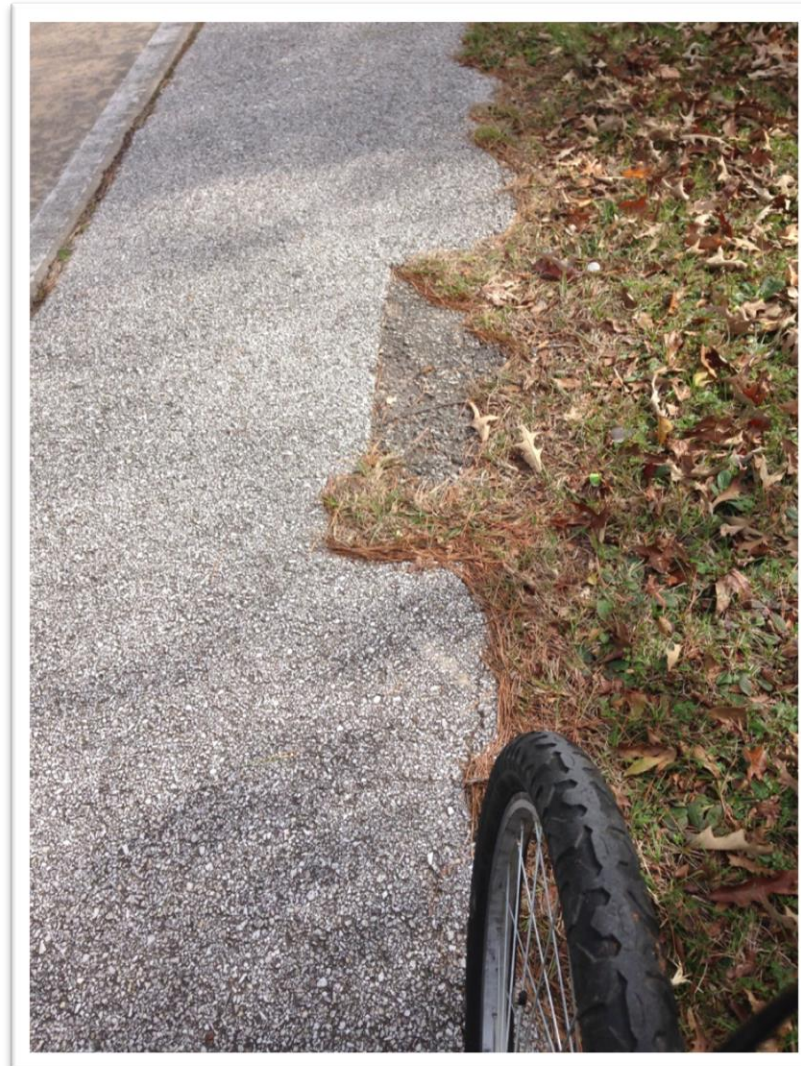
Location SR-2  
Sterling Ridge  
Eastbound

Hazard Type: Rough Area  
Severity: 2

Vegetation is starting to penetrate the perimeter of the patch.

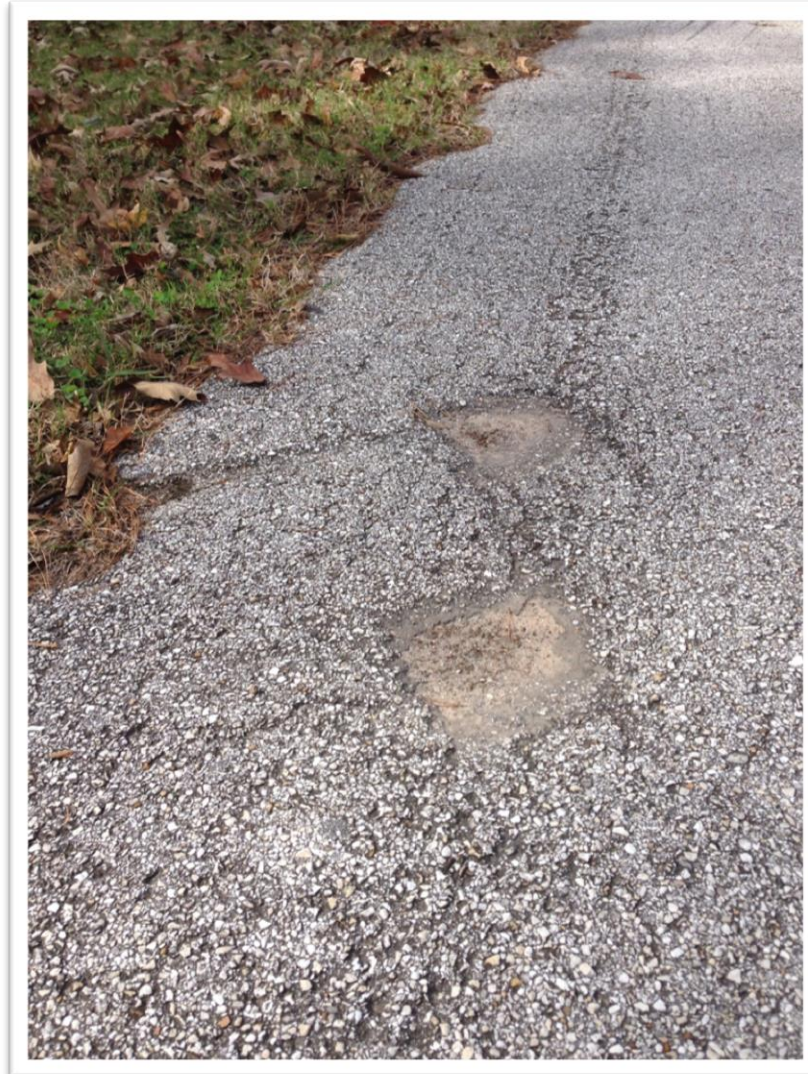
Location SR-3  
Sterling Ridge  
Eastbound

Hazard Type: Rough Area  
Severity: 3
